परियोजना का नाम :- जनपद नैनीताल के अन्तर्गत विकास खण्ड रामगढ़ में मौना-ल्वेशाल-कालापातल मोटर मार्ग के कि०मी० 10 से इंटर कॉलेज व प्रा० पा० होते हुए मटियाली से प्राचीन मंदिर कालीरौ तक मोटर मार्ग के निर्माण हेतु।

भू-वैज्ञानिक की आख्या

Geological Assessment for construction of 3.0 Km long alignment corridor proposed from Km 10 of Mauna-Loshal-Kalapatal motor road to Matiyali village, District- Nainital.

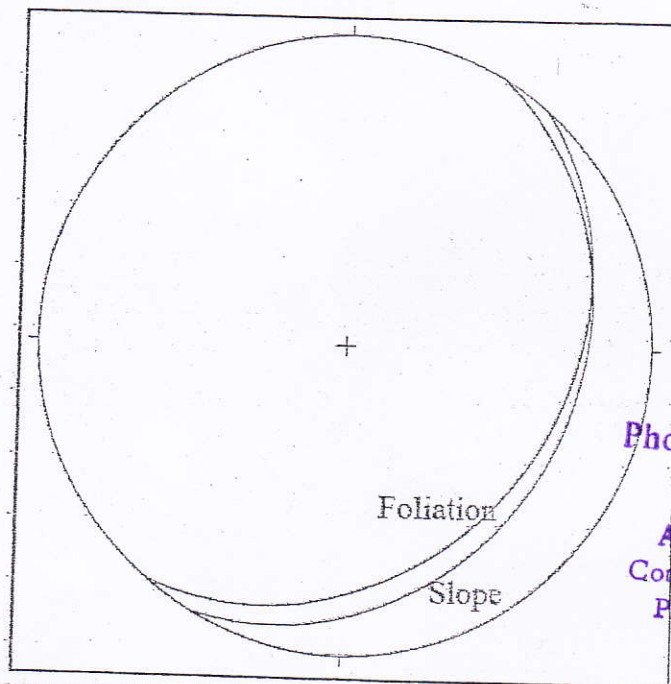
Figure 1 Stereographic projection of foliation and slope data observed in quartzite

From the above stereographic projection (Fig 1) it is clear that Joint J2 is susceptible for planar failure as it is parallel to the slope face until unless if there is a releasing surface such as tension crack on the slope. Thus joints do not create much impact on the stability of the area.

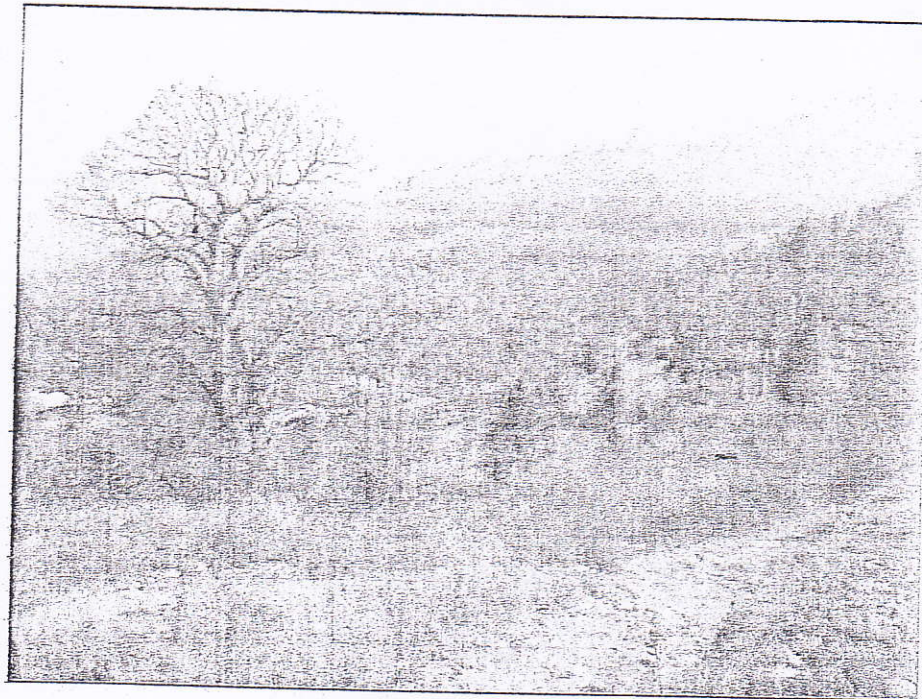
Figure 2 General topography of the area

Topography of the area overall is gentle. Manmade terraces were also observed which are mostly cultivated. Starting portion of the area is much steeper and is mostly covered with forest than the rest of the km's which falls on the terraces from where the alignment has been proposed (Fig. 2). Majority of area passes through cultivated terraces. Slope angle varies from place to place. Slope angle ranges from 25°-65° and slope direction varies from N130°-360°. Hydrological conditions are mainly dry, except in rainy season. No prominent nala is observed at the site. Largely the rocky strata along this alignment are capped by thin overburden material which varies in thickness from place to place and overall less than 1m. The soil material has micaceous content and the

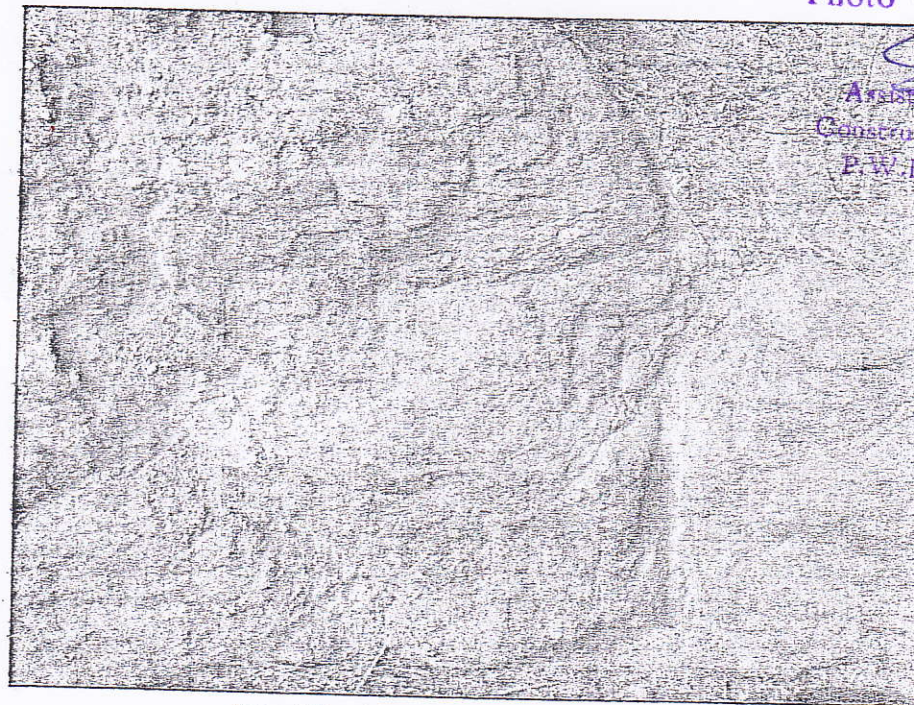
Figure 3 Quartzite rock outcrop observed at site

Rock type in the area is schist (Fig. 3), which is weak in strength. At some places the rock is highly sheared and weathered. Weathering grade ranges up to W₂-W₄. High grade of deformation is observed. Foliation has been observed in schist at the site which is as follows-
