स्थल निरीक्षण

कार्य का नाम — मा0 मुख्यमंत्री घोषणा संख्या-2294/2015 के अन्तर्गत जनपद अल्मोड़ा के वि०स० क्षेत्र सोमेश्वर के अन्तर्गत धामस-ज्योली मोटर मार्ग के विस्तार का समरेखण प्रस्ताव।

Geological Assessment of 11.2 Km long extension of Someshwer-Khut-Dhamas-Basar-Joili motor road Almora District.

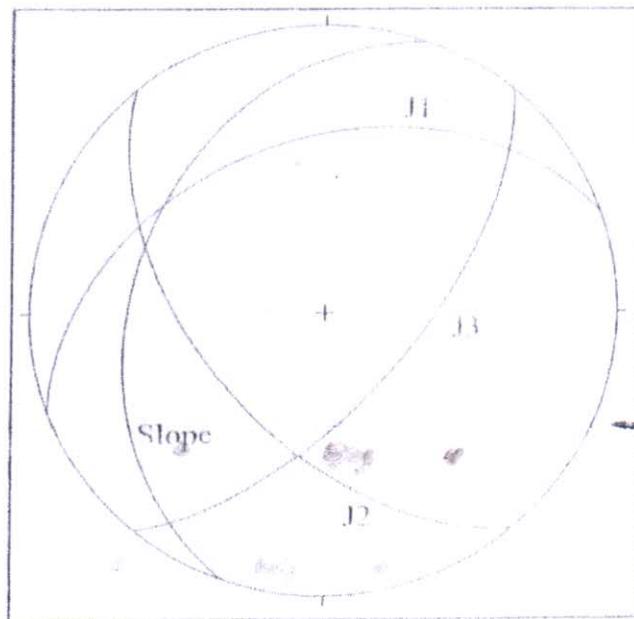
Figure 15 Stereographic projection of joints and slope data observed in quartzite

From the above stereographic projection (Fig 1) it is clear that joints J1 & J2 are forming a small wedge in the slope direction. If any joint or tension crack acts as a releasing surface along the alignment the failure can occur.

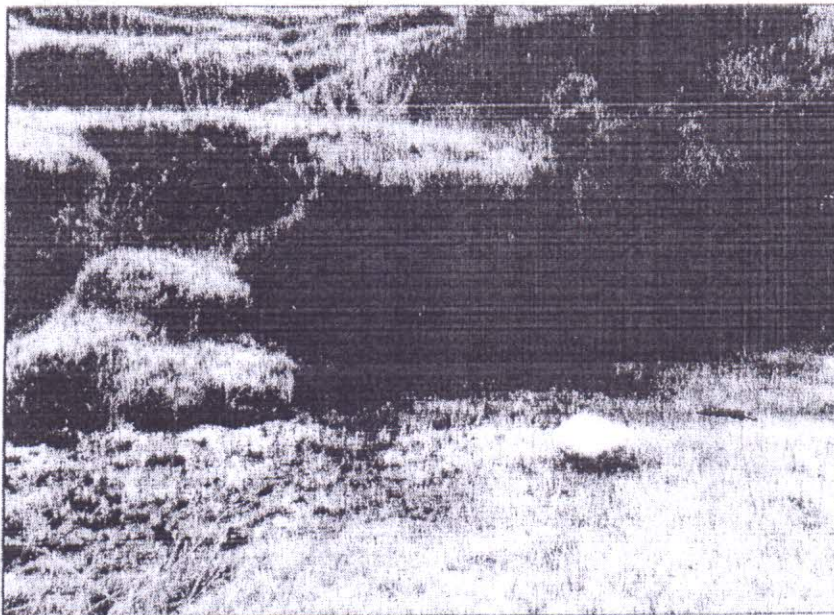
Figure 2 Water seepage from the ground observed at the 1st km of the road.

- 3- Properly designed culvert/bridges must be constructed over the nala whichever is suitable.
- 4- Construct U shaped lined drain all along the hill side of the road and made adequate cross drainage arrangements. The accumulated rain water from upper reaches of the hill must not allow to flow freely over the road constructed and its lower hill slopes.

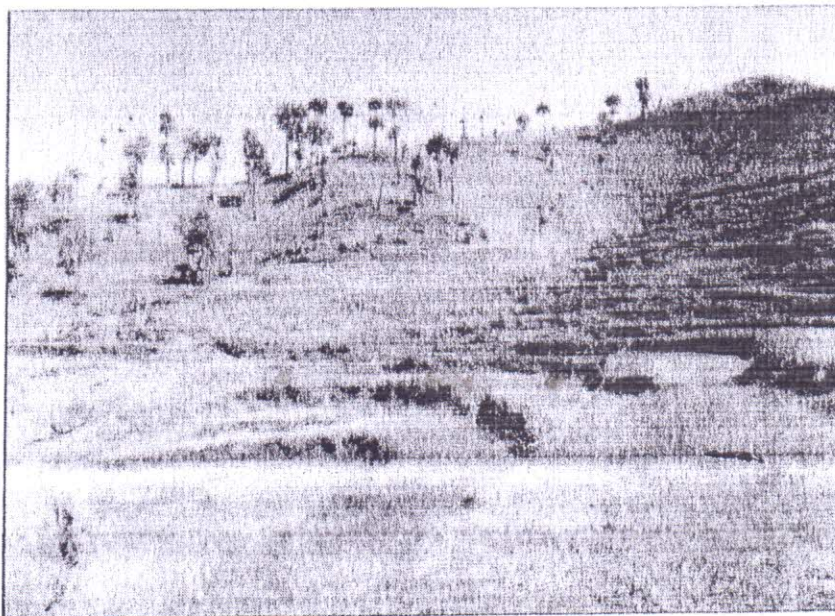
Figure 3 General topography of the area

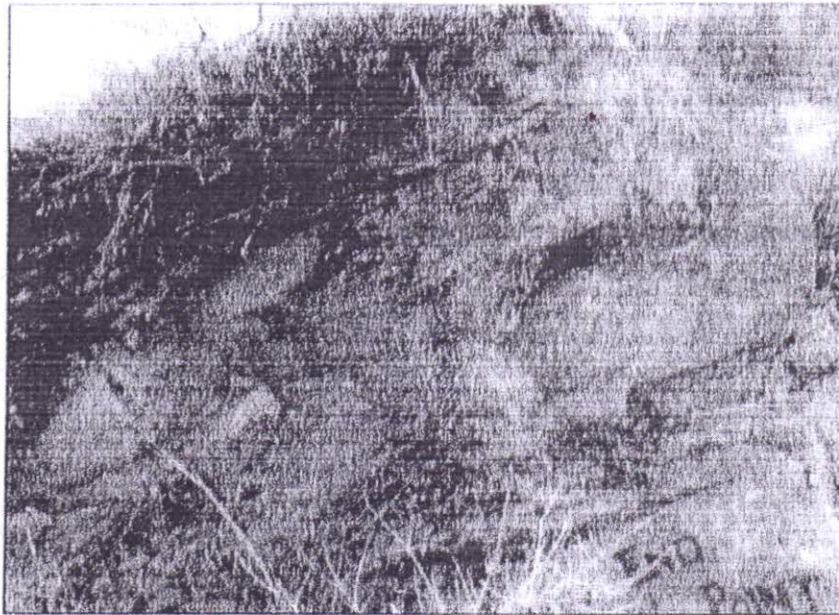
Figure 4 Micaceous Quartzite rock observed along the alignment
