Geological Assessment of 3.40 Km long Taintuda to Naini Motor Road
between CH 0.00 to 3.40 Km, Gairsain Block,
District Pauri (Garhwal)
Tushar Sharma
14/08/2019

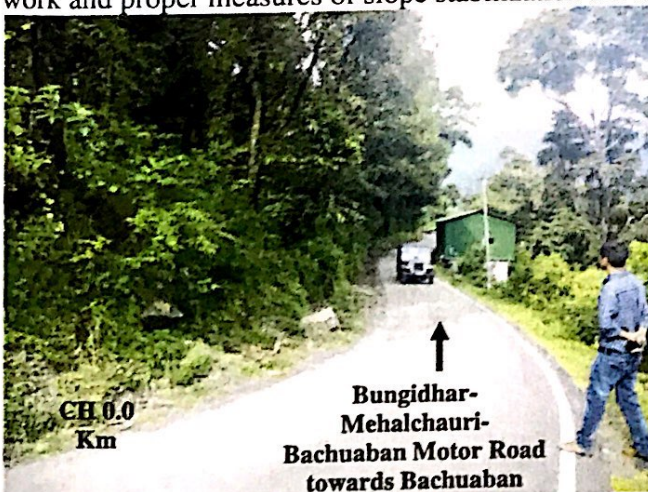
View of motor road alignment site at CH 0.0 Km

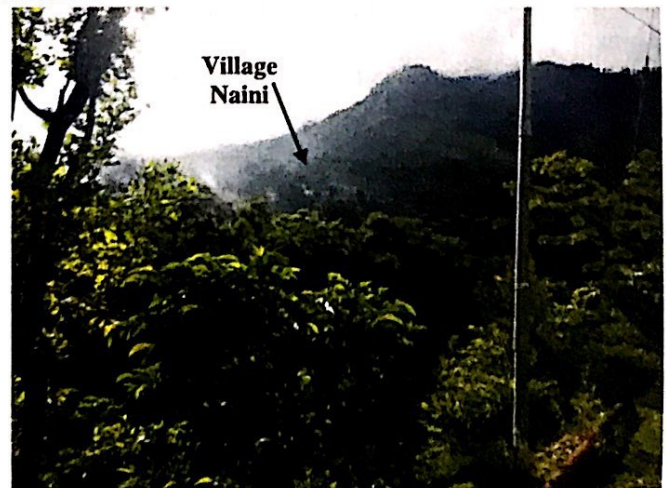
View of hill slope of motor road alignment site
