Geological Assessment of 8.675 Km long Dhotigad-Pachgaon-Syura link motor road District- Almora.

Priya Joshi

18/11/2016

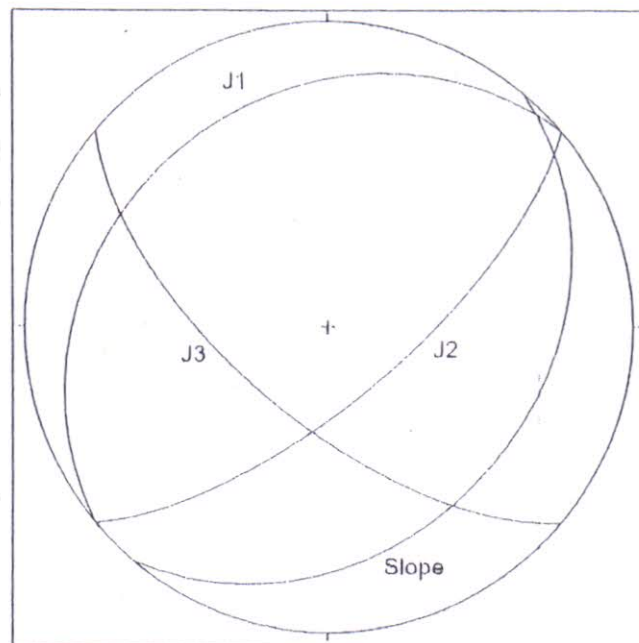
Figure 1 Stereographic projections of joints and slope data in Quartzite

From the above stereographic projections (Fig1) it is clear that none type of translational failure is observed in the quartzite thus joints do not create much impact on the stability of the area.

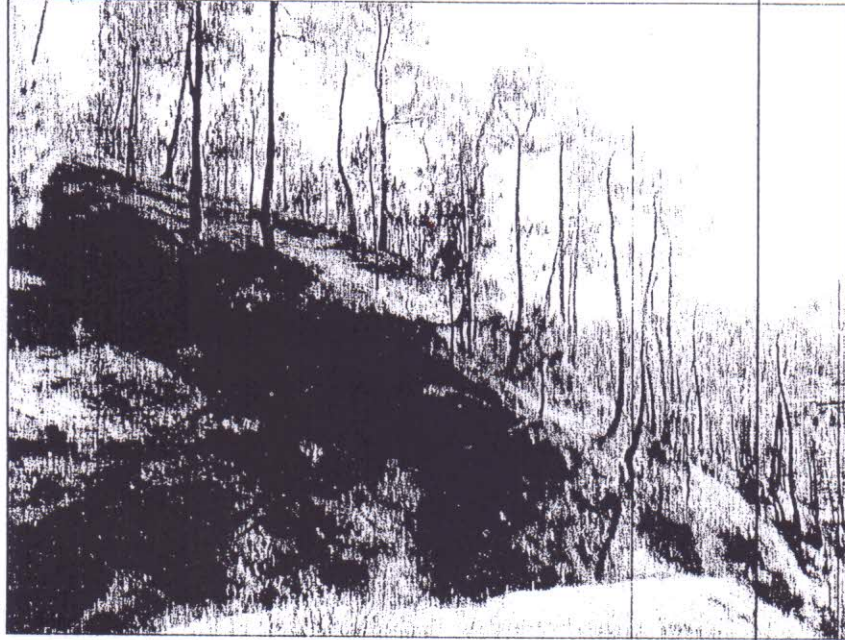
Figure 2 General topography of the area

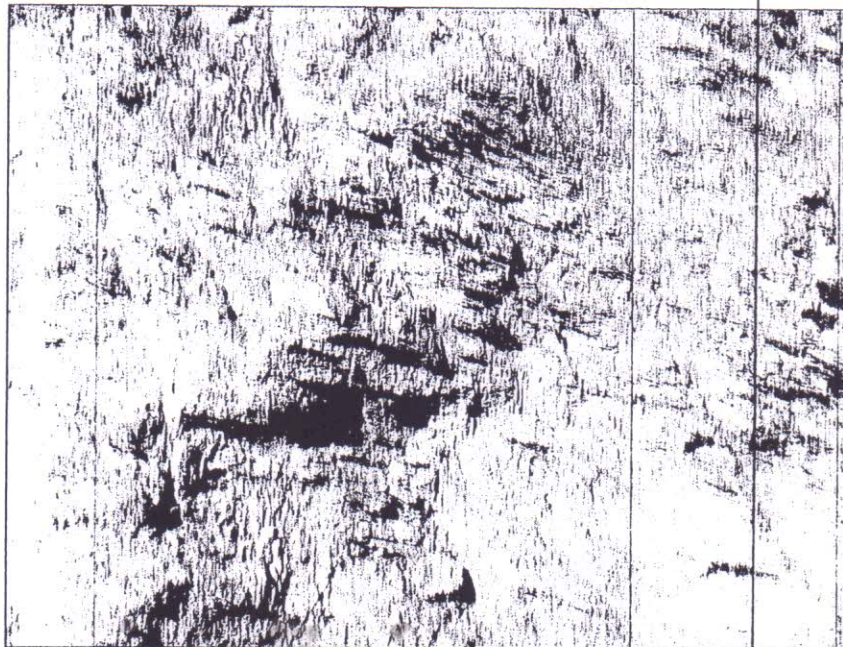
Figure 3 Schist outcrop observed at site

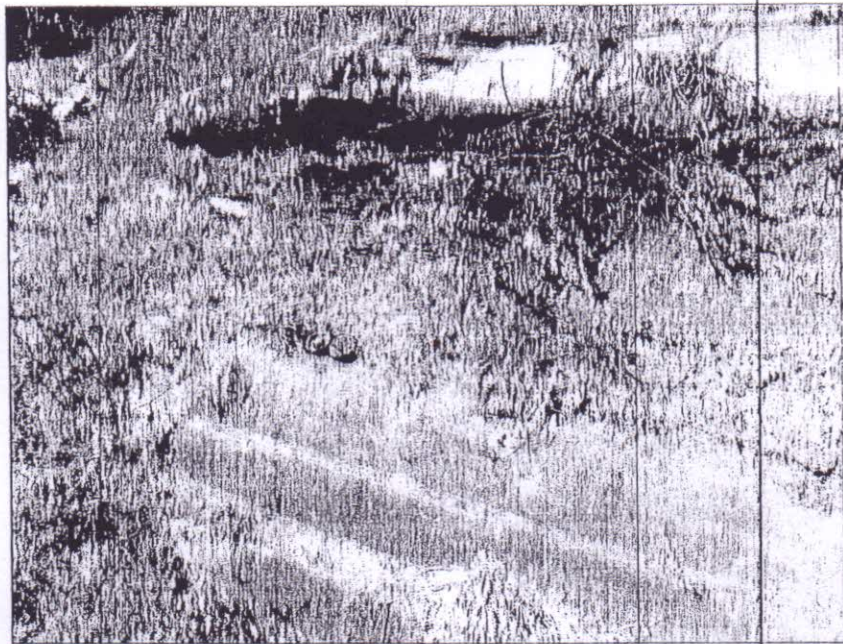
Figure 4 Quartzite rock observed at the site in between thin band of Schist
