## Geological Assessment of the alignment corridor proposed from Manan of Takula to Chandrapur length 2.0 Km District Almora.

**1- Introduction:-** The Construction Division, Public Works Department, Almora has proposed the construction of 2.0 Km motor road from Manan of Takula to Chandrapur District Almora. On the request made by Mr. B. C. Pant Executive Engineer Construction Division Almora, I carried out the geological assessment of the proposed site of the above said motor road on dated 29.08.2018. Junior Engineer Mr. Kishor Bangari accompanied during the site visit.

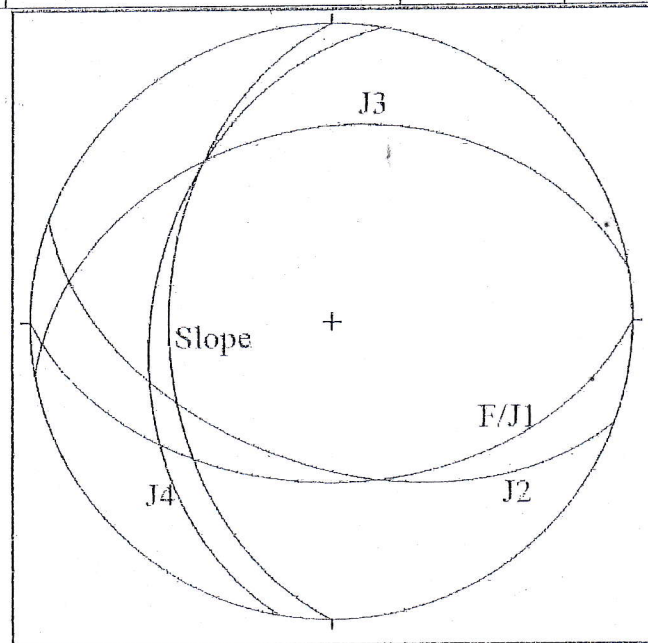
Figure Stereographic projection of joints and slope data recorded from the outcrop.

From the above stereographic projection it is clear that joint J4 dips in slope direction which is forming planar failure condition at given location along with a wedge is also forming due to the intersection of J2 and J3 and dips in slope direction thus failure can occur; if any joint or tension crack acts as a releasing surface.

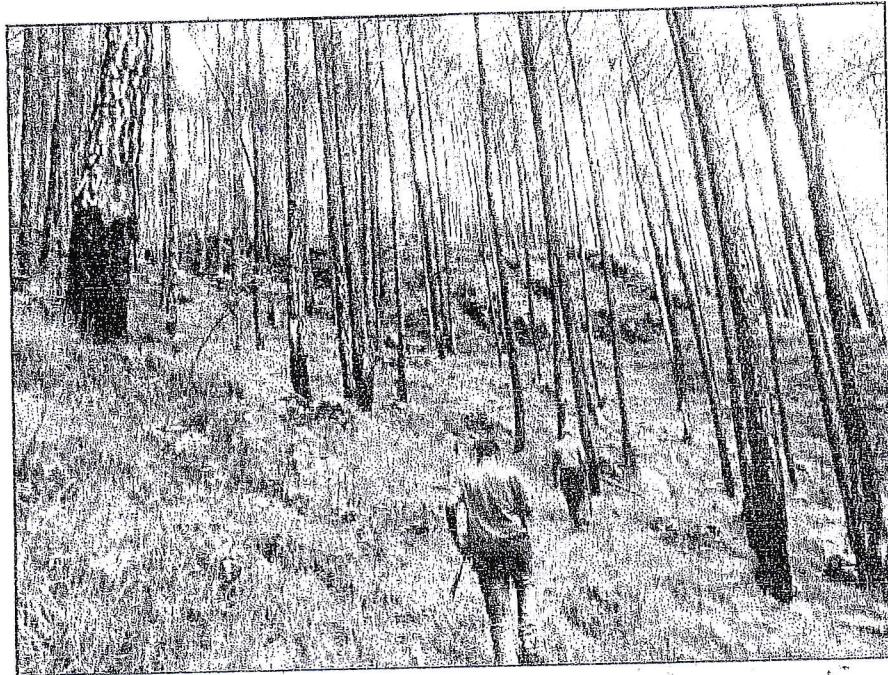
Figure 2 General topography of the site

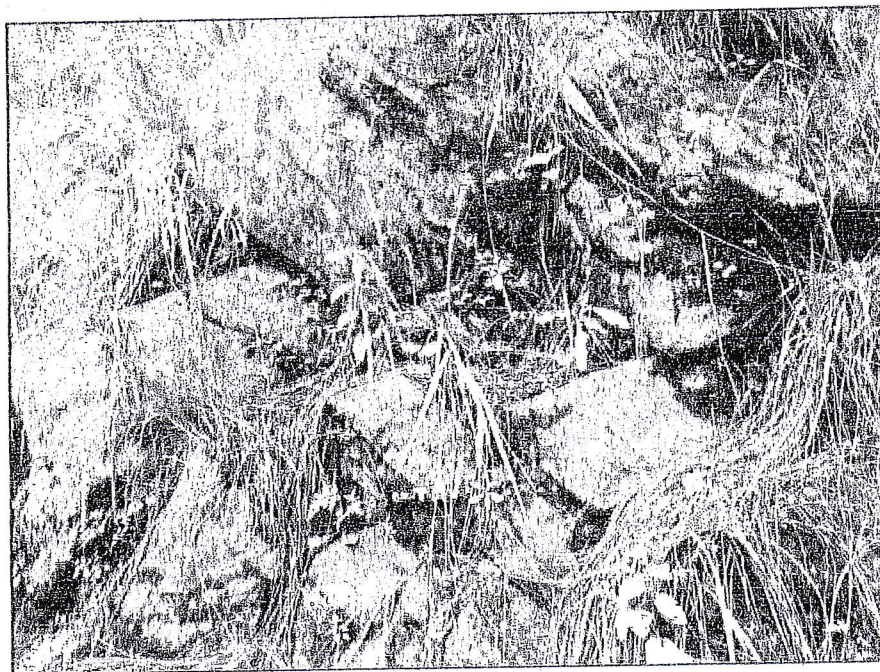
Figure 3 View of planting point comparing of slope landslide depth
