**Geological Assessment of the alignment corridor proposed for the  
Construction of 5.0 Km Majhera-Kumarti-Saure-Naurad motor  
road in Bhikiyasain Block, Ranikhet District-Almora.**

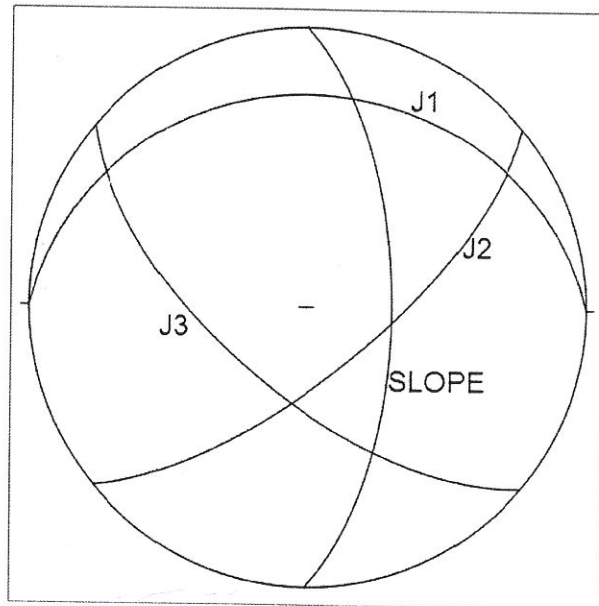
Remaining portion of the alignment is comprised of quartzite which contains mica, thus a minor schistosity is observed. The rocks are massive, hard and compact in nature. These rock masses have been dissected by many linear discontinuities. Three prominent sets of joints are prominently identified (Fig.1). Quartzites are hard compact in strength and show not much sign of deformation. The rocks are slightly weathered and oxidized up to  $W_1$  grade. Hydrological conditions in this area are mainly dry in the fair weather. The prominent joint sets recorded from the rock outcrops exposed at the site are as follows-

Fig. 1 Stereographic projection of joints and slope data of Bhikiyasain road which lies above the proposed motor road

From the above stereographic projection it is clear that the joints  $J_1$  and  $J_2$  form a slight wedge but it do not create much impact on the stability of the area, as the rock is quite competent and hard in physical strength. It is apprehended that small rock slides may be

encountered during the construction at the starting point but the rest part of the alignment looks stable and quite competent from the stability point of view.

- 1- Construct the road by half cut and half fill method and compact the fill material properly, preferably by the dynamic compaction.
- 2- In the rocky part do not blast heavily by explosives. It is recommended that the blasting shall be carried out by controlled method i.e. by leaving large volume of dummy holes.

- 3- The entire hill and valley side slope along the whole length of the road must be protected by suitably designed retaining/ breast walls. This work should be done simultaneously with the advancement of the road cutting. It is advised to leave sufficient weep holes in the walls; this is so as to facilitate the subsurface drainage.
