कार्यालय मुख्य अधियन्ता, लो०निं०वि०, अल्मोड़ा  
Office of the Chief Engineer, P.W.D., Almora

विषय - मोटर मार्गों के भूगर्भीय निरीक्षण के सम्बन्ध में।

## Geological Assessment of the alignment corridor of Matela-Gairoli motor road, length 1.5 km, District-Almora.

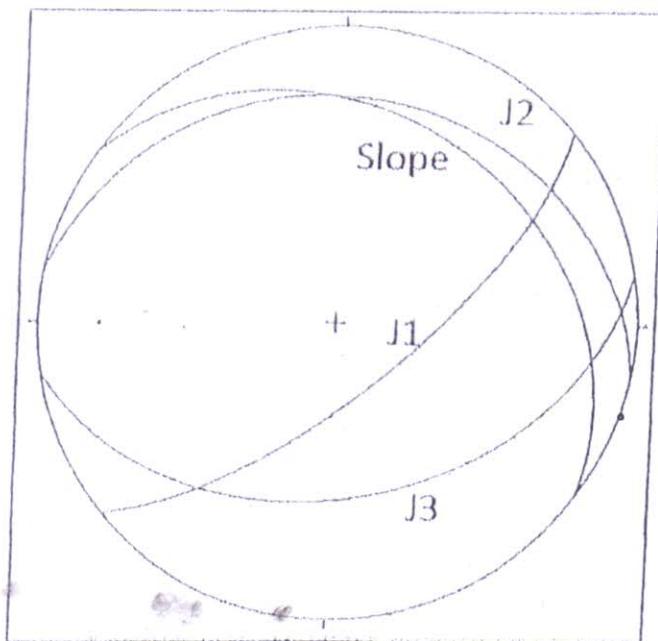
Figure 1 Stereographic projection of joints and slope data

From the above stereographic projection Fig 1 it is clear that the foliation/Joints do not create much impact on the stability of the area. The plunge direction of the wedge which is forming due to the interaction of the joints J1 and J2 is different from slope direction from which it looks stable and quite competent from the stability point of view.
