Geological Assessment of 4.00 Km long motor road from Km 13.900 of Kakdighat-Sitlakhet motor road to Village Matila (S.C. Basthi) District- Almora.

1- Introduction- Provincial Division, Public Works Department Almora entrusted in construction of 4.00 Km long motor road from Km 13.900 of Kakdighat-Sitlakhet motor road to Village Matila (S.C. Basthi) Almora District. On the request of Executive Engineer, Provincial Division, Almora I carried out geological assessment of the above said motor road on dated 29/11/2019. Assistant Engineer Mr. Kamal Goyal and Junior Engineer Mr. Jagdish Prasad accompanied during the site visit.

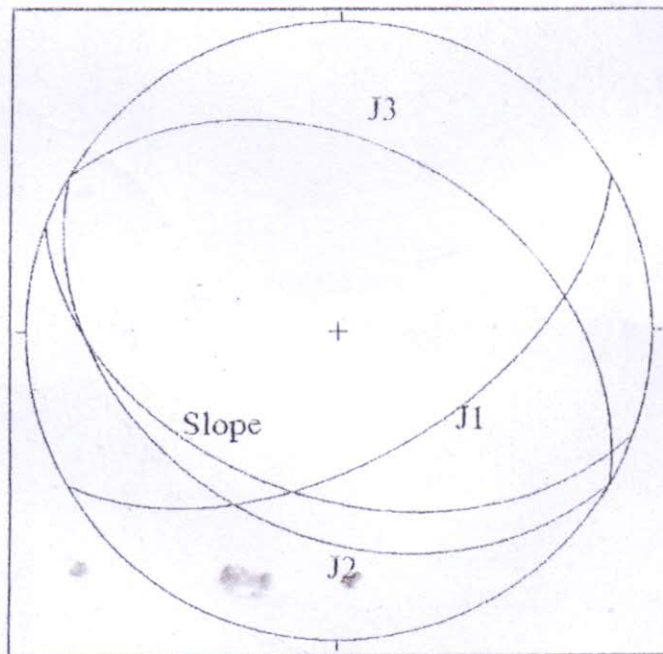
Figure 1: Stereographic projection of joints and slope data recorded from quartzite outcrop

From the above stereographic projections it is clear that planar failure can occur along joint J2 as the joint J2 dips in the slope direction and a wedge is also forming due to

intersection of joints J2 and J1 but does not dips in slope direction. Planar and wedge failure can occur in case if any joint or tension crack acts as a releasing surface

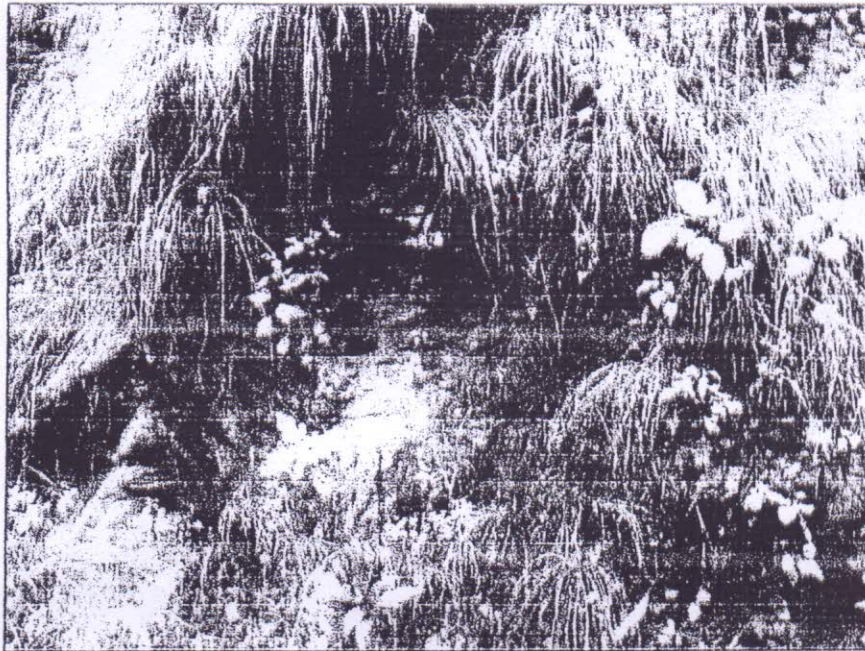
Figure 2 Highly defuncted shear zone in the slope exposed at the site

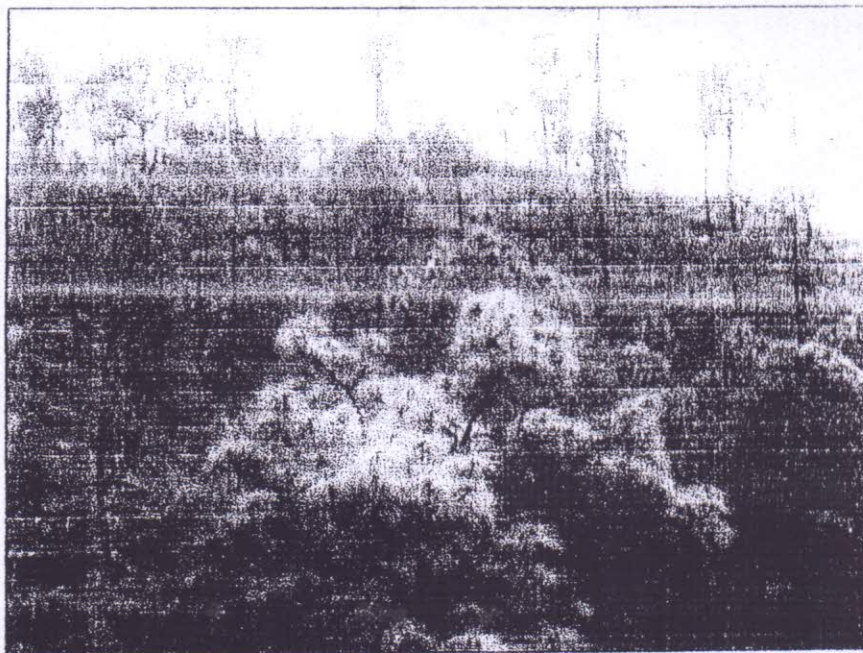
Figure 1 General topography of the area

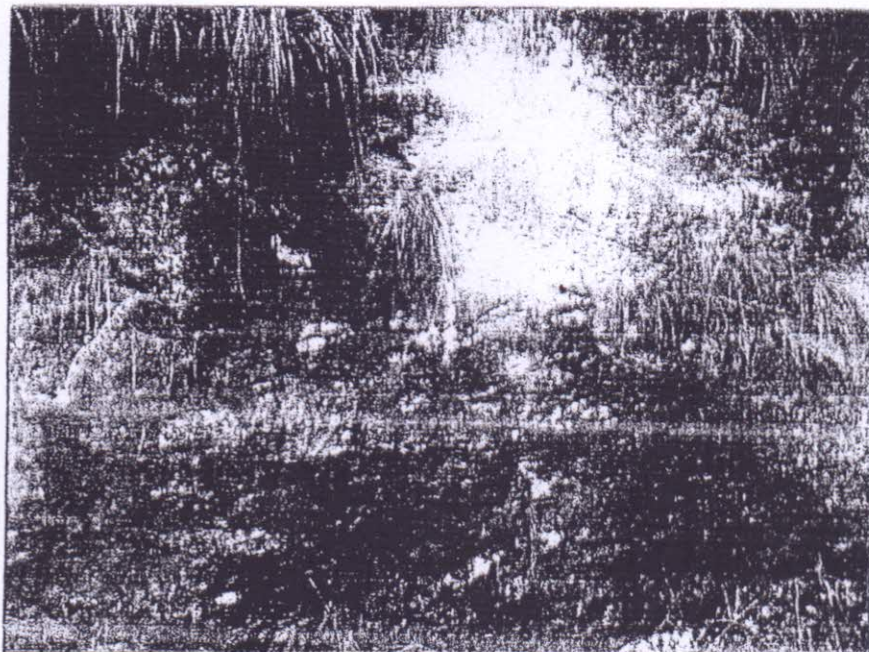
Figure 4 Gneiss outcrop with quartz veins observed at the starting point
