भू-गर्भीय निरीक्षण आख्या ए0जी0- 287 / सड़क / पुल / समेखण / उत्तराखण्ड / गढ़वाल-2020

Geological Assessment of the alignment corridor proposed for the  
construction of 10.40 km long motor road joining village Purkul to  
Bhirtali-Kimadi motor road, in Sahaspur block, distt. Dehradun.

03 फरवरी 2020

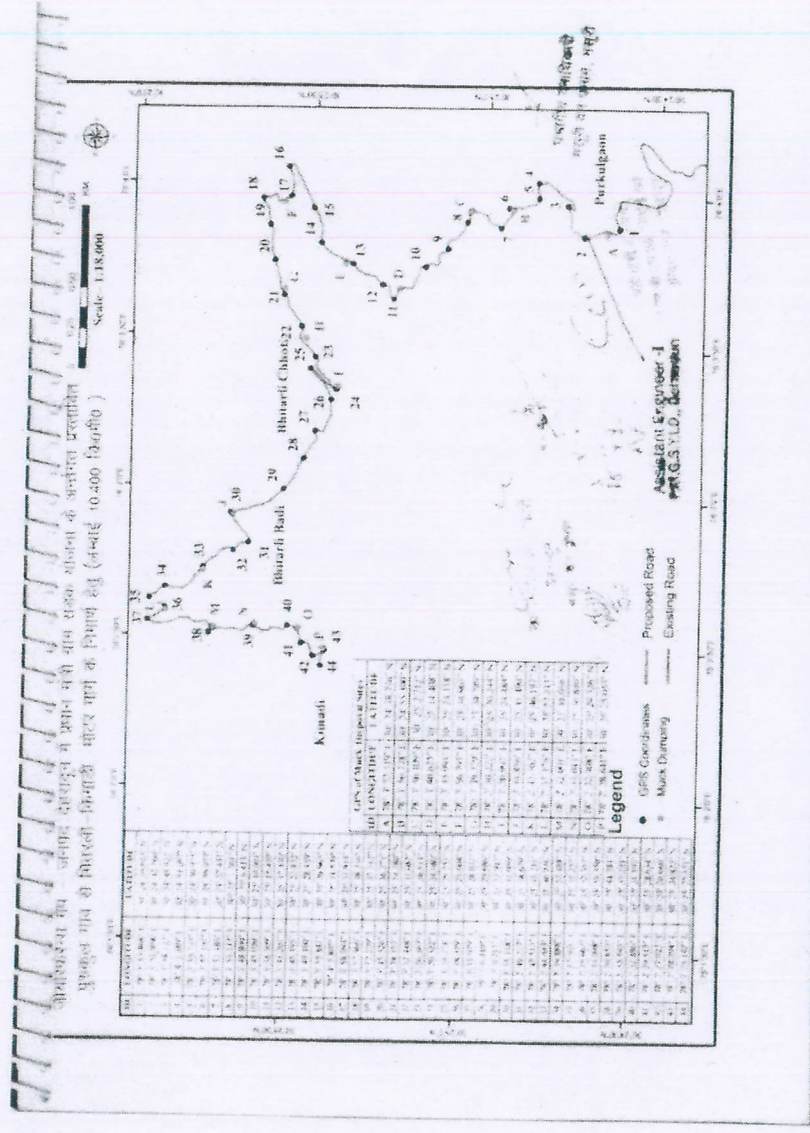
Digital map of the proposed alignment of village Purkul to Bitharli-Kimadi motor road, distt. Dehradun

Due to the existing narrow jeep road(point no. 25 in digital map shown below) and a stretch of steep hill slope(point no. 11), the alignment 1 was questioned by the "Department of Forest and Climate Change". Therefore, on the request made by Er. Sanjay Singh, Executive Engineer, I carried out the geological assessment of the whole alignment with special focus on the "questioned stretch" of the alignment on 30.01.2020 in the presence of Er. S.B Lingwal, Assistant Engineer and Er. Vikas Barthwal, Junior Engineer, PMGSY, Irrigation Division, Dehradun.

The proposed 10.40 km long alignment corridor originating from km 6 of Malsi-Purkul motor road in the upslope direction comprising 5 HP bends following the upslope of the high gradient jeep road, in Sahaspur block, distt. Dehradun. The alignment stretch in questioned is the point no. 11 and 25 as shown in the digital map (explained in details below).

At the point no. 11 as per digital map, there is a small slip zone which activated recently before 2-3 years forming 2 chure. Prima Facie, it seems to be activated due to the continuous hydraulic impact at the toe of the hill slope as the gadera bears the sinous course with left bank as the cut-off side and right bank as slip-off side. The stretch of 40-50 m near point no. 11 passes across this steep slope have extensive seepage with fractured bedrock underneath. Therefore, toe protection is essential to avoid any toe erosion and facilitate sliding in future.

At the point no. 25, there is a existing jeep road but have gradient of 1:6 to 1:12 which is extremely high in comparison to the proposed gradient of 1:24 to 1:20. Also, the current jeep road passes across a slide zone which may become huge post toe-cutting. Therefore, the proposed alignment passing above the crown of the active slide zone.

1. Across the steep slope, i.e near point no. 11 in digital map, the construction for 50 m stretch of road should be carried out by half cut and half fill method with ascent upward. The extensive seepage will reduce the intergranular shearing strength and may facilitate sliding. Therefore, the slope with basement for gabion wall should be strength by deeply anchored soil nailing technique (for foundation) followed by shotcreting, so as to improve the ground characteristics and minimize the probability of any rock fall/sliding.

2. Due to the sinous course of the gadera, Gabion wall in 2-3 step should be construct at the toe of the hill slope point no. 11 (in digital map) to avoid toe scouring/erosion by the huge discharge of gadera in monsoon.
