## **Note on Geological Aspects–Kolidhek Artificial Lake Project, Champavat (Uttarakhand)**

### **1. Background**

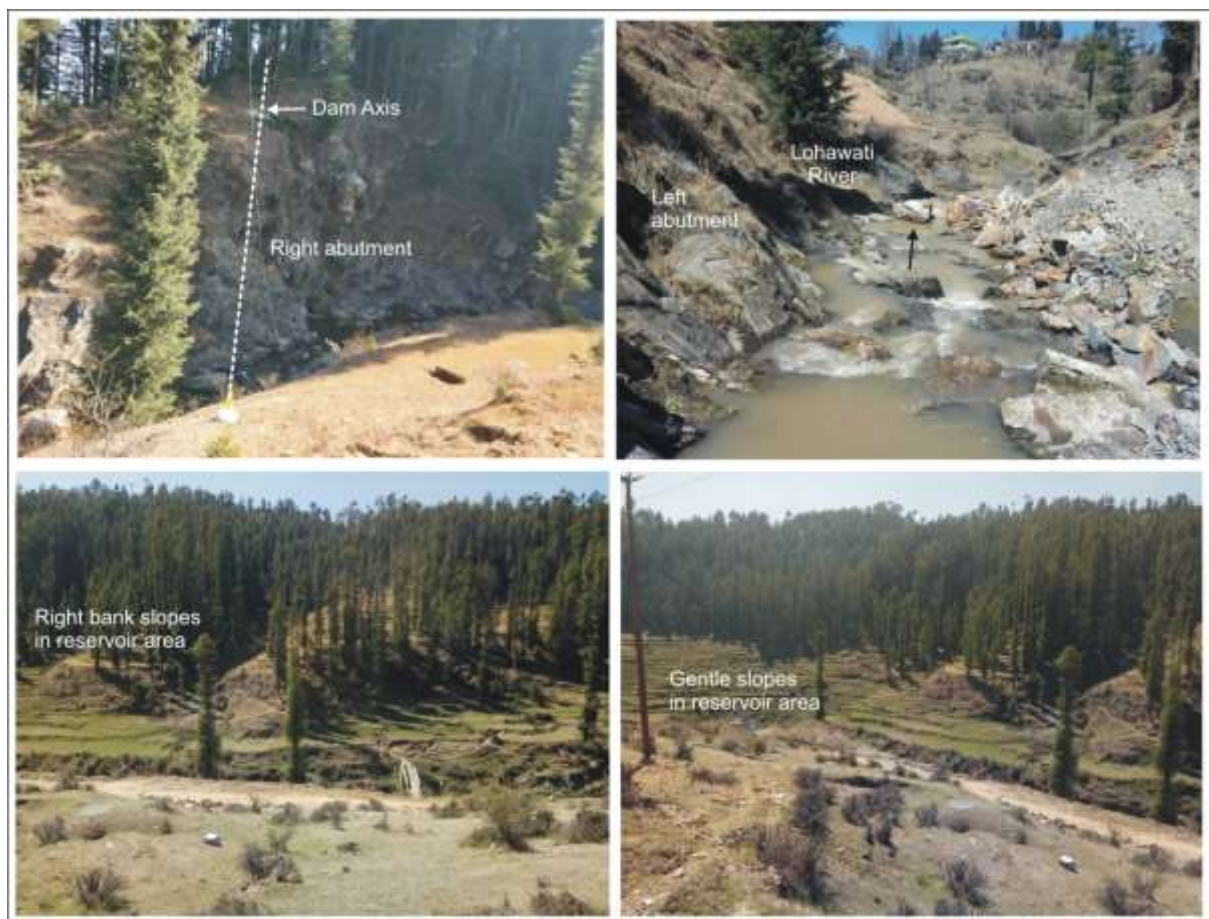
The proposed reservoir slopes of the Kolidekh project are mostly gentle along the left and right bank of the river (Plate 1). The slopes are mostly terraced and are covered by agricultural and barren lands. The right bank slopes near to the dam site and in the middle portion of the reservoir are partly covered by the forest land. The left bank slopes are relatively gentle, terraced and are covered by barren lands around the dam site, in the middle portion and in the uppermost portion of the reservoir (Fig.1).

**Plate 1 View of dam site and reservoir area**

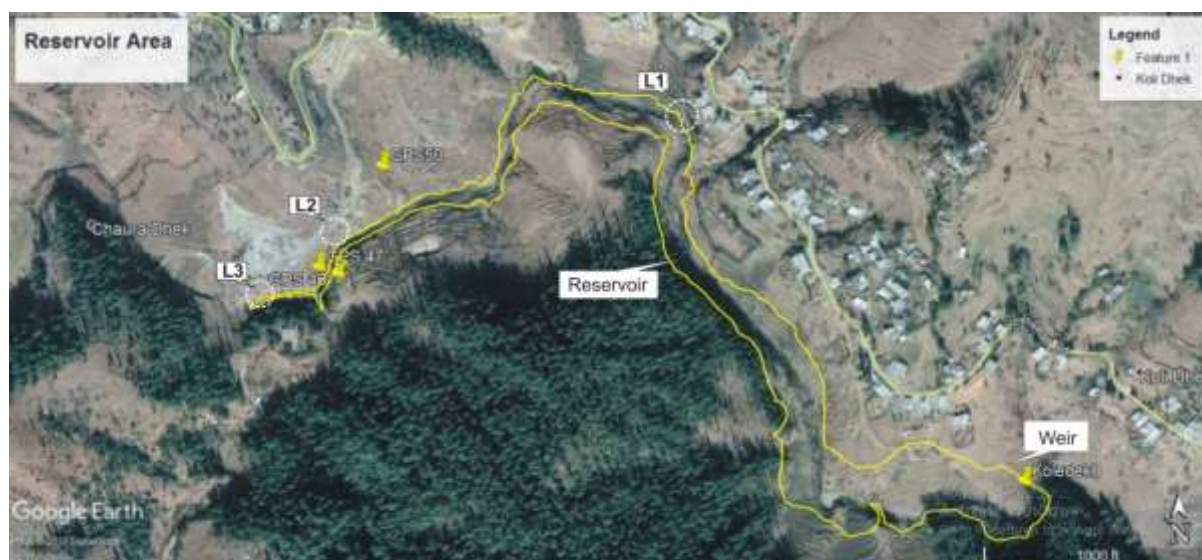
**Fig.1 Reservoir area of Kolidekh artificial lake project as seen through Google Earth image**

The middle portion of the left bank and the upper middle portion of the right bank slopes are covered by the agricultural lands. Since most of the lands on the either banks of the reservoir are terraced and gently inclined slopes, the slopes in general are considered to be stable under anticipated adverse conditions. The slopes along the river banks in the lower most reaches are generally rocky and form steep sections of low height. In these sections possibility of isolated rock failure may exist wherever kinematic conditions would be satisfied. However, such small failure may not have a potential to generate destructive waves that may adversely affect the stability of the project. Moreover, these steeper rock slope sections would be partially or fully submerged under reservoir water. A horizontal thrust would be exerted by the reservoir water which may improve the stability of the slope. Further, during reservoir operation rising and drawdown may bring changes in the material properties, particularly changes in the shear strength that may affect the stability of the slope section within the fluctuating zones. The rising of reservoir will saturate the overburden material and the rock mass sections and on the same time a horizontal thrust will also be provided by the reservoir. During drawdown minor changes are expected that may possibly destabilize the slopes. However, it will depend on the slope inclination, slope material, landuse, kinematic conditions and the shear strength properties of the slope material.

Finally, based on the topographical and geological considerations, prima facie, it may be concluded that the filling of the reservoir may not affect the stability conditions of the reservoir slopes. Thus, there seems to be no possibility of generation of destructive water wave in the reservoir due to any major slope failure under anticipated adverse conditions that may possibly affect the stability of the dam. Further, in the reservoir area along the left bank three slope sections, marked as L1, L2 and L3 (Fig.1) may require slope protection works. These locations have habitations and a road section well above the reservoir level. Slope protection at these locations will add to the safety of these features.
