Geological Assessment of 5.2 Km long alignment from Sahid Inder Singh Bargali motor road to Khanshyu motor road, Okhalkanda Block, District- Nainital.

Pravin Joshi
25/06/2019

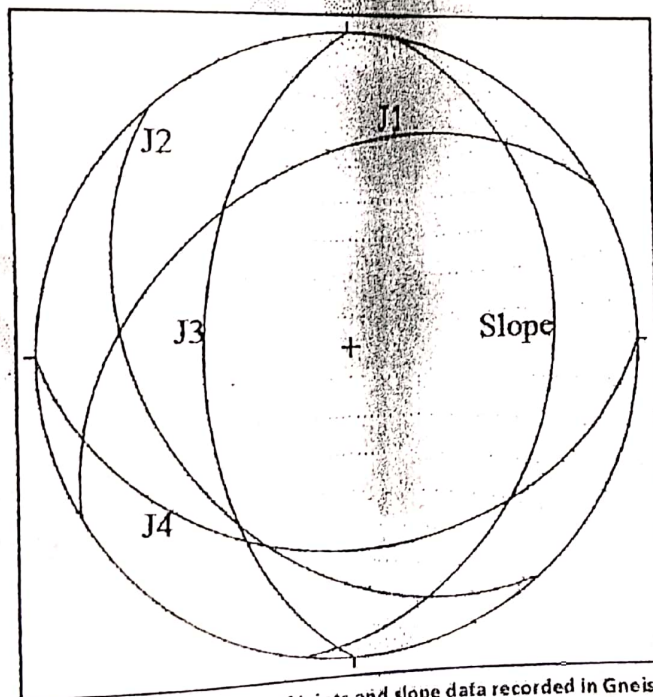
Figure 1 Stereographic projection of joints and slope data recorded in Gneiss outcrop.

From the above stereographic projection (Fig 1) it is clear that due to intersection of joints J1, and J2 is forming wedge in slope direction which is prone to failure, if any joint

or tension crack acts as a releasing surface along the alignment then the wedge failure can occur.

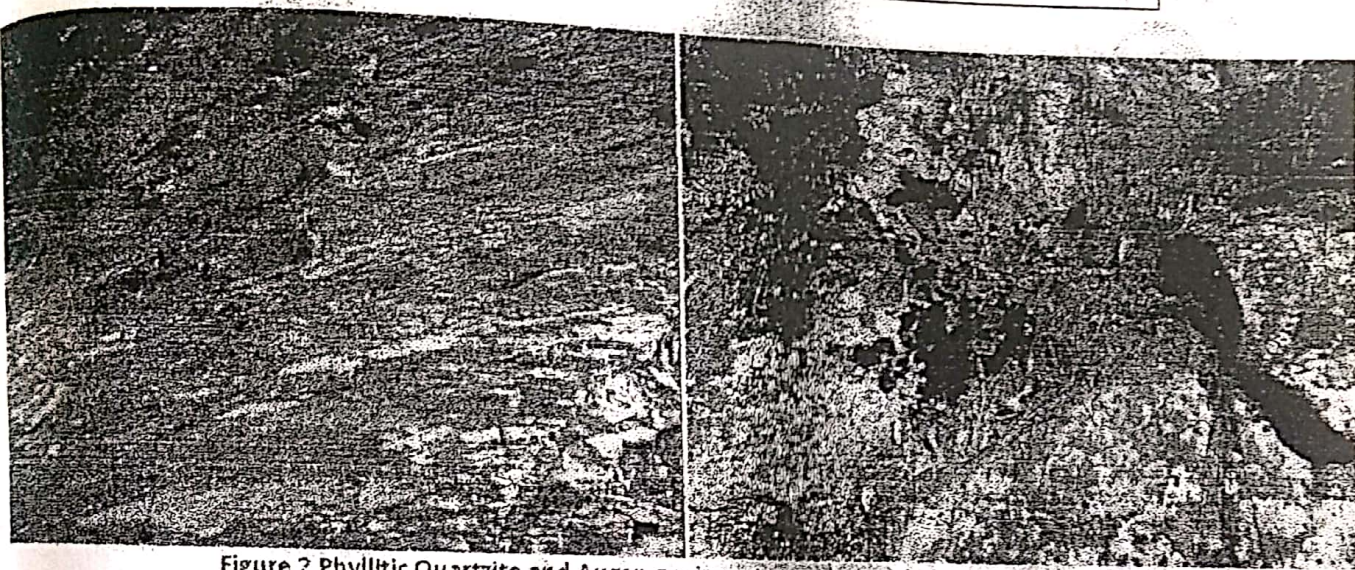
Rock type in the area is Phyllitic Quartzite and Augen Gneiss, which is hard and compact in strength. Quartzite is more deformed, fractured and weathered than the gneiss. Strength of the rock is estimated with manual test. At some places the rock is highly sheared and weathered. High grade of deformation is observed at the starting point, rocks are highly deform and weak. Four sets of joints have been observed at the site (Table- I). Joint J1 is very closely spaced then the other joint sets. The filling in-between joint plane is clay. Joint sets recorded from the outcrop are as follows-

Figure 2 Phyllitic Quartzite and Augen gneiss outcrop observed along the proposed alignment

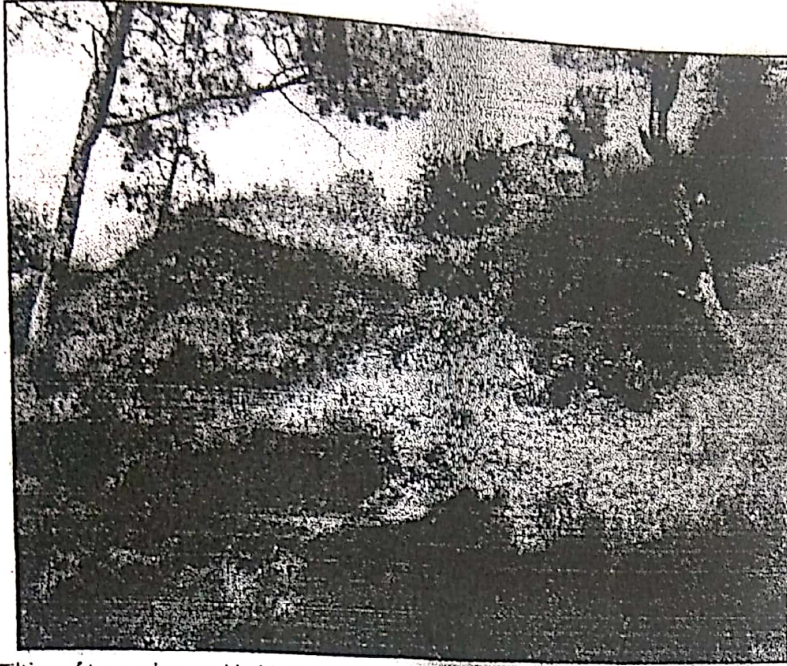
Weathering condition is moderate to high in the area. Approximately at 525m slide portion is observed behind the school boundary before second hp bend. The slope comprises of highly deformed and weathered rockmass of older landslide deposit having very low strength. Tilting of tress also suggests slow creep movement (Fig. 4).

Figure 4 Tilting of trees observed behind the school also the slope comprises of previous landslide deposit.

- 7- The portion of the road which passes through the cultivated field where water seepage from the ground is high; RCC should be done.
- 8- Proper protection must be given on the first km and behind the school boundary in both upslope and down slope region as the area comprises of deformed rock. Also protection must be given to prevent failure anywhere along the alignment during and post construction.
