उत्तराखण्ड राज्य में ऑल वेदर रोड़ परियोजना के अंतर्गत जनपद टिहरी गढ़वाल के राष्ट्रीय राजमार्ग-58 के कि०मी० 253.000 से कि०मी० 254.000 के मध्य में सड़क के चौड़ीकरण एवं सुदृढीकरण हेतु हॉट मिक्सिंग प्लांट के लिए राष्ट्रीय राजमार्ग लोक निर्माण विभाग श्रीनगर का वन भूमि हस्तान्तरण प्रस्ताव।

परियोजना के निर्माण हेतु भू-वैज्ञानिक की आख्या

Preparation Detailed Project Report (DPR) for Redesigning, Rehabilitation & Up-gradation to 2-lane/2lane with paved shoulder configuration & Strengthening of Rishikesh – Rudraprayag from km 228.000 to km 368.000 section of NH-58 in the State of Uttarakhand.

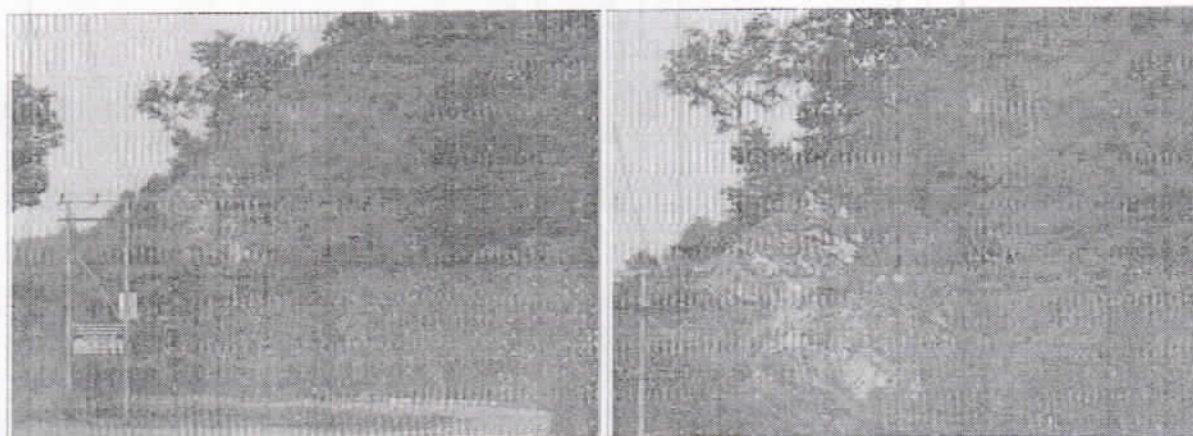
Slide No.1 at about Ch. 234.500

The above slide is an old rock slide not very significant threat to the road widening activity. The bed rock is bedding plane having attitude of $N/65^{\circ}-70^{\circ}$. The bed rock is thinly bedded and local warping is also observed on the plane of failure. At upper reaches there are few meters of slope wash rest on the bed rock. The mechanism seems to be failure along two set of discontinuity in the

bed rock making a wedge. Thus it is suggested that while cutting of the hill slope during widening toe should be necessarily protected.

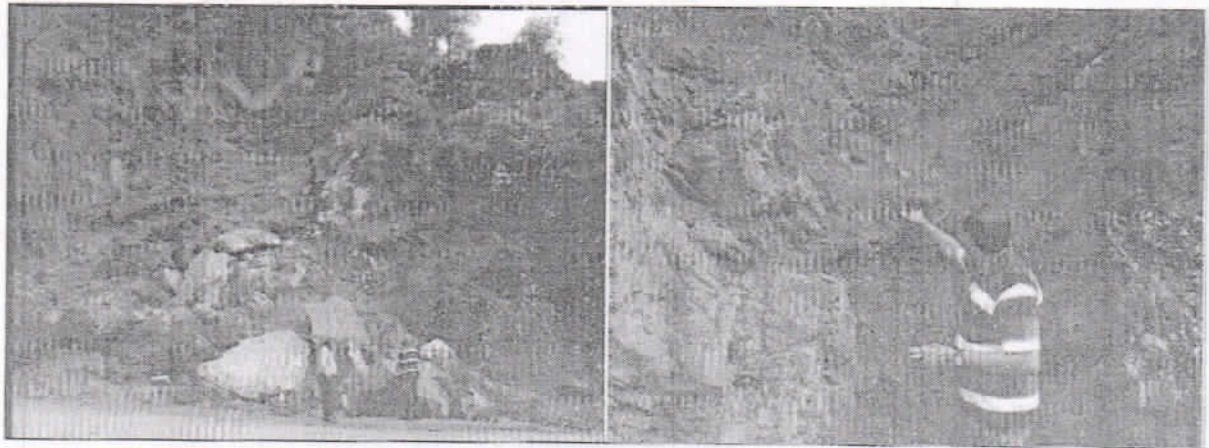
Slide No. 2 at about Ch.234.600

The above Slide is a typical wedge failure in the bed rock which is mainly limestone. A closer view shows that the limestone suffers high grade of weathering in the exposed surface. This is not very significant as the natural hill slope in this case is almost maintaining the angle of repose. However, the degree of weathering is very high. Thus it is suggested the toe support measure should be taken while widening.

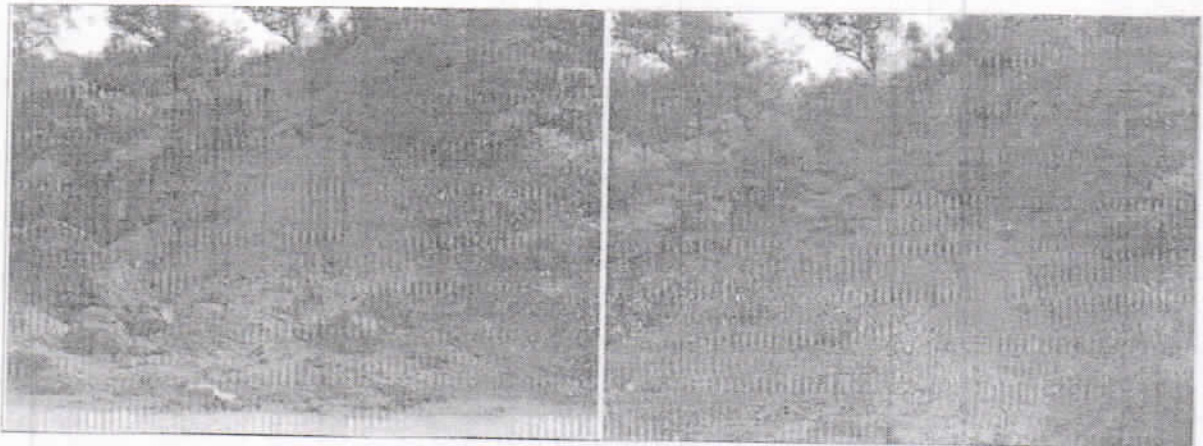
Slide No. 3 at about Ch.235.100

The above area is highly weathered zone where bed rock is completely disintegrated due to chemical weathering. This slide zone is not seems to be any significant threat to during widening of road.

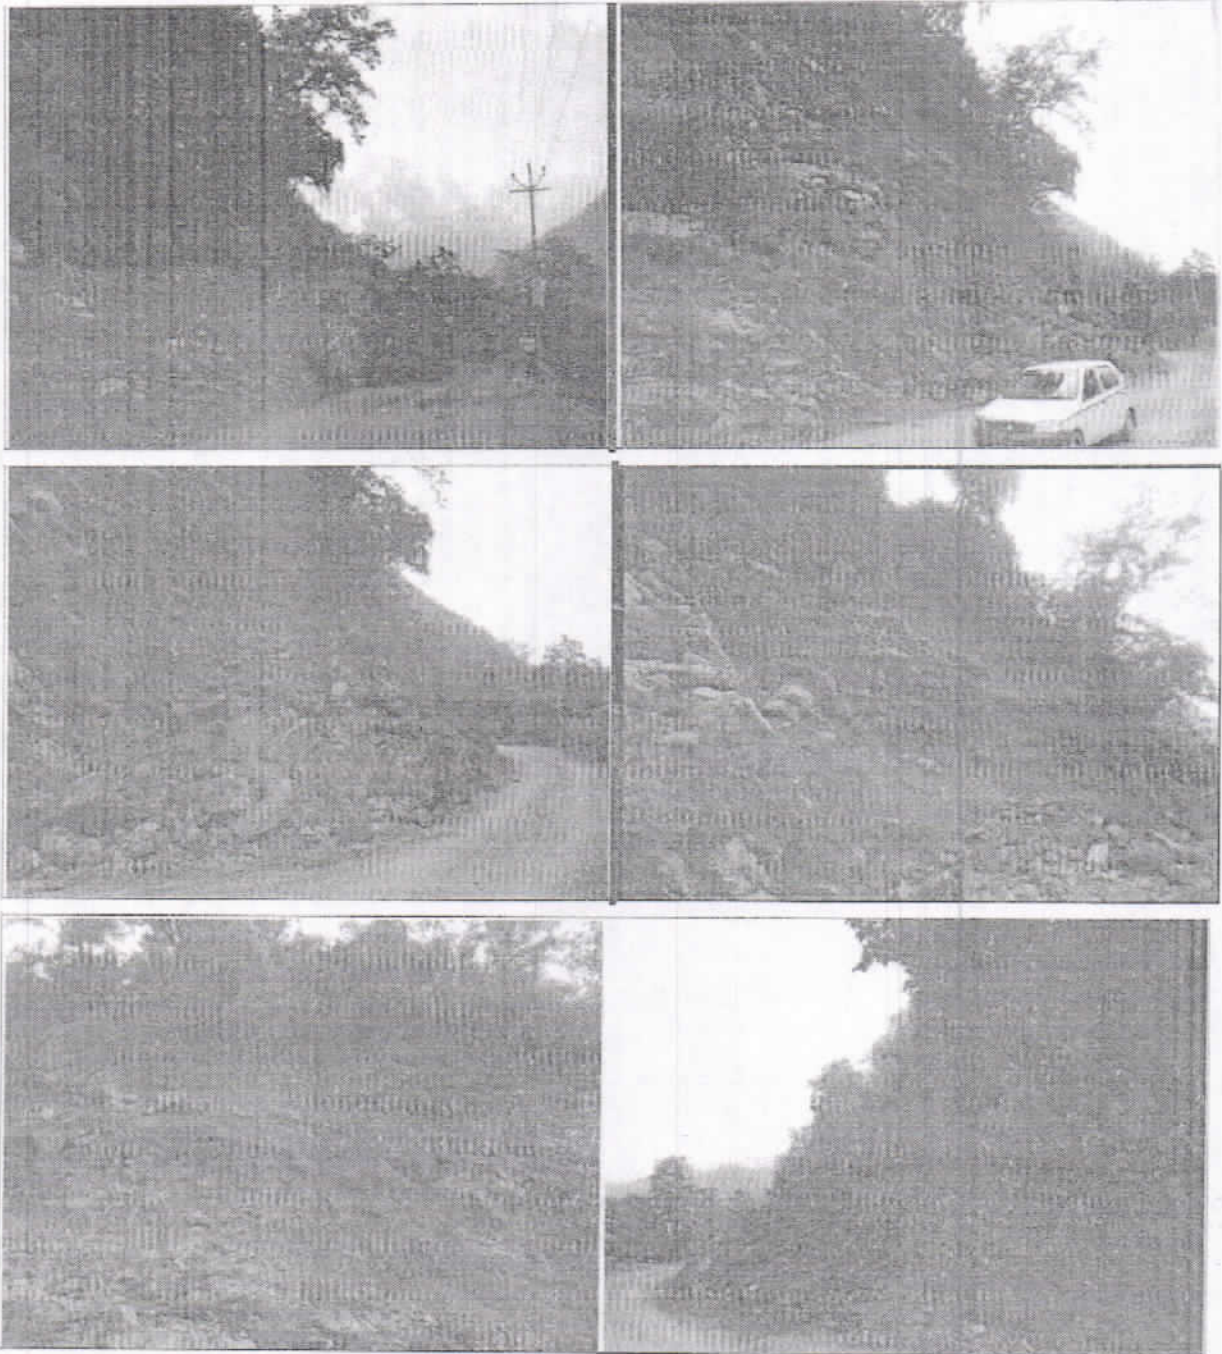
Slide No. 4 at about Ch.236.900

This rock slide occurs at Ch. 236.900m. The bed rock is highly jointed and fractured quartzite. The bed rock is thinly bedded and is having prominent discontinuities of $070^{\circ}/65^{\circ}-70^{\circ}$; $150^{\circ}/80^{\circ}-85^{\circ}$

and $290^{\circ}/35^{\circ}$ - 40° . This collapse occurs due to wedge failure in the bed rock. During widening of the road the toe of the slope should be supported to prevent further aggression of the slope failure.

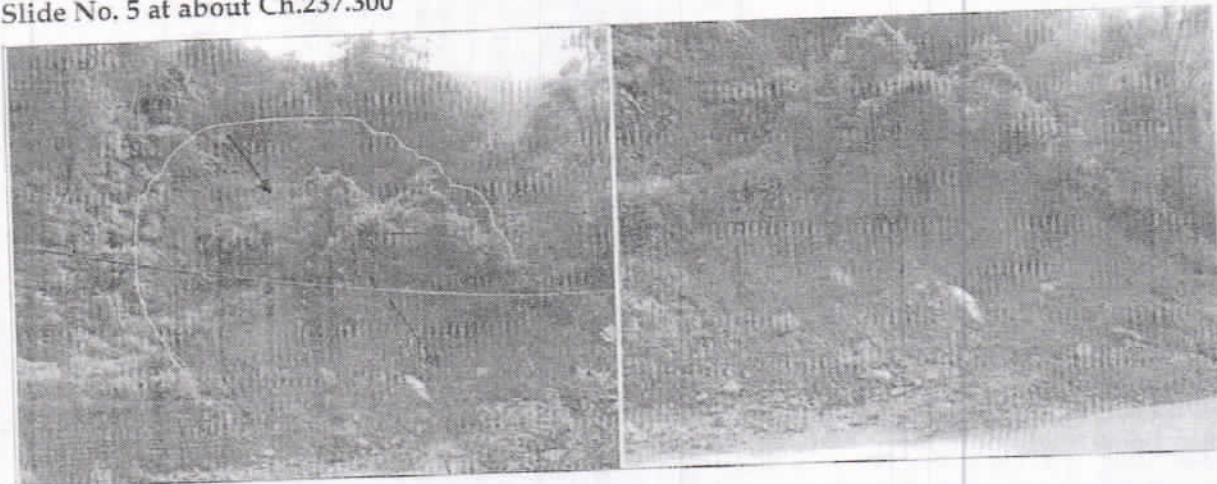
Slide No. 5 at about Ch.237.300

This is an old slide in area covered by slopewash material. The slid material is mainly composed of medium to coarse grained sand and silts with angular to sub-angular small fragments of bed rock material. It is not very significant and disturbing during widening and slope cutting. However toe support to also required to further initiation of slide during widening.

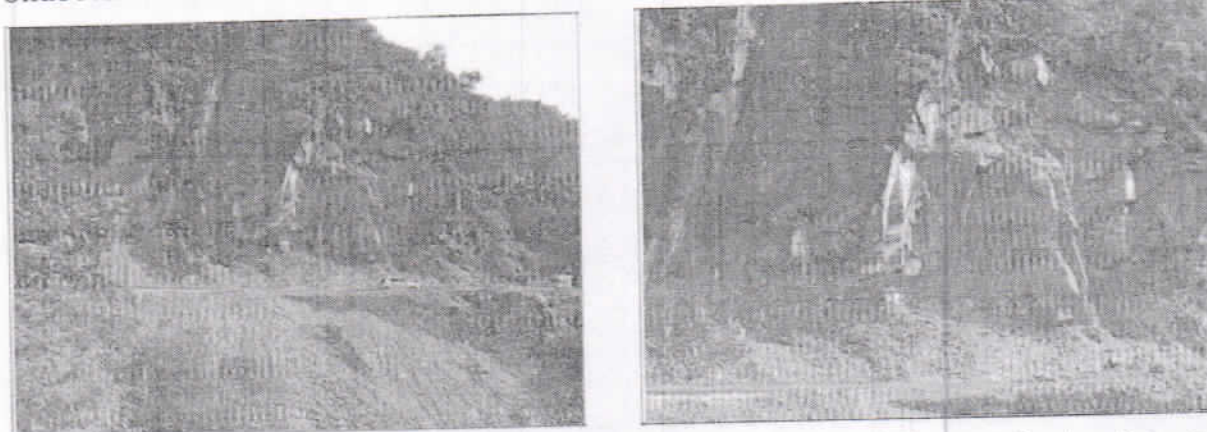
Slide No. 6 at about Ch.239.000

The above slide zone is a rock slide in massive hard quartzites. The failure mechanism is typical case of wedge failure govern by two prominent set of discontinuities which are $110^{\circ}/75^{\circ}$ - 80° and $225^{\circ}/70^{\circ}$ - 75° . While cutting this bed rock during widening of road, the toe support measures should be provided immediately after excavation.

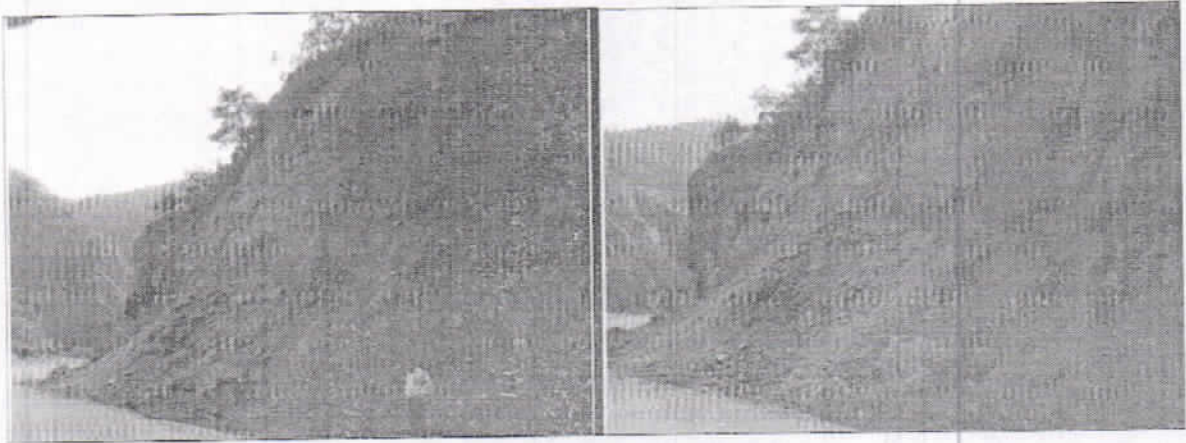
Slide No. 7 at about Ch.241.700

The above slide area is mainly rock slide in highly weathered fractured rock mass. Rock mass is slid from discontinuities which is filled by clayey material. It is basically a type of planer failure which occurs due to rain water that dilate the undulating sub-vertical planer surface. Not very significant threat to road during widening. However basical toe support measures should be taken care.

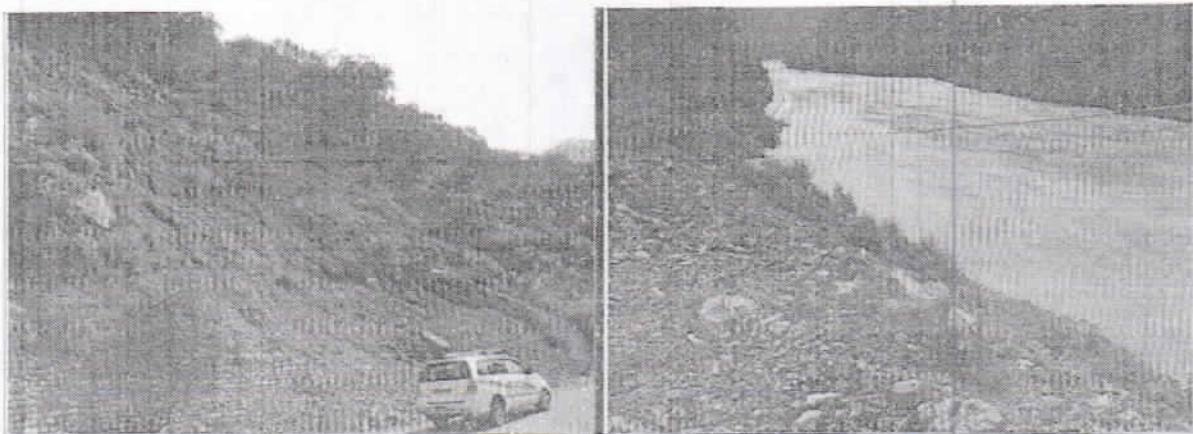
Slide No. 8 at about Ch.244.800

The above slide is the slide in slope wash material which is mainly composed of medium to coarse grained sand and silts with small fragments of angular to sub-angular rock material. The failure is triggered due to rain water that lubricates the pervious slope wash material rested on the hill slope.

Thus it is advisable to protect the toe of such slope during cutting of the existing slope for widening.

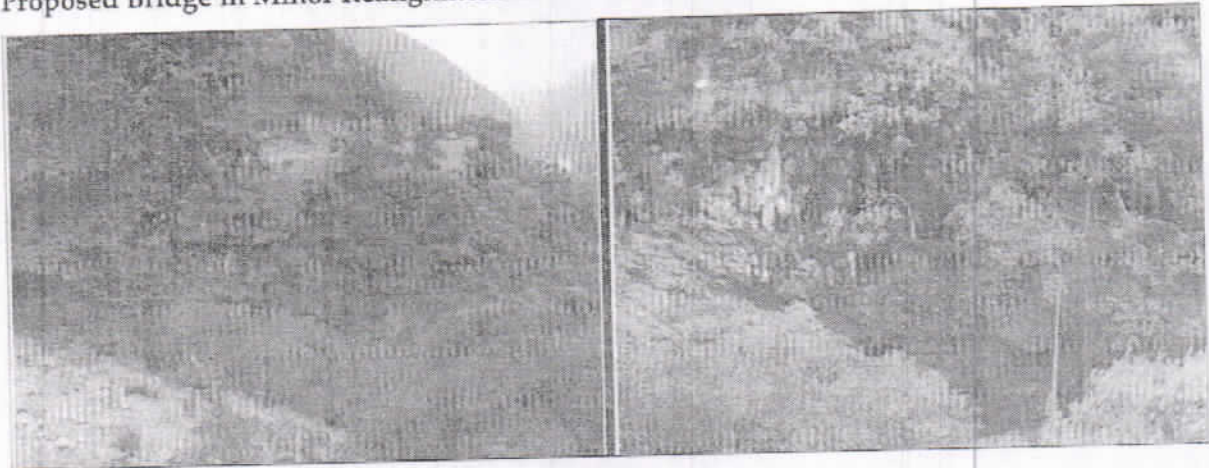
Proposed Bridge in Minor Realignment at Ch. 250.650 to 250.800m

The area in the pictures is the upstream pier side of the proposed bridge where brown coloured phyllites are exposed in the bottom of the road. However the outer part of the road at corner is over hang on the bed rock. These foundation rocks suffer scouring by the nalla flow during high flood time. Above the road the hill slope is covered by slope wash material. Similarly the downstream side entire area is covered by slope wash material and vegetation. Thus it is suggested that during construction of the bridge both the piers should founded on the firm bed rock and its load bearing capacity has to be ascertained.

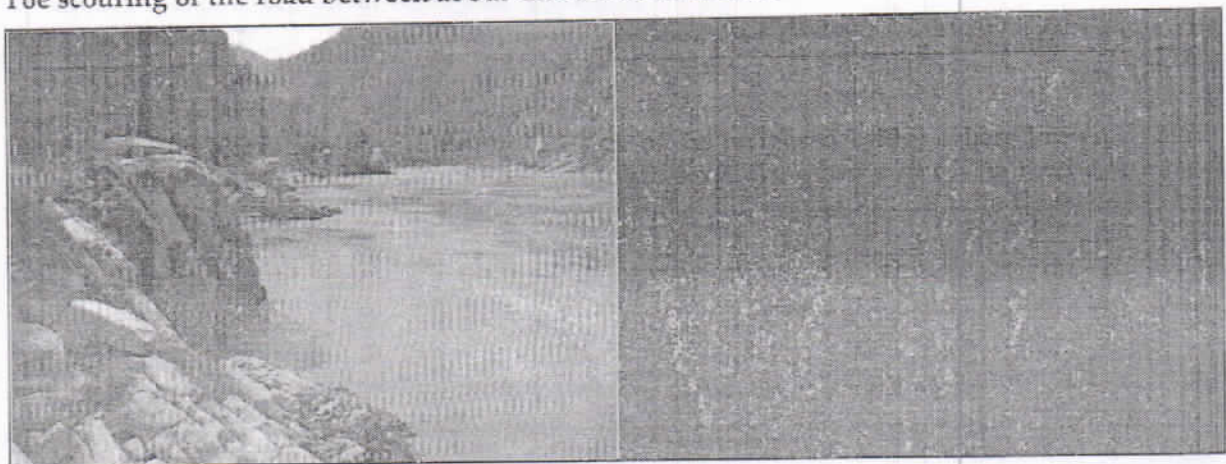
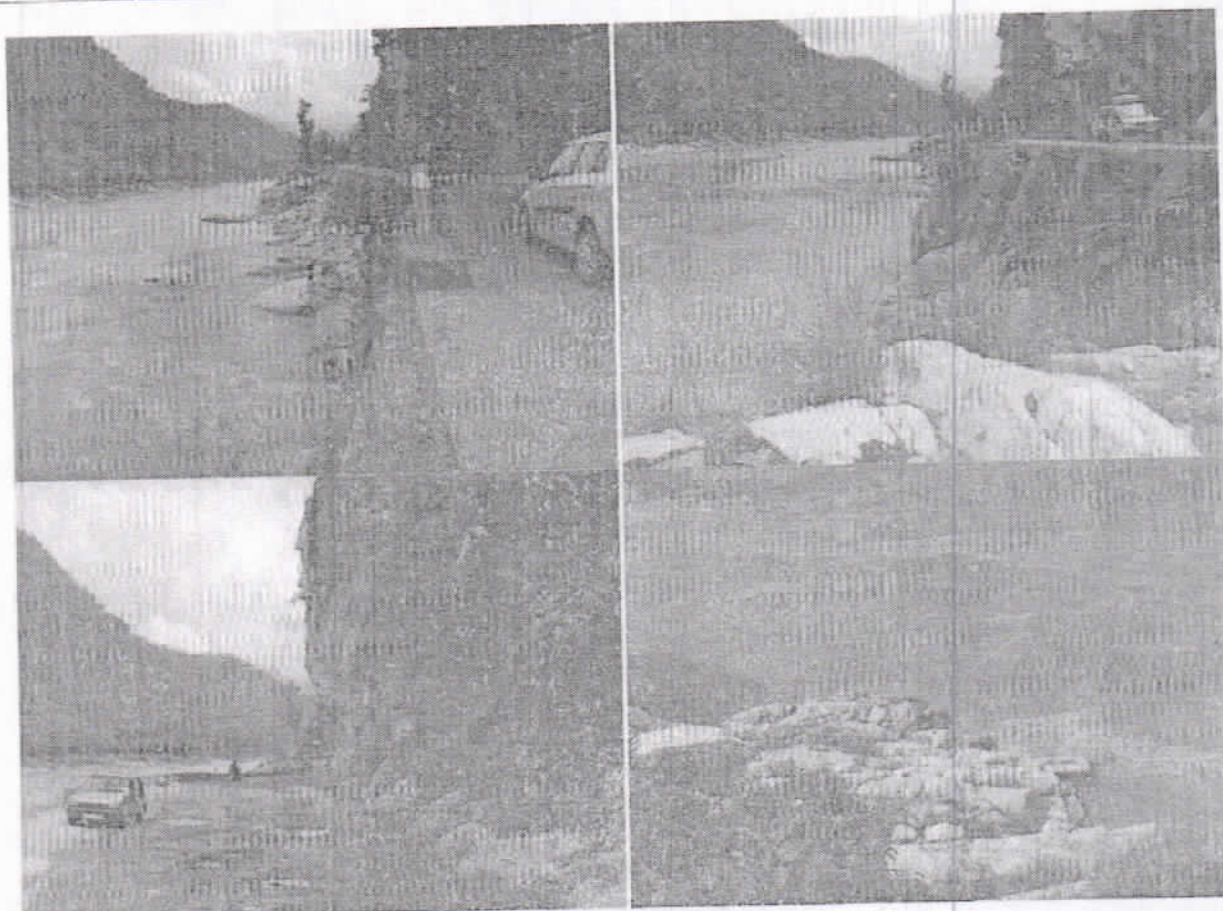
Toe scouring of the road between about Ch.253.000 to 254.300

The area showing in the above pictures is in between Ch. 253.000 to 254.300 where road is running almost parallel to the river flow. The bed rock is exposed along the hill slope which is almost vertical and at places over hanging above the road. The bed rock is massive quartzite, which is traversed by four set of joints. The prominent discontinuities are $215^{\circ}/55^{\circ}$ (S-1), $030^{\circ}/35^{\circ}$ (S-2), $300^{\circ}/15^{\circ}$ (S-3) and $320^{\circ}/85^{\circ}$ (S-4). The river is flowing few meters below the existing road. At many places river scouring action active on the exposed rock below the road which create a threat for stability of the road in future. Another point of concern is the widening of road in this rocky stretch. Cutting of hill slope in this stretch is a herculean task simultaneously making any structures towards river side is also a cumbersome job. However, as the rock exposed in the bottom just at river level below the road, there is a possibility to construct wall which will rest on the rocky foundation. This concrete wall will restrict the river scouring at toe furthermore and on the hill side of the wall after filling, road can be widened. Keep in view of the above situation it is advisable that during designing of any of such structure, precautions should be taken and design it keeping in view of heavy water discharge in future.

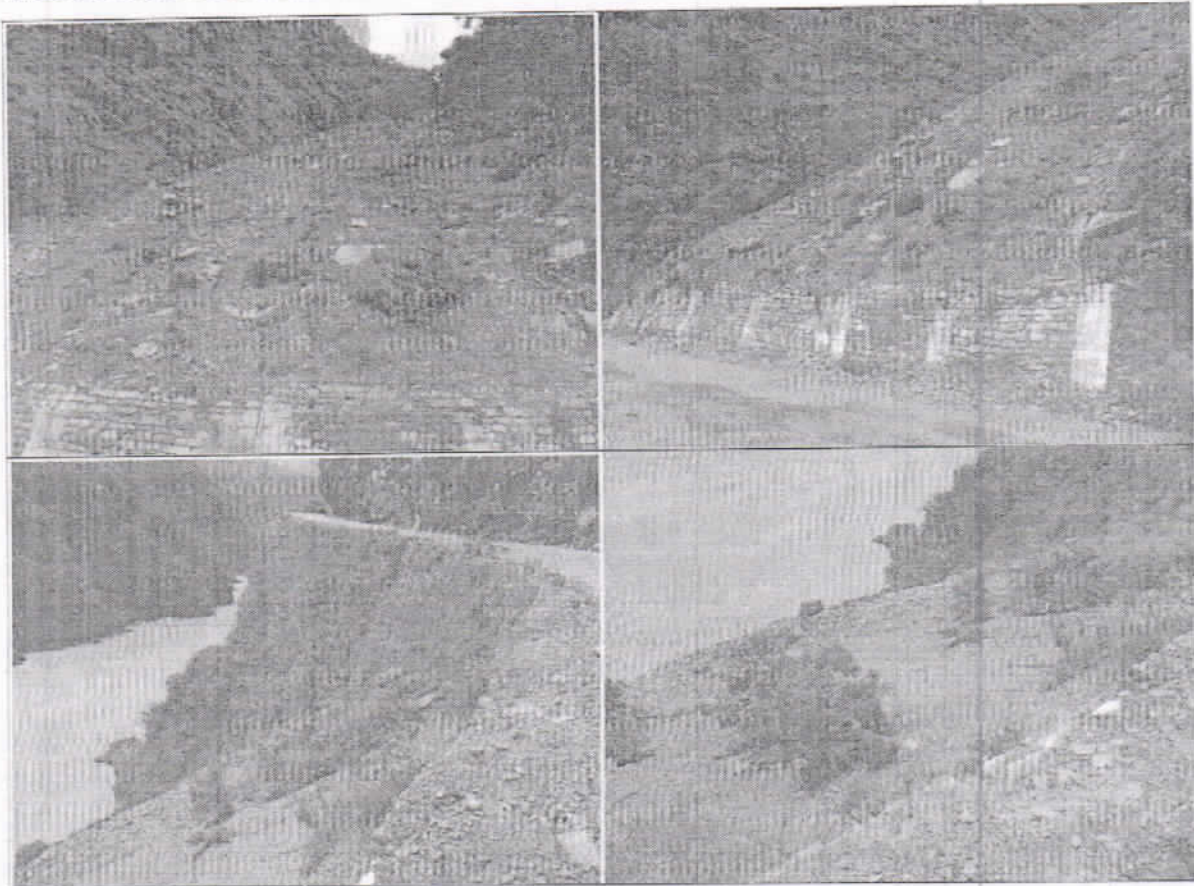
Slide No. 9 at about Ch.264.100

The above slide is mainly along the topographic depression which followed by the seasonal nalla. Nalla debris is resting throughout the course of this depression from top to the river level. Thus it is suggested that this seasonal water flow should be detoured by any over bridge and synonymous structures. So that water and its debris material in case of rainy season can move beneath the road and movement will not restrict in any case.
