परियोजना का नाम:- जनपद बागेश्वर में मण्डलसेरा मोटर मार्ग के किमी 0 2 से कलियाबगड़-गोगिनापानी तक मोटर मार्ग निर्माण कार्य।

भू-वैज्ञानिक की आव्याप्ति

## Geological Assessment of 3.0 km long alignment from Mandelsera motor road to Kaliabagar-Goginapani motor road District-Bageshwar.

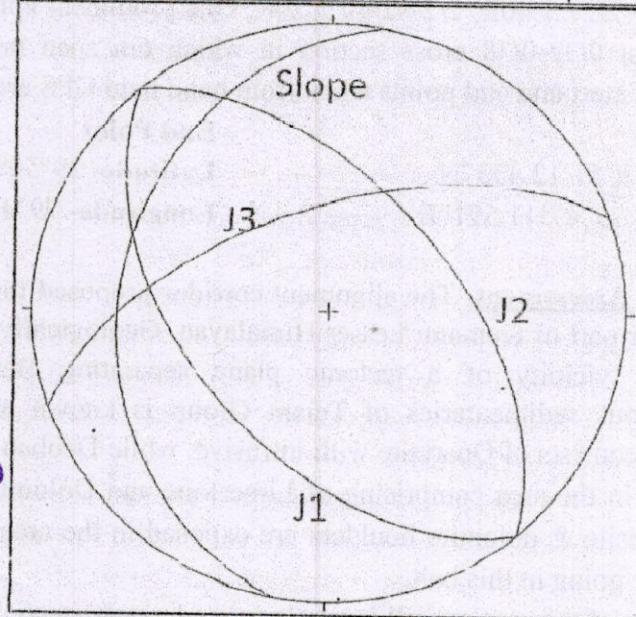
Figure 1 Stereographic projection of Joints and slope data recorded from Soapstone

From the above stereographic projection, it is clear that wedges are forming due to intersection of joints but does not dips in slope direction. Planar and wedge failure can occur along the alignment, in case if any joint or tension crack acts as a releasing surface and if any wedge or any joint comes parallel to the slope.
