Geological Assessment of 5.5 Km long Salla Bhatkot-Sukna Salyudi motor road District- Almora.

1- Introduction- Construction Division, Public Works Department entrusted in construction of 5.5 Km long Salla Bhatkot-Sukna Salyudi motor road District-Almora. On the request of Assistant Engineer, Construction Division, Almora I carried out geological assessment of the above said motor road. Junior Engineer Mr. K. S. Patwal accompanied during the site visit on dated 01/01/2019.

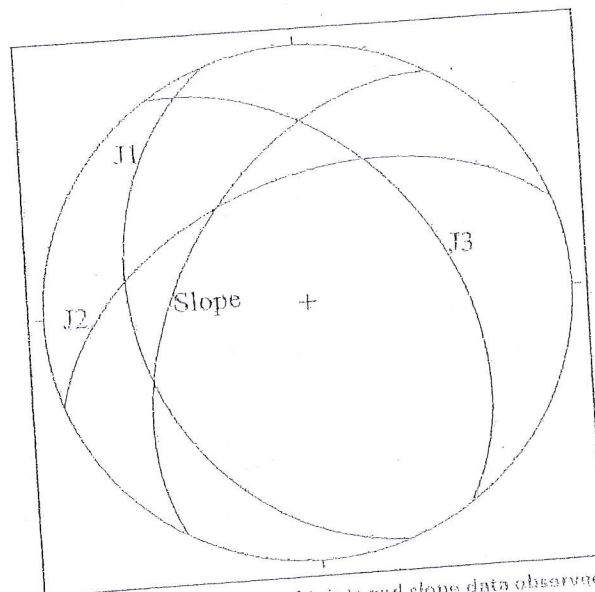
Figure 1 Stereographic projection of joints and slope data observed in Schist.

From the above stereographic projection Fig 1 it is clear that Joints J1 and J2 are forming a wedge in slope direction thus wedge failure can occur if any joint or tension crack acts as a releasing surface. At the starting point of the road landslide is observed (Fig 3) which consists of mainly debris and crushed rockmass.

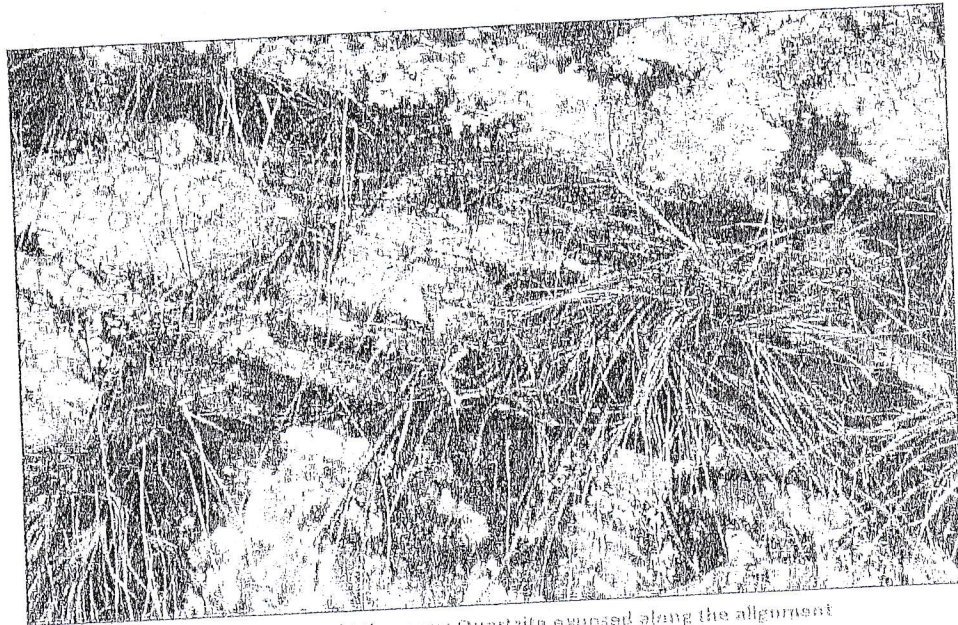
Figure 2 Outcrop of Micaceous Quartzite exposed along the alignment

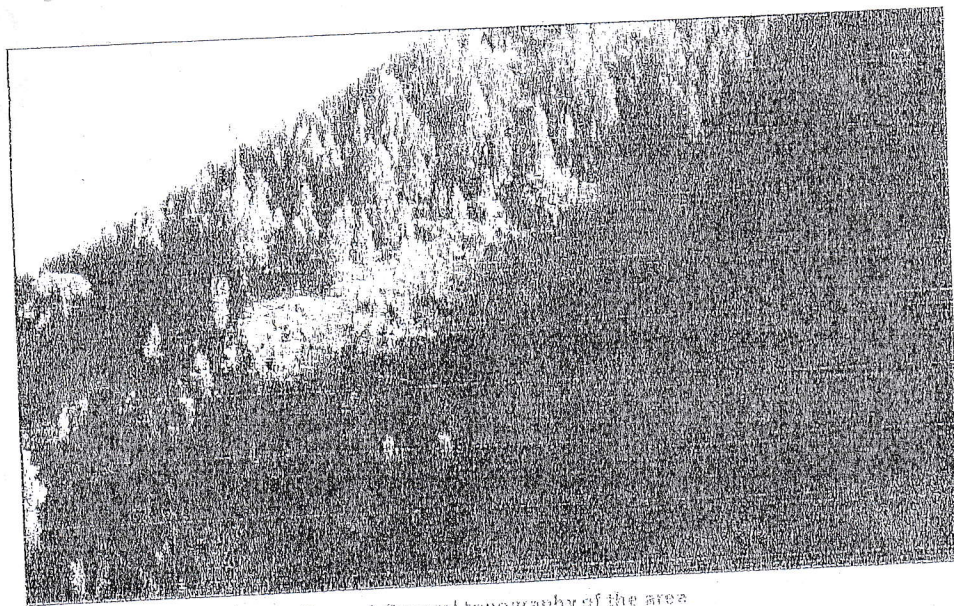
Figure 3 General topography of the area

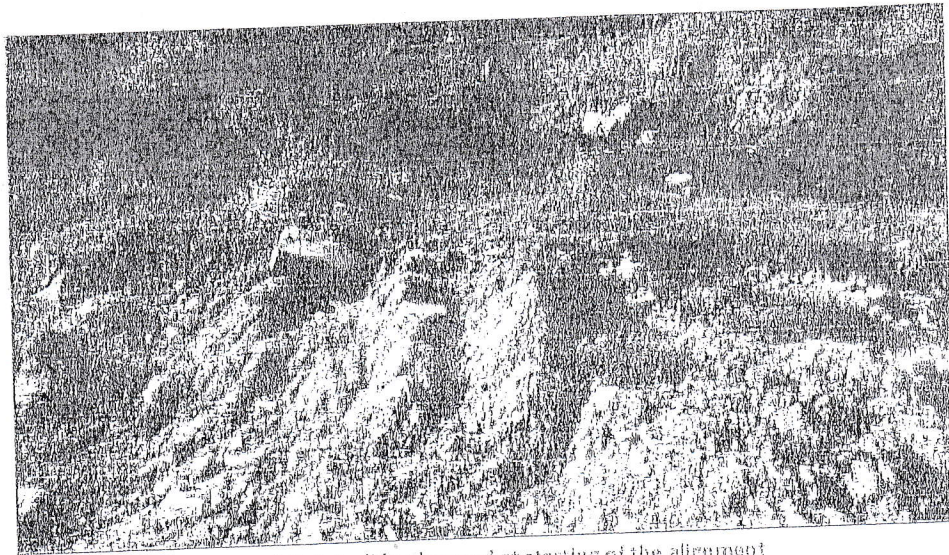
Figure 4 Debris slide observed at starting of the alignment

- 7- Protection must be given if failure occurs anywhere along the alignment during and post construction.
- 8- All the HP bends must be constructed with standard gradient and protection must be given on the hill side to retain the slope.
- 9- All the construction activities must be carried out as per the prescribed norms and the standard codes of the practice laid by BIS and MORTH.
