Geological Assessment of Kasardevi (Tiwarikhan) to Maath 2.50 Km District- Almora.

Priya Joshi
27/08/2018

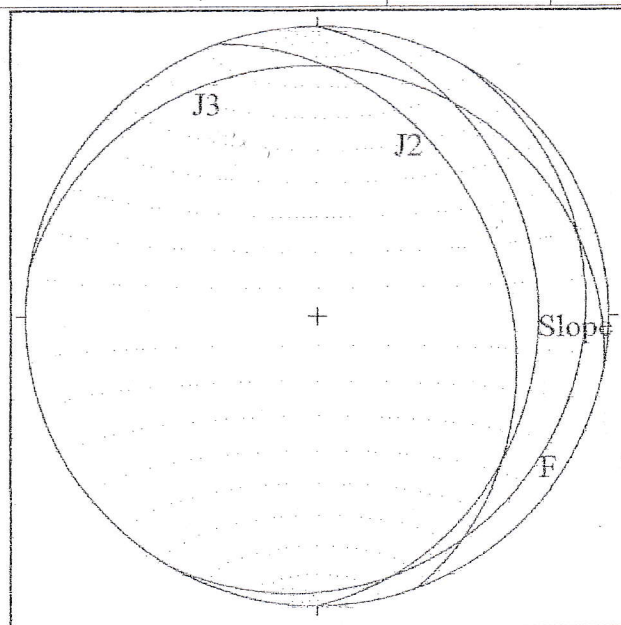
Figure 1. Stereographic projection of Joints and slope data in micaceous quartzite

From the above stereographic projection it is clear that foliation dips in slope direction which is forming planar failure condition at given location along with this wedge is also forming due to the intersection of J2 and J3 but dips in different direction; if anywhere along the alignment wedge or joint dips in slope direction then failure can occur if any joint or tension crack acts as a releasing surface.

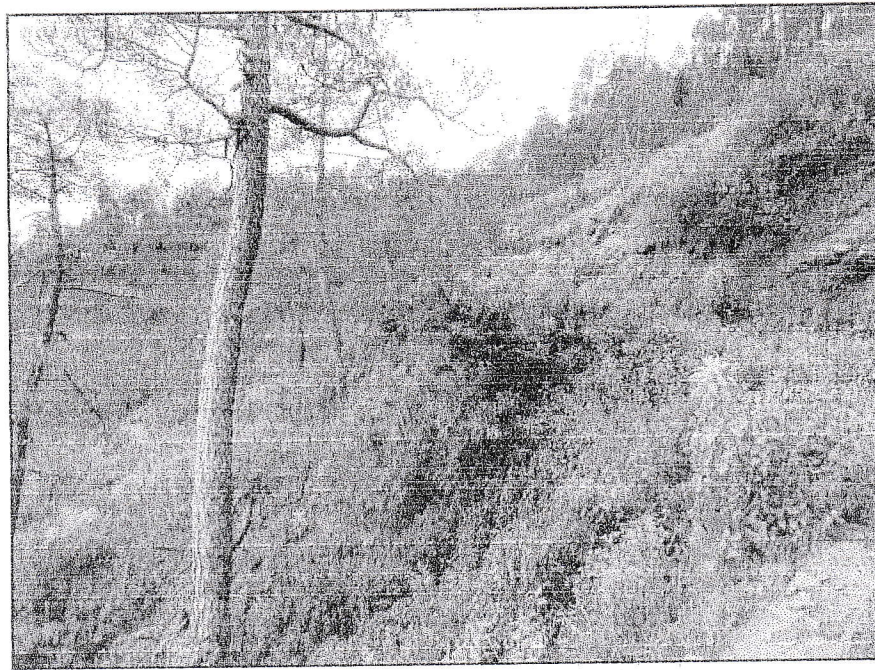
Figure 2 General topography of the area

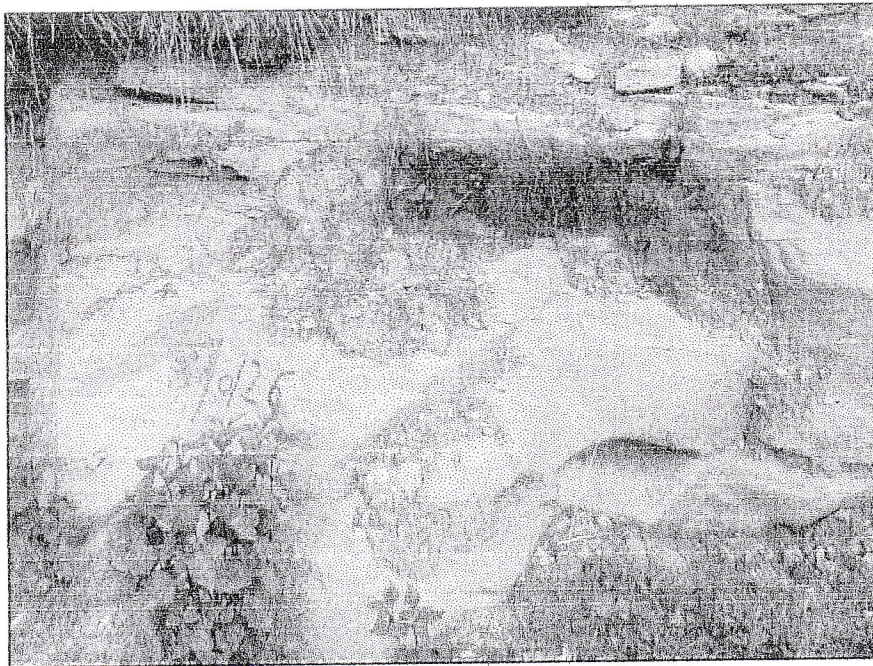
Figure 3 Micaceous Quartzite outcrop observed
