कार्यालय मुख्य अधिकारी
लोक निर्माण विभाग, अल्मोड़ा

Geological Assessment of the alignment corridor proposed for Baheda-Rehadhar-Chauniya-Dalmodi 6.0 Km District Almora.

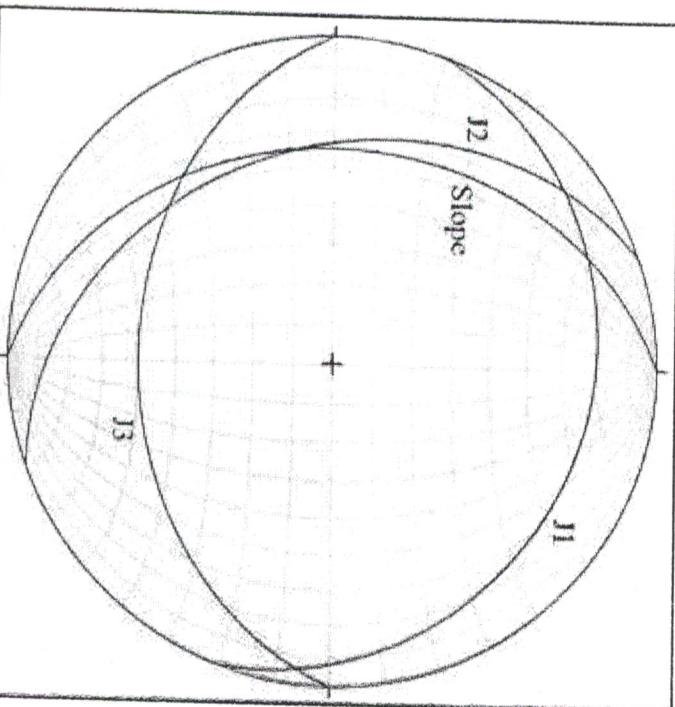
The topography of the area is gentle to moderately steep. Starting 300m portion of the proposed alignment passes through steep hill slope, remaining portion passes through moderately steep forest to gentle cultivated terraces. Gradient of the road is gentle. The rocks are slightly- moderately weathered and oxidized up to W_1 - W_2 grade. Hydrological conditions in this area are mainly dry in the fair weather. Slight subsidence is observed towards the end of the first km tilting of trees are also observed. Foliation in the schist is trending in $N100^{\circ}$ direction with gentle gradient. Four prominent joint sets which were recorded from the quartzite outcrops exposed at the site are as follows-

S.No.	Feature	Dip angle	Azimuth
1	Joint J1	21°	N 20°
2	Joint J2	35°	N 250°
3	Joint J3	40°	N 180°
4	Slope	35°	N 270°

Figure 1 Stereographic projection of joints and slope data observed in quartzite
