GEOLOGICAL REPORT ON PROPOSED
LINK ROAD FROM DADRIARA TO
CHAKKI, DISTRICT CHAMBA HIMACHAL
PRADESH

PUBLIC WORKS DEPARTMENT
HIMACHAL PRADESH

DEPARTMENT OF CIVIL ENGINEERING
NATIONAL INSTITUTE OF TECHNOLOGY
HAMIRPUR (H.P)

Geological Report

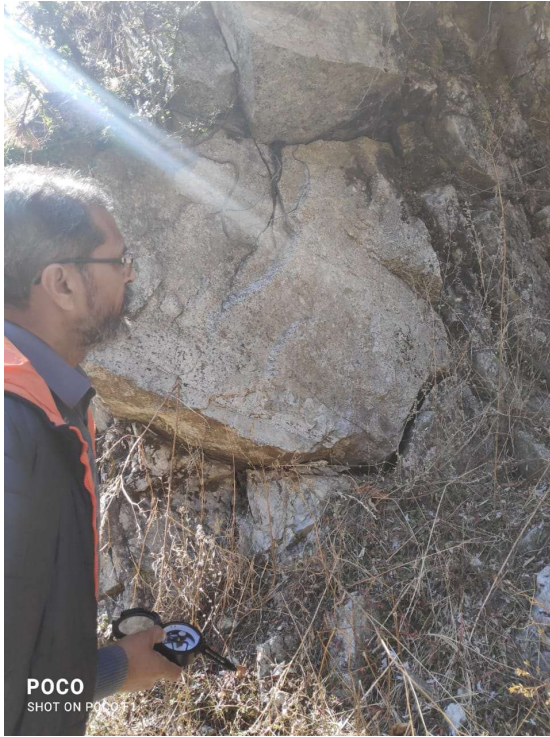
Fig. 1 Outcrop of a mildly jointed rock mass.

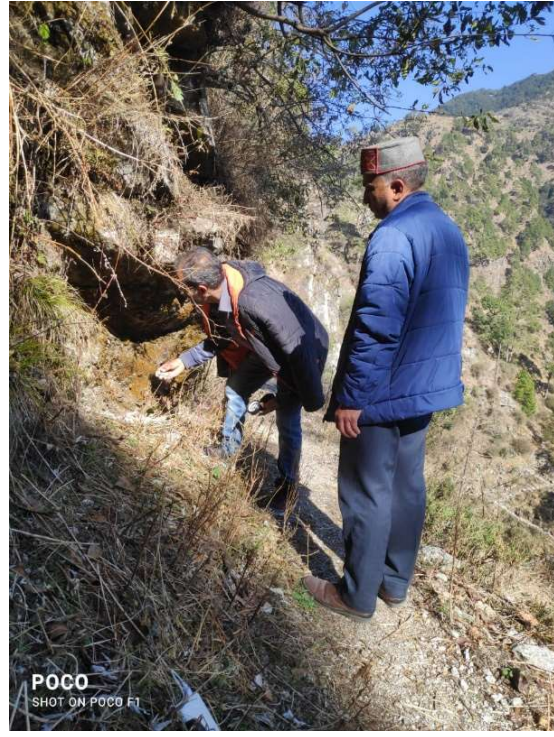
Fig. 2 Weathered gauge material in the joints.

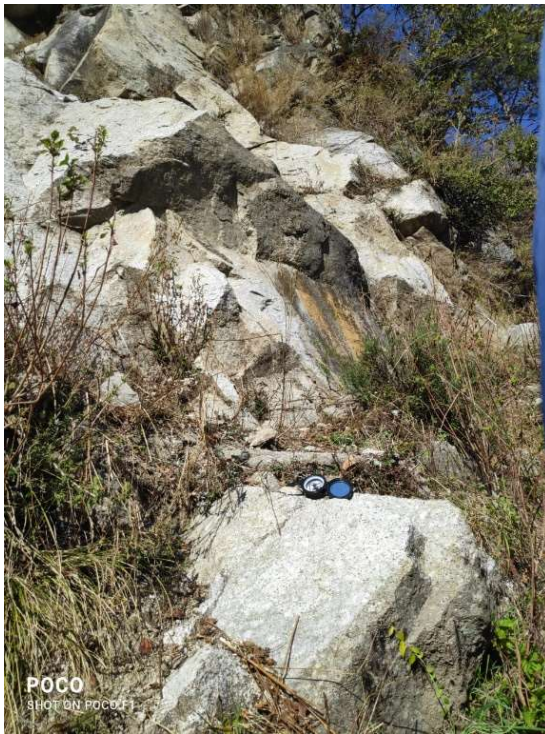
Fig. 3 Crystalline rocks exposed along the road alignment.

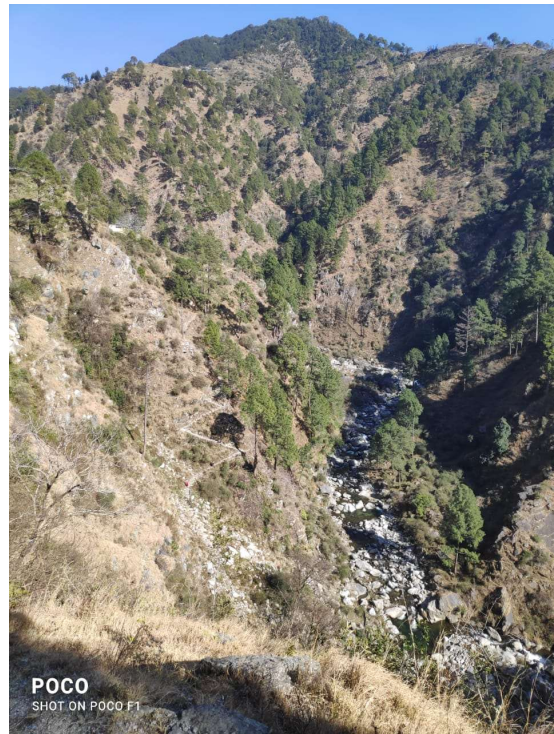
Fig. 4 Deep gorge encountered enroute to Chakki.

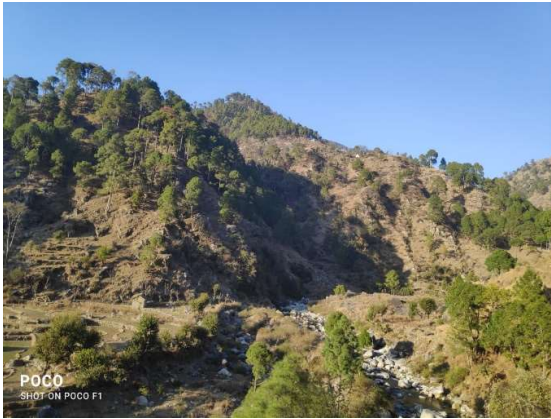
Fig. 5 Panoramic view of the right bank of the valley along which the proposed road alignment has been done.
