NATIONAL HIGHWAYS & INFRASTRUCTURE DEVELOPMENT CORPORATION LTD.

## GEOLOGICAL AND GEOTECHNICAL SUMMARY REPORT

## KM - 83<sup>RD</sup> TUNNEL

MAY 2020

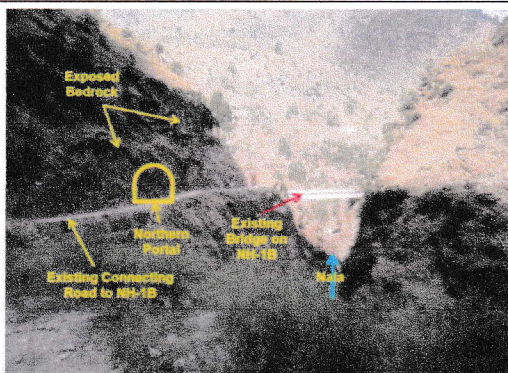
The northern portal of the tunnel is located on the way of Chamoti village from main existing highway NH-1B. Exposed bedrock is observed along entire portal and tunnel alignment (**Photo 1**). The southern portal is located on existing highway NH-1B (Doda-Kistwar road) i.e left bank of Chenab river. Thinly foliated mica schist (**Photo 3**) and schistose gneiss with intercalation of quartz veins (**Photo 4**) is observed in and around southern portal (**Photo 2**). Exposed bedrock is observed all along the hill slope during detailed surface geological mapping. At some places surficial overburden is also observed. Slope around the portal is moderately steep to steep.

**Photo 1: Broader view of Northern portal area**

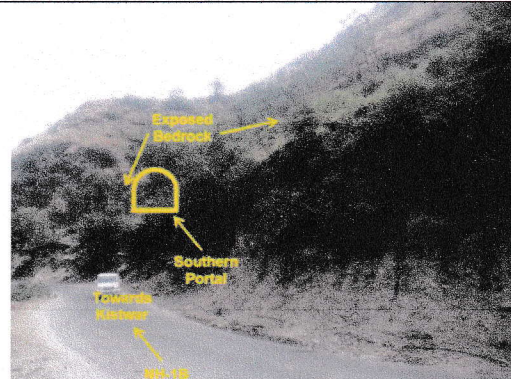
**Photo 2: Broader view of Southern Portal area**

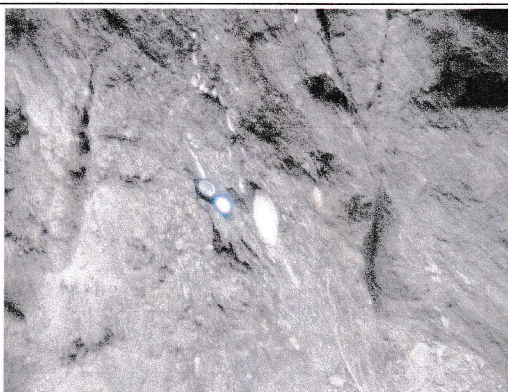
**Photo 3: Mica schist with intrusion of quartz veins**

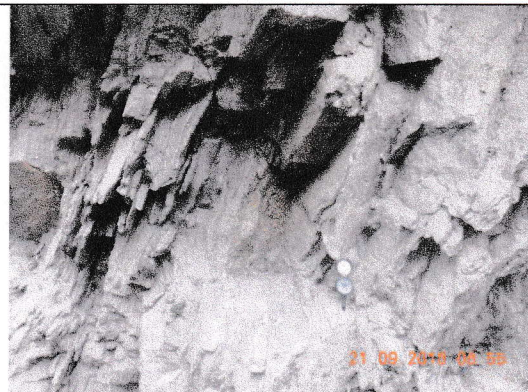
**Photo 4: Schistose gneiss with intrusion of quartz veins**

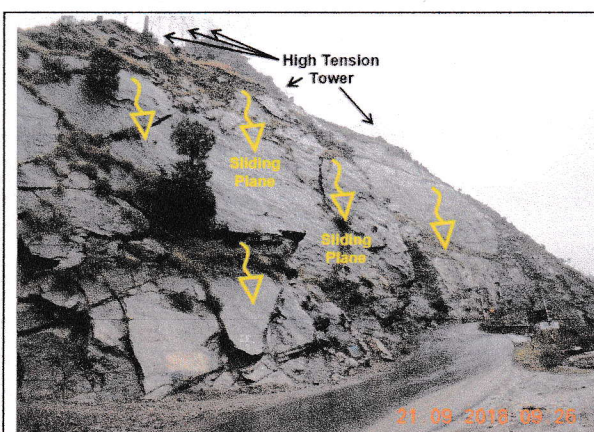
It is observed from above table that the joints belonging to set J1 have high persistence are closely to widely spaced and have smooth planar and undulating as well as slickensided undulating surface with tight to partly open aperture and occasionally clay filling & surface staining on surface. Along the road cutting of National Highway (NH-1B), due to high schistosity and smooth planer surface along the major joint set, planar failure along this joint set is observed (**Photo 5 & 6**). Joints belonging to set J2 medium to high persistent with tight to partly open and staining on surface. Joint sets belonging to J3 is low to medium persistent, moderately to widely spaced with tight aperture, no filling & alteration.

**Photo 5: Planar failure along foliation due to high schistosity & unfavourable joint set**

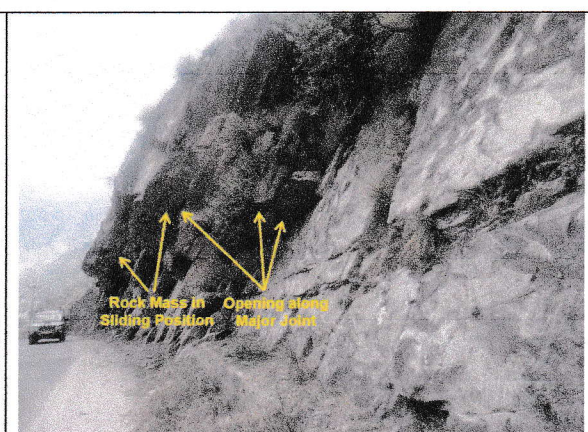
**Photo 6: Rock mass is in sliding position along foliation**

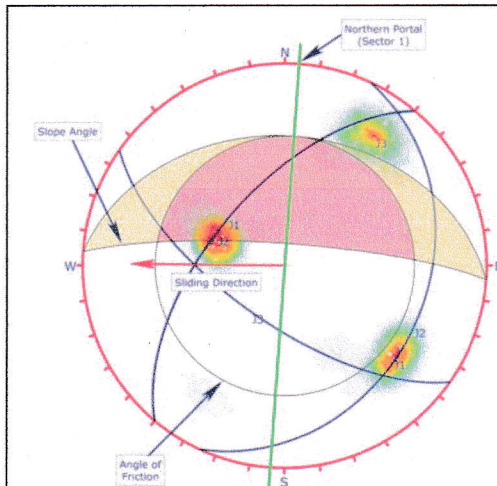
**Figure 3: Wedge analysis along northern portal of tunnel**

The Northern portal of tunnel is located on the left bank of nala (tributary of Chenab river) and in the direction of 004° - 184° with its portal located on rock facing towards 004° (**Figure 3**). The slope cut at portal face would be 1 in 6 in the rockmass and the angle of internal friction of the rockmass has been considered as 37°. From the stereo

plot it is observed that while excavating portal slope failure may take place on joint plane J1. Thus, the excavation profile and design support above portal is to be designed accordingly.

The northern portal is oriented in the direction of  $004^{\circ}$  -  $184^{\circ}$ . With this orientation and disposition of joint sets it indicates that wedge failure from eastern wall may take place along the line of intersection of joints 1 and 3. From western wall of the tunnel, the planar failure may take place on joint plane 2. Support design has to be taken up accordingly.

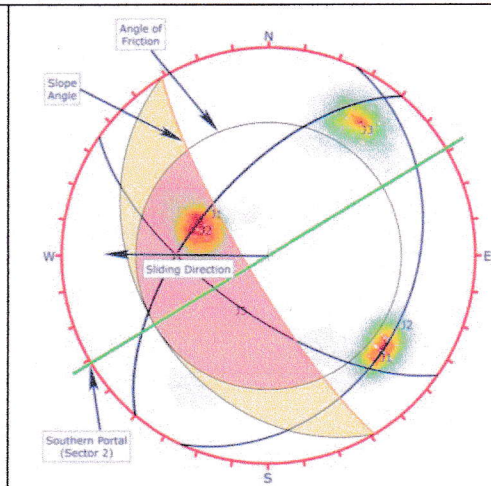
**Figure 4: Wedge analysis along southern portal of tunnel**

This tunnel is aligned in the direction of  $059^{\circ}$  -  $239^{\circ}$  direction with its portal facing towards  $239^{\circ}$ . The co-efficient of internal friction for the rock mass has been considered as  $37^{\circ}$ . From the stereo-plot it is observed that while excavating portal slope failure may takes place on joint plane 3 and wedge failure may take place with the intersections of joints J1 and J3. Thus, the excavation profile and design support above portal is to be designed accordingly.

The tunnel is oriented in the direction of  $059^{\circ}$  -  $239^{\circ}$ . With this orientation and disposition of joints indicates that wedges failure from SE wall may takes place along the line of intersection of joints 1 and 3 (**Figure 4**). From south-east wall of the tunnel, the planar failure may take place on joint plane 1 and from north-west wall of the tunnel, planar failure may take place on joint plane J2. Design support is to be evolved keeping the sliding movements to contain the wedges.
