GEOMORPHOLOGICAL & GEOLOGICAL STUDY OF  
HALAIPANI SMALL HYDRO ELECTRIC PROJECT  
(16 MW)  
ANJAW DISTRICT, ARUNACHAL PRADESH

M/S HALAIPANI HYDRO PROJECT PRIVATE LIMITED

M/S GREJ ENGINEERS PRIVATE  
LIMITED

JANUARY 2024

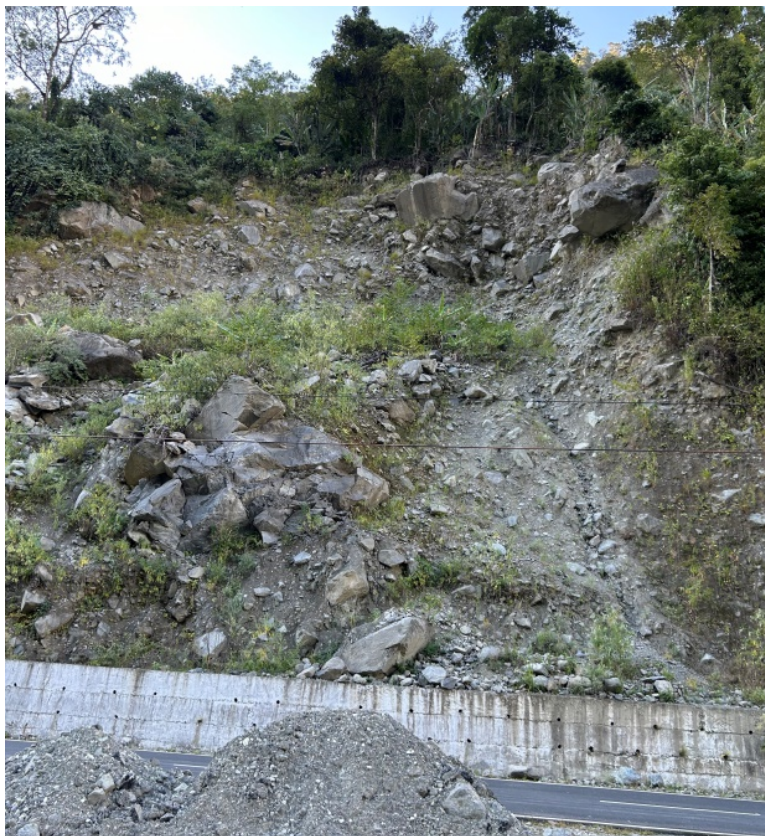
Fig. 9 A View of landslide beside the Anchor/Saddle block for penstock

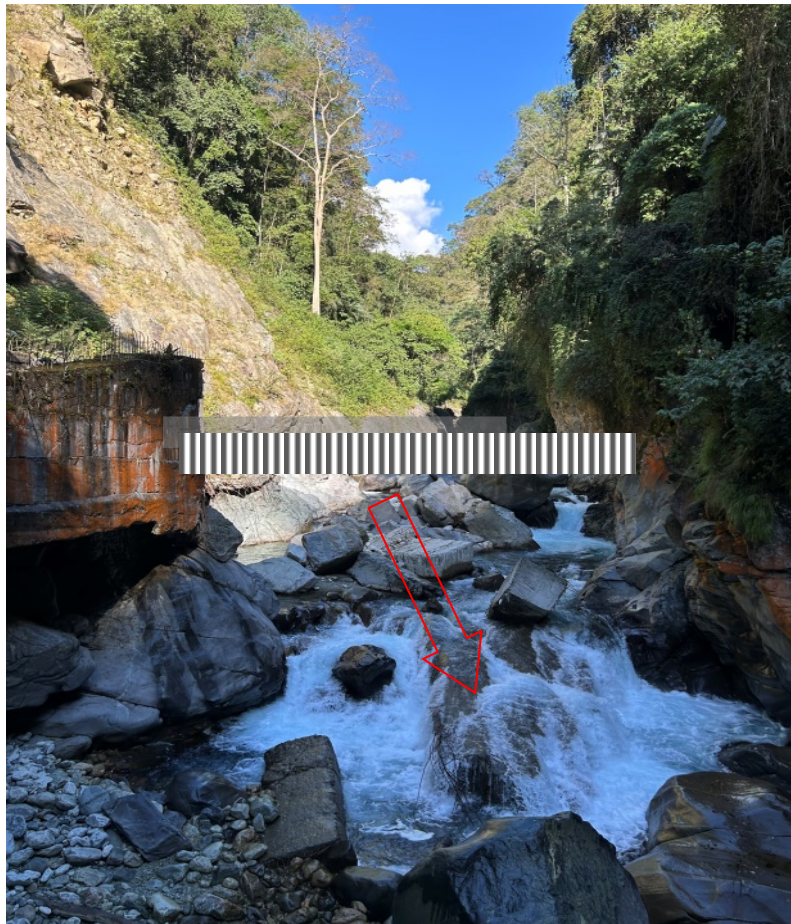
At proposed Barrage site, Halai River is quite narrow flows through a span of 12-15m in the direction of N 190° E i.e. SW directions (Fig. 13). The proposed Barrage area (upstream & downstream) is having large sized boulders and cobbles which must be removed by blasting. River bed is full of river born materials mainly consist of loose boulders, cobbles of granite, granodiorite, gneiss & and damaged RCC block of Barrage. The Left abutment of the Barrage is having steep rocky slope compared to right abutment.

Active slide zone and loose debris over hill slope

Fig. 13 A view showing the location of proposed Barrage site

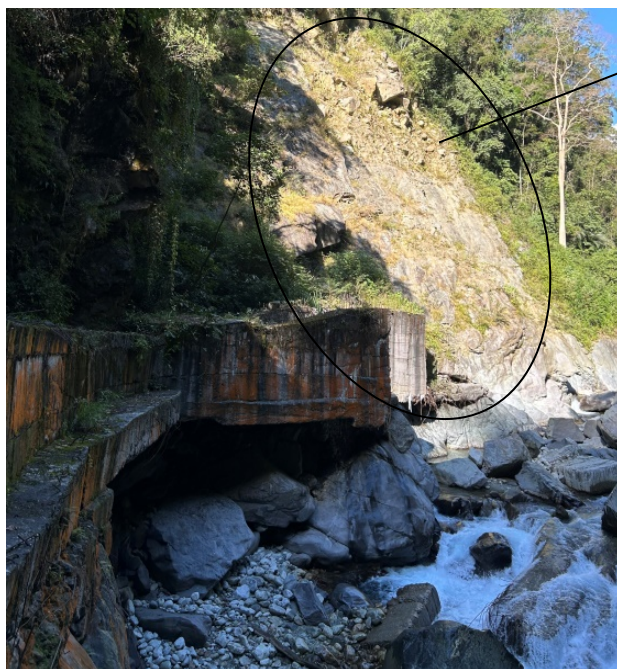
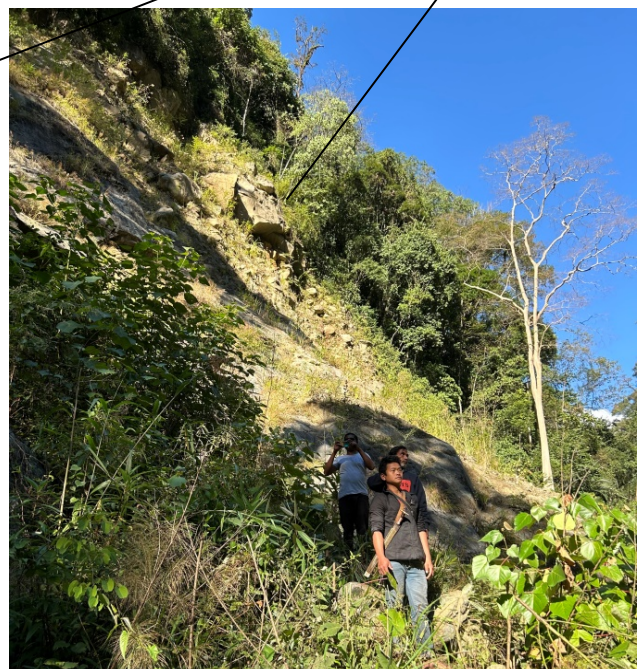
A major landslide has been observed at the right bank of the barrage axis which seems to be the main cause of intake damage (Fig. 14). The slide area is having loose in-situ rock boulders mixed with grit soil. The depth may vary as 7-8m towards hill or may be high.

The Left abutment of Barrage site is safe but right abutment shows some kind of slope failure as there is a landslide noticed over hill slope.

Fig. 14 Views showing the slide at right abutment of Barrage Axis

It is suggested to do 02 nos. of boreholes at abutment location and slide zone to identify the depth of debris deposit for safer design and construction. The sediment carrying capacity of the river is very high and huge sediments have been observed in upstream area due to previous flood and cloudburst. The barrage structure design should be done on considering 1 in 100 years flood and free from scouring of river. Large boulders must be removed from river bed and foundation shall be done over hard rock formation. Grouting/shotcreting will be required at the abutment to seal open joint and loose sediments. The Barrage axis can be shifted 30-35m downstream side but it will lead to increase the height of Barrage. To work with the same axis, Slope protection measures must be carried out to protect the right abutment slope.

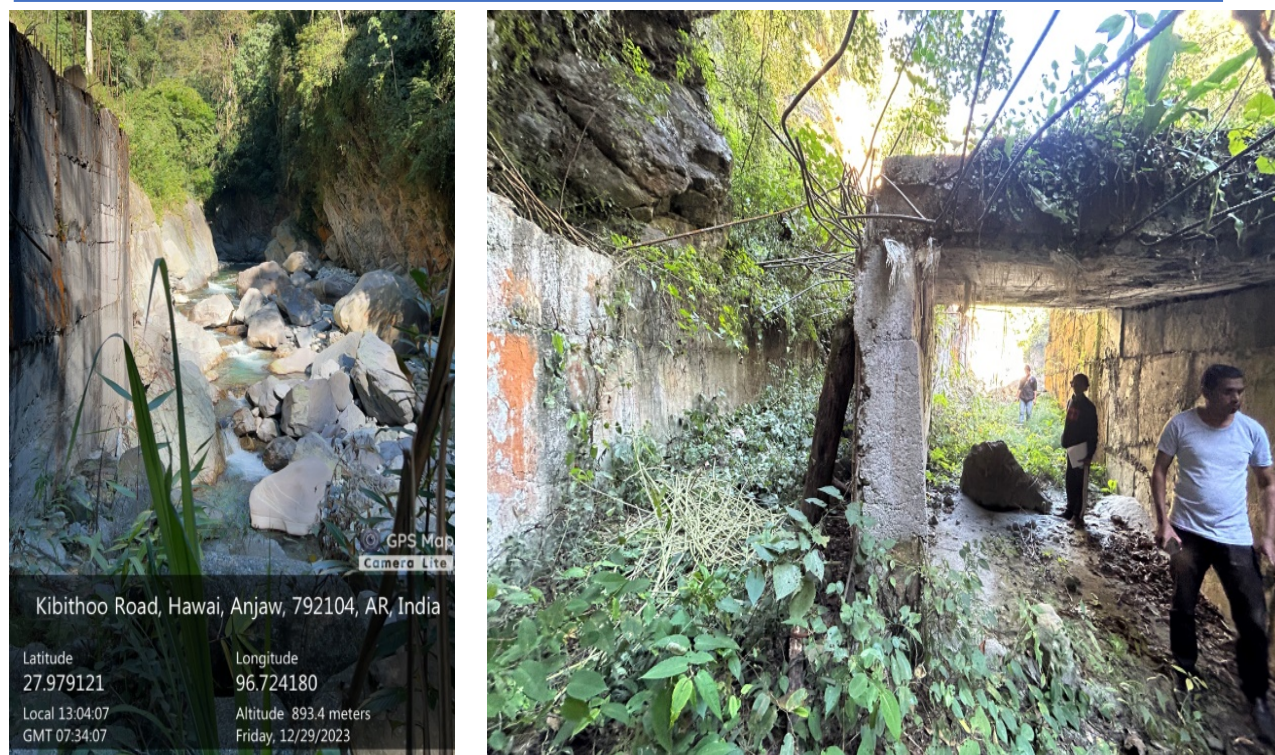
The Intake has been constructed on the right bank and partially damaged in flood (Fig. 15). The base of the intake area has washed away as that area constitutes debris deposit/river born materials along the flank of river.

Fig. 15 View showing the existing Intake structure

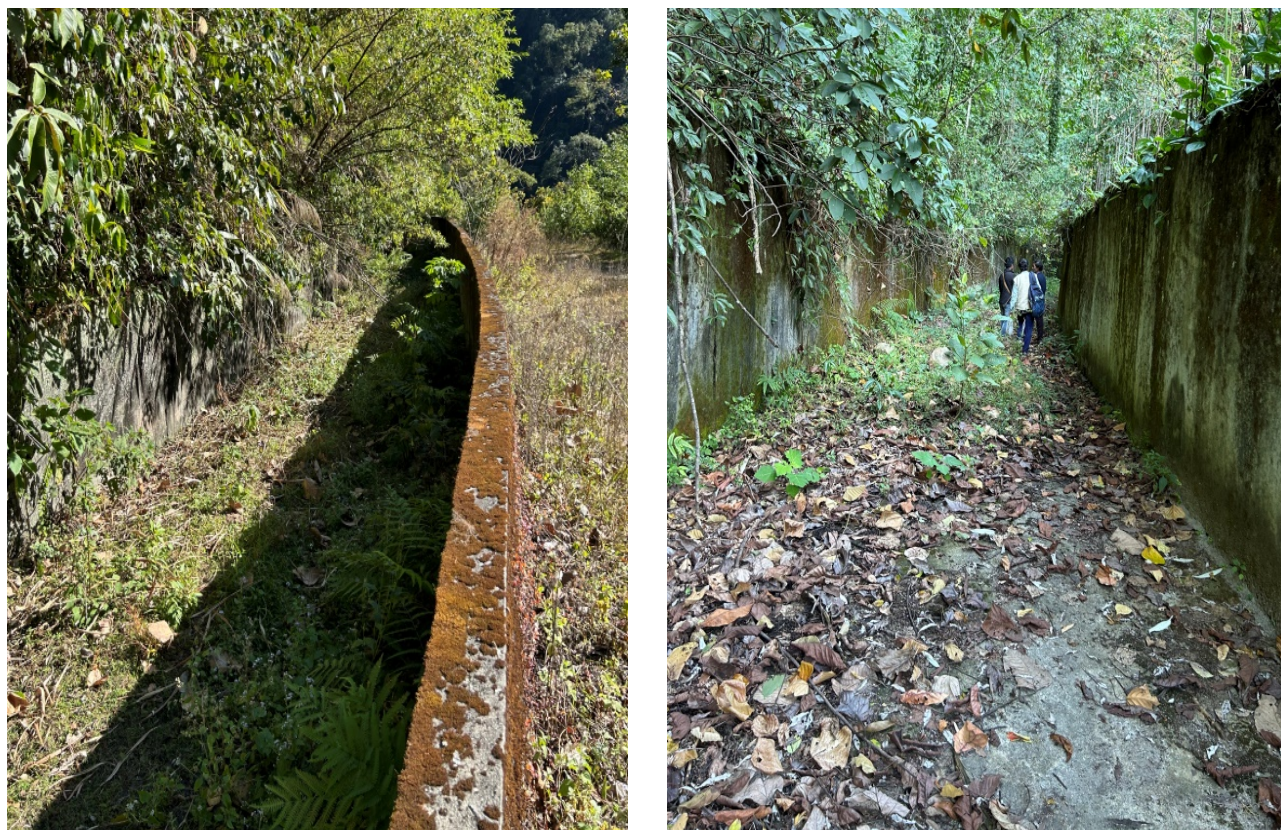
Existing Channel passes through hill slope made up of Granodiorite rocks of Lohit Granitoid complex and debris deposit. The rocks are fresh, hard and massive in nature. The exposures are limited as the entire area has thick vegetation and already construction done over such rock (Fig. 16). The measured length of channel alignment is about 1944m (405m- Feeder Channel & 1539m- Power Channel) which crosses through few minor gully and seasonal Nala. Due to heavy rain some nalas/ gullies fed by heavy sediments in to channel at few places. That locations need to be covered with RCC. At places, The channel has been filled with muck and partially damaged. Moreover Channel is safe and minor repair and cleaning is required. Geological assessment states that the alignment is safe and passes over stable slope.

Fig. 16 A view showing the existing channel filled with sand/silt

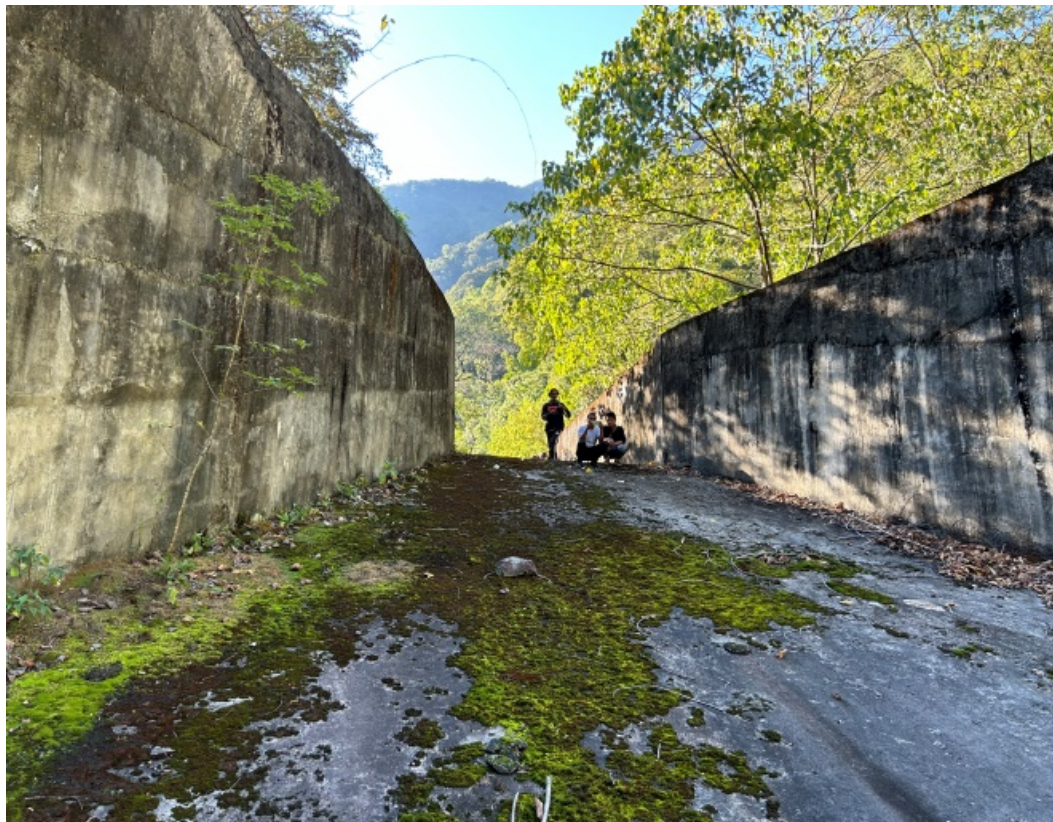
The 63m x 18m Desilting tank has been constructed over a gentle to low hill slope made up of consolidated debris and hard rock (Fig. 17). The area has dense vegetation and bushes cover. Outcrop of bed rock is observed at the back slope of D-tank which belongs is assumed that the structure has been kept over strong foundation.

Fig. 17 A view showing the existing D- Tank

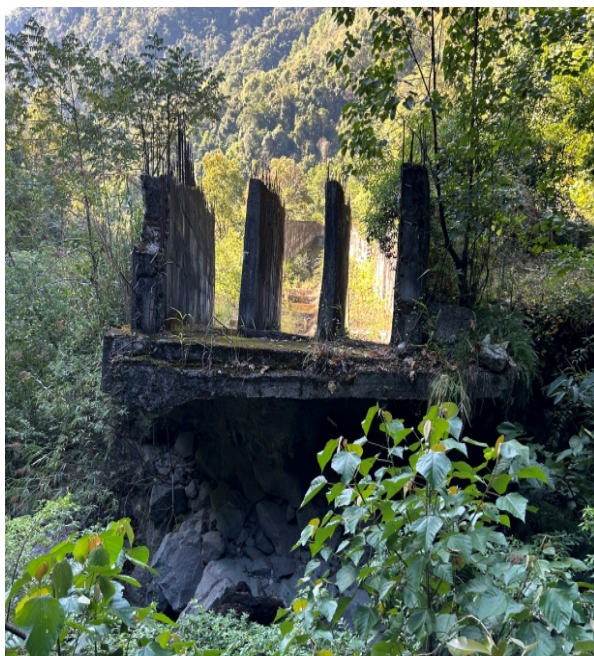
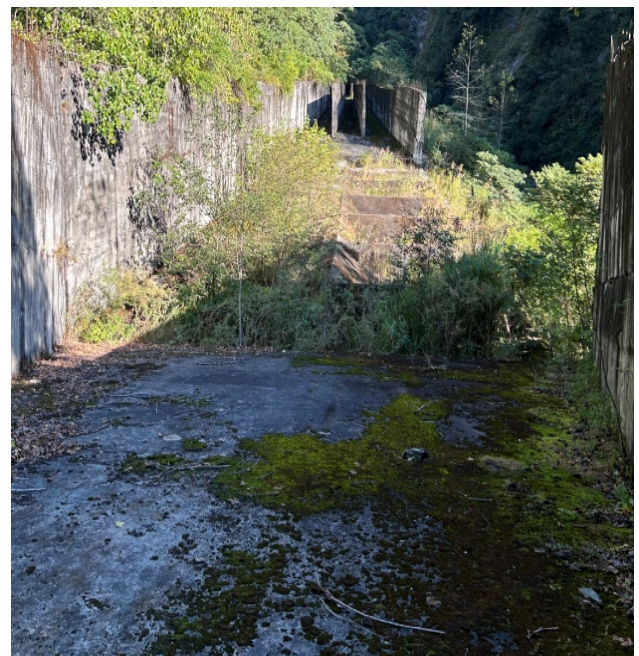
The entry point of tank is damaged and subsidence noticed due to scouring of river. It has been observed that the foundation has been kept over consolidated debris which may eroded in heavy flood (Fig. 18). The main structure is safe and doesn't show any movement which confer that the tank position has been kept over solid and hard rock.

Fig. 18 Another view showing damaged portion of D-Tank

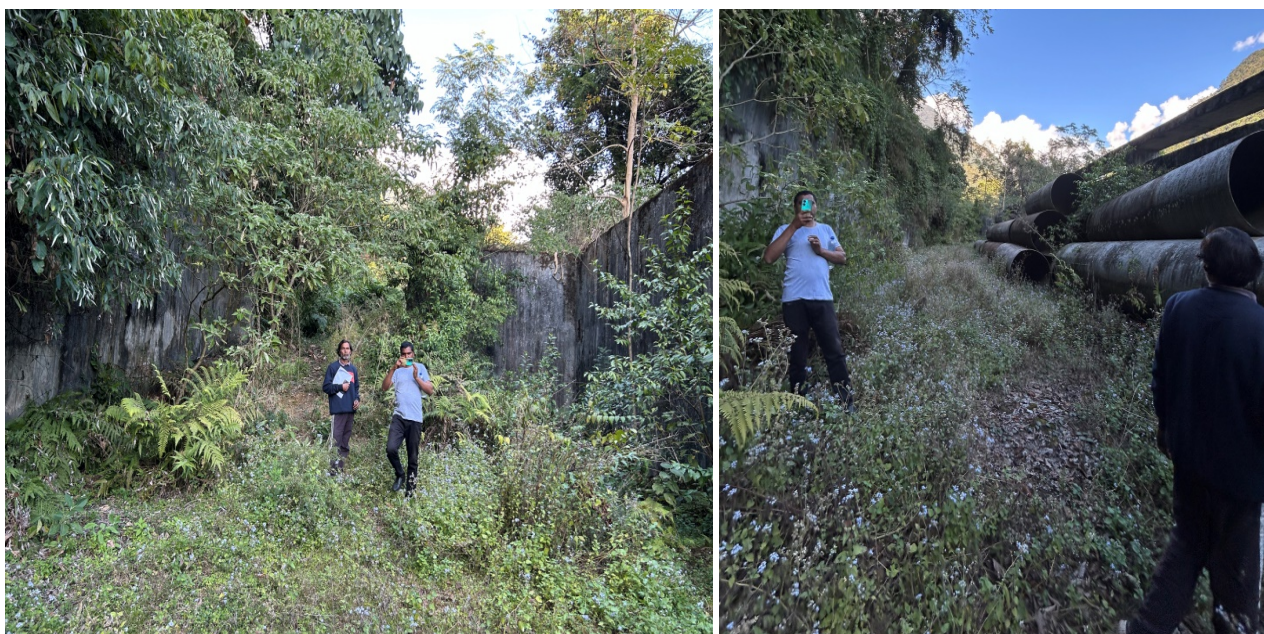
The 66m x 10m forebay tank is constructed over a gentle hill slope made up of consolidated debris deposit (Fig. 19). The area has dense vegetation and bushes cover. Outcrop of bed rock is not observed in the area as the entire forebay area has been constructed. The structure is safe and in good condition. Only cleaning is required as the entry point has been filled with small quantity of slope debris. The tank location is geologically safe and stable.

Fig. 19 Views showing the existing Forebay Tank area

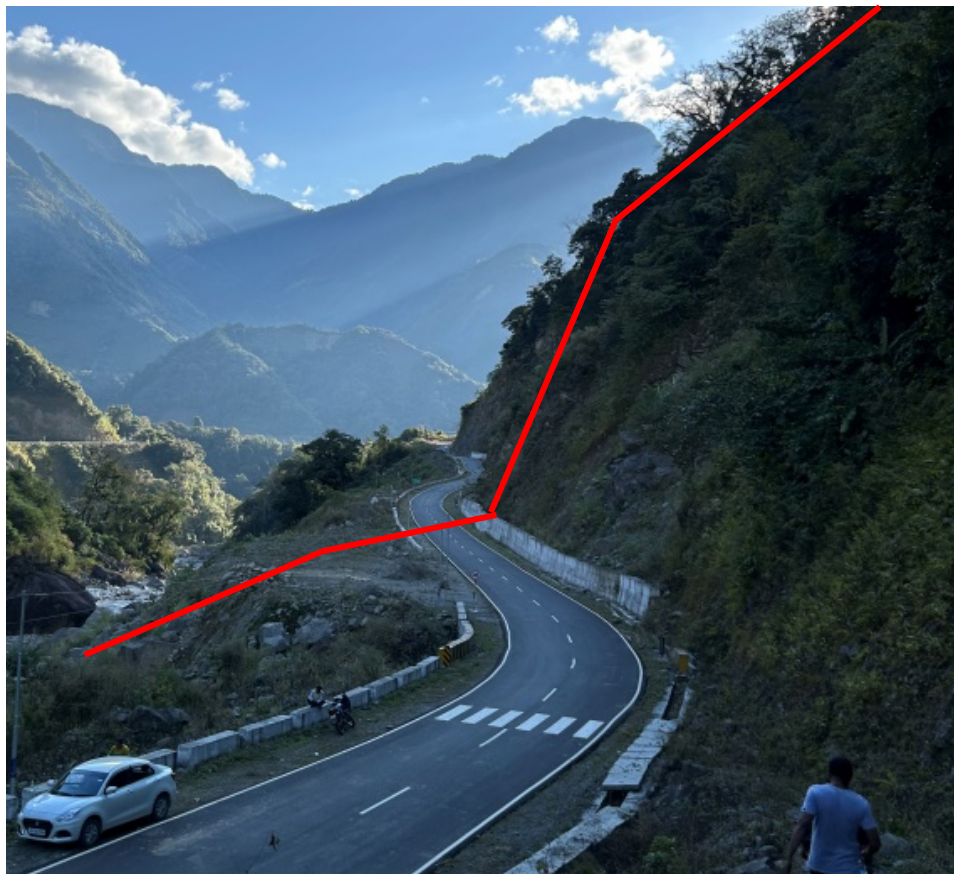
Four Nos., 1.3m dia and 174m long penstock pipe has been proposed over gentle to moderate hill slope. Penstock alignment traverses over hill slope made up of debris deposit which is partially consolidated (Fig. 20). A slide zone has been developed beside the alignment which shows the subsurface geology is made up of loose debris made up of rock boulders mixed with soil. Some Saddle/Anchor block has been eroded near road side due to loose nature of deposit. The slope angle is moderate about 45°-50° at its initial reach then it will drop at high angle about 70° and will cross NH 113 before it reaches to Power house.

Fig. 20 A view showing the hill slope for Penstock Alignment

It is suggested to have detailed slope stability assessment of alignment slope for the safe alignment under global failure condition. Also need to calculate safe bearing capacity at

location of Anchor/Saddle block to examine the foundation failure at these critical structures.

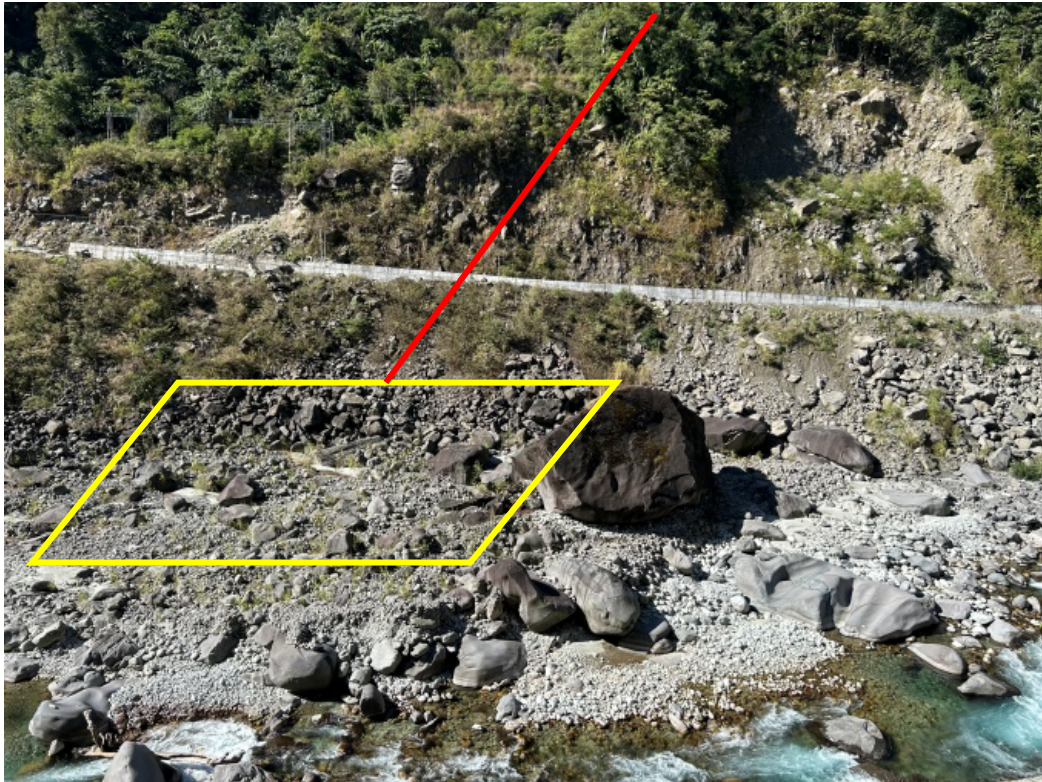
A surface Power house has been proposed on the right bank of the Halai River. The proposed area has flat terrace made up of flood deposits such as river born sediments (Fig. 21). The back slope of the site has cut and fills materials and needs slope protection work. Exposure of bed rock is not observed as the entire area is having loose debris and flood deposit (Fig. 22). Few large boulders of variable size are noted at the proposed location. The access to the power house should be above from the HFL of the Halai River.

Fig. 21 A view showing the flood terrace where Power House is proposed

It is suggested to do 02 nos. boreholes at proposed PH site to assess the flood deposit thickness and depth of bed rock. The site also requires river training works for at least 1 in 100 years flood condition throughout the length from bridge to Power house complex for safe and suitable.

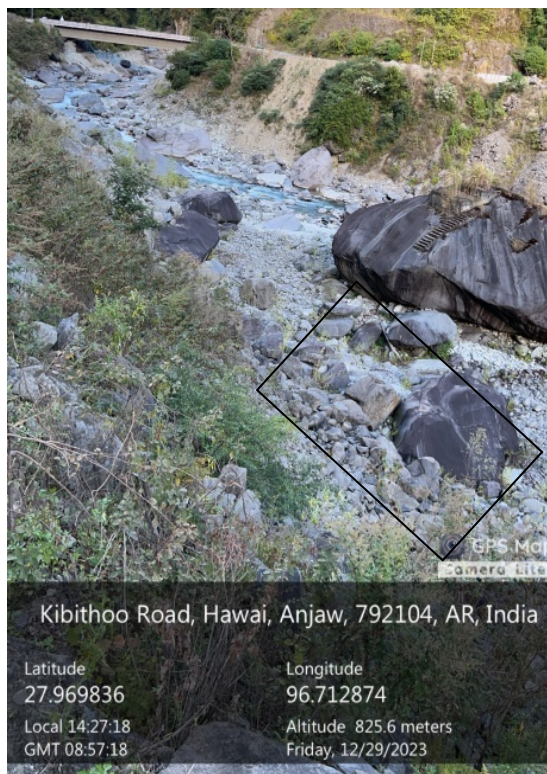
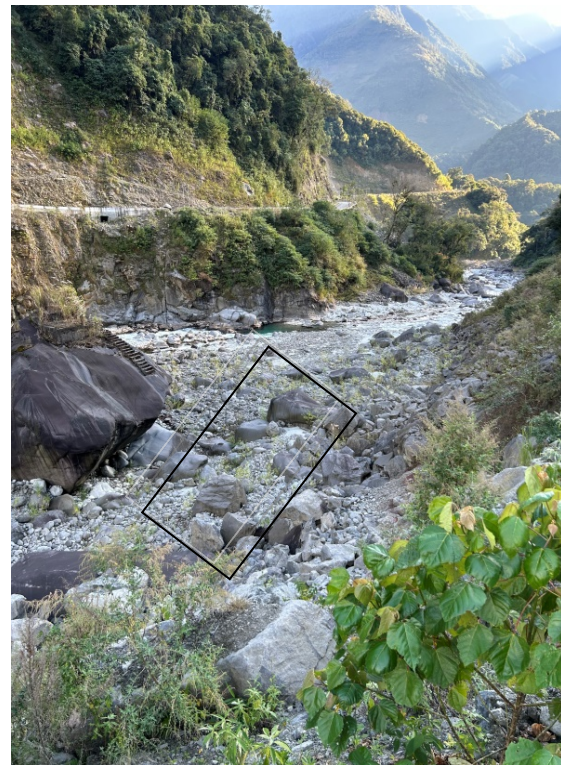
Fig. 22 Another views showing proposed PH site

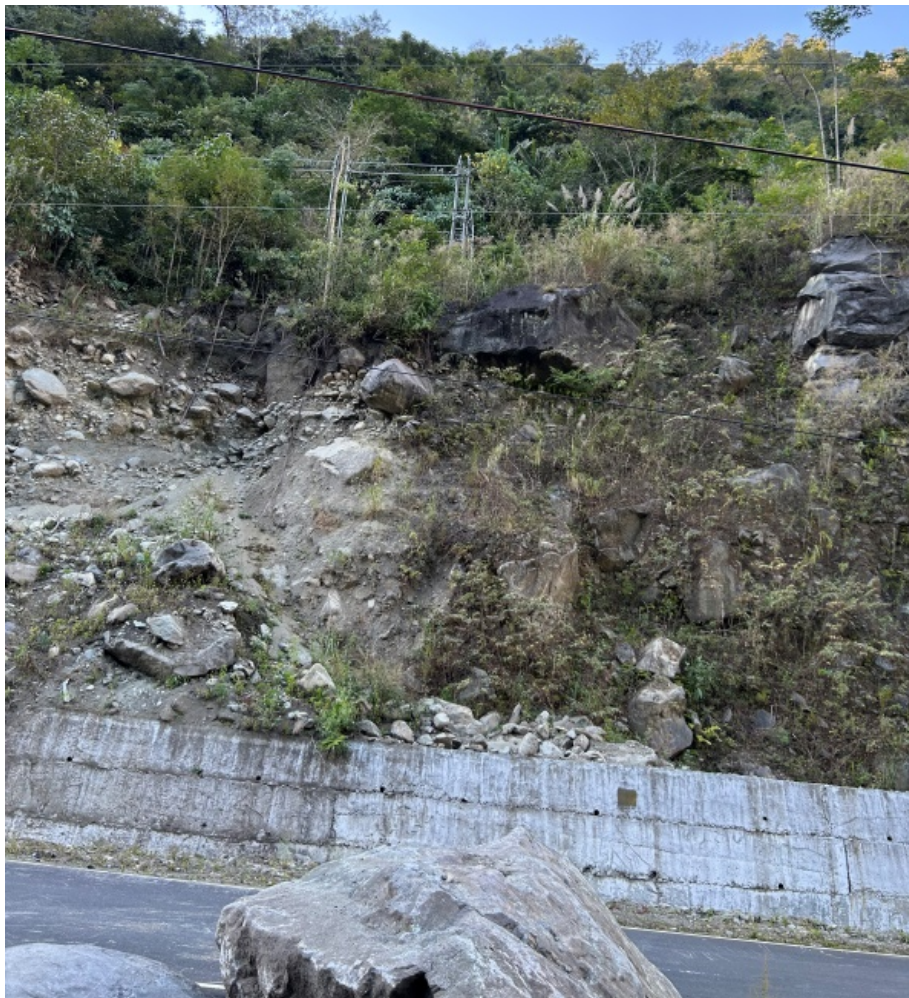
Existing Switchyard site has been damaged due to slide occurred at the bottom (Fig. 23). It was planned over hill slope made up of partially consolidated debris deposit as it can be seen from roadside. Geologically the site is neither safe nor stable as this area is having loose sediments.

Fig. 23 A view showing damaged Switchyard

It is suggested to shift at another location which is identified on the right bank of Halai River beside National Highway NH 113 (Fig. 24). The site seems to be a dumping yard used for road construction which is more favorable as compared to previous site. Recommended two nos. borehole at the location for the safe design and strong foundation. The bottom/base of the slope must be protected by construction of a retaining wall which will prevent from scouring.

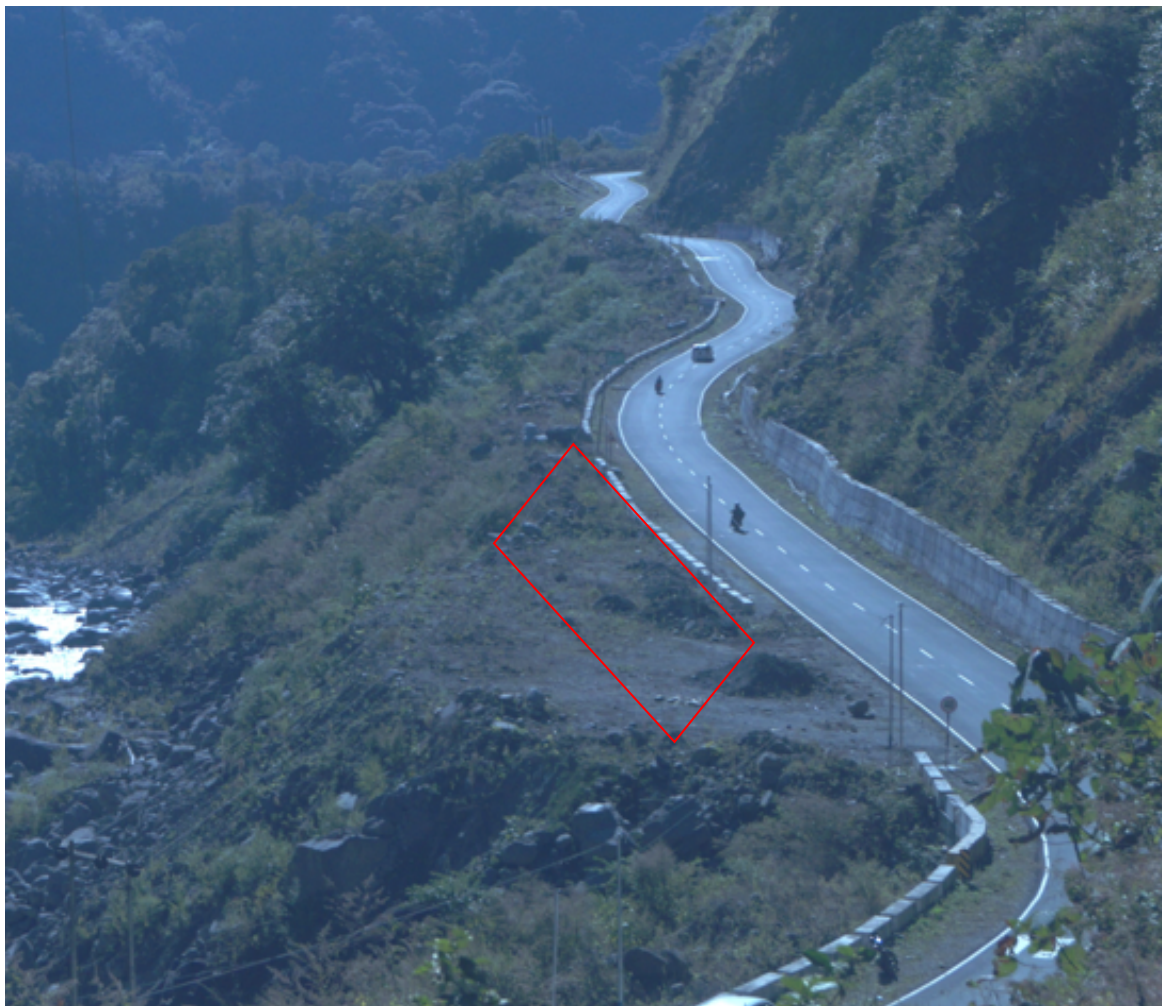
Fig. 24 A view showing the alternate location of proposed switchyard
