Site Inspection Report of S Sasikumar IFS, Deputy Inspector General of  
Forests (Central), Integrated Regional Office, Chennai

Date of Site Inspection: 3<sup>rd</sup> January 2023

Proposal No: FP/TN/IRRIG/118339/2021

**Purpose of the project:** Construction of fuse plug pertaining to Thandarampattu Taluk of Tiruvannamalai District for discharge of heavy floods from Sathanur Reservoir in Tiruvannamalai District

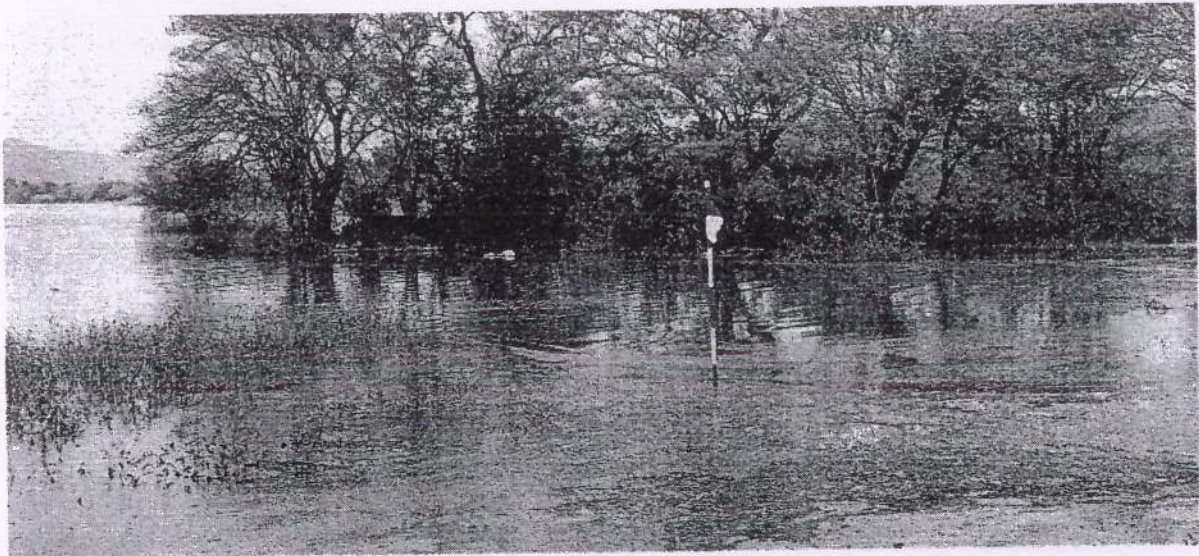
**Annexure-I**

**The proposed site of Fuse plug where in FRL is seen in full capacity**

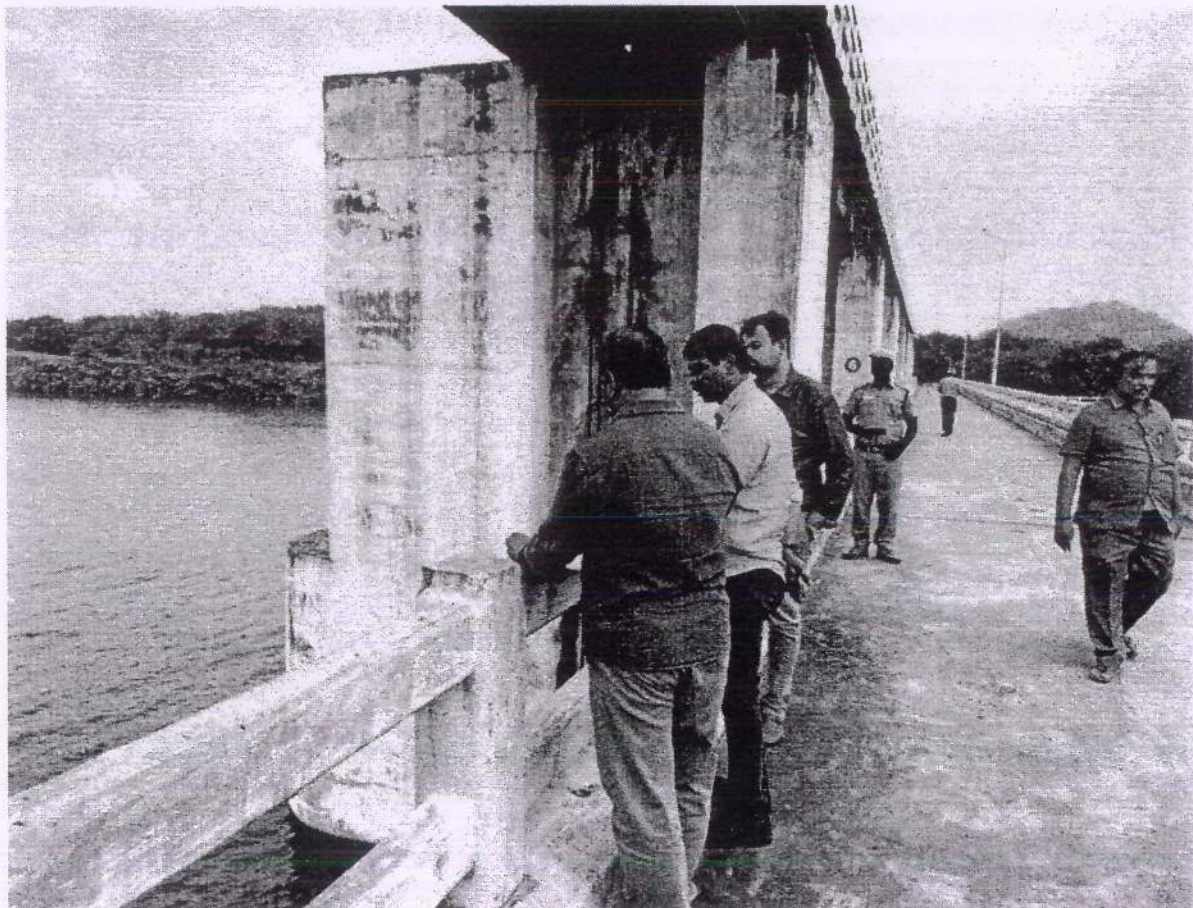
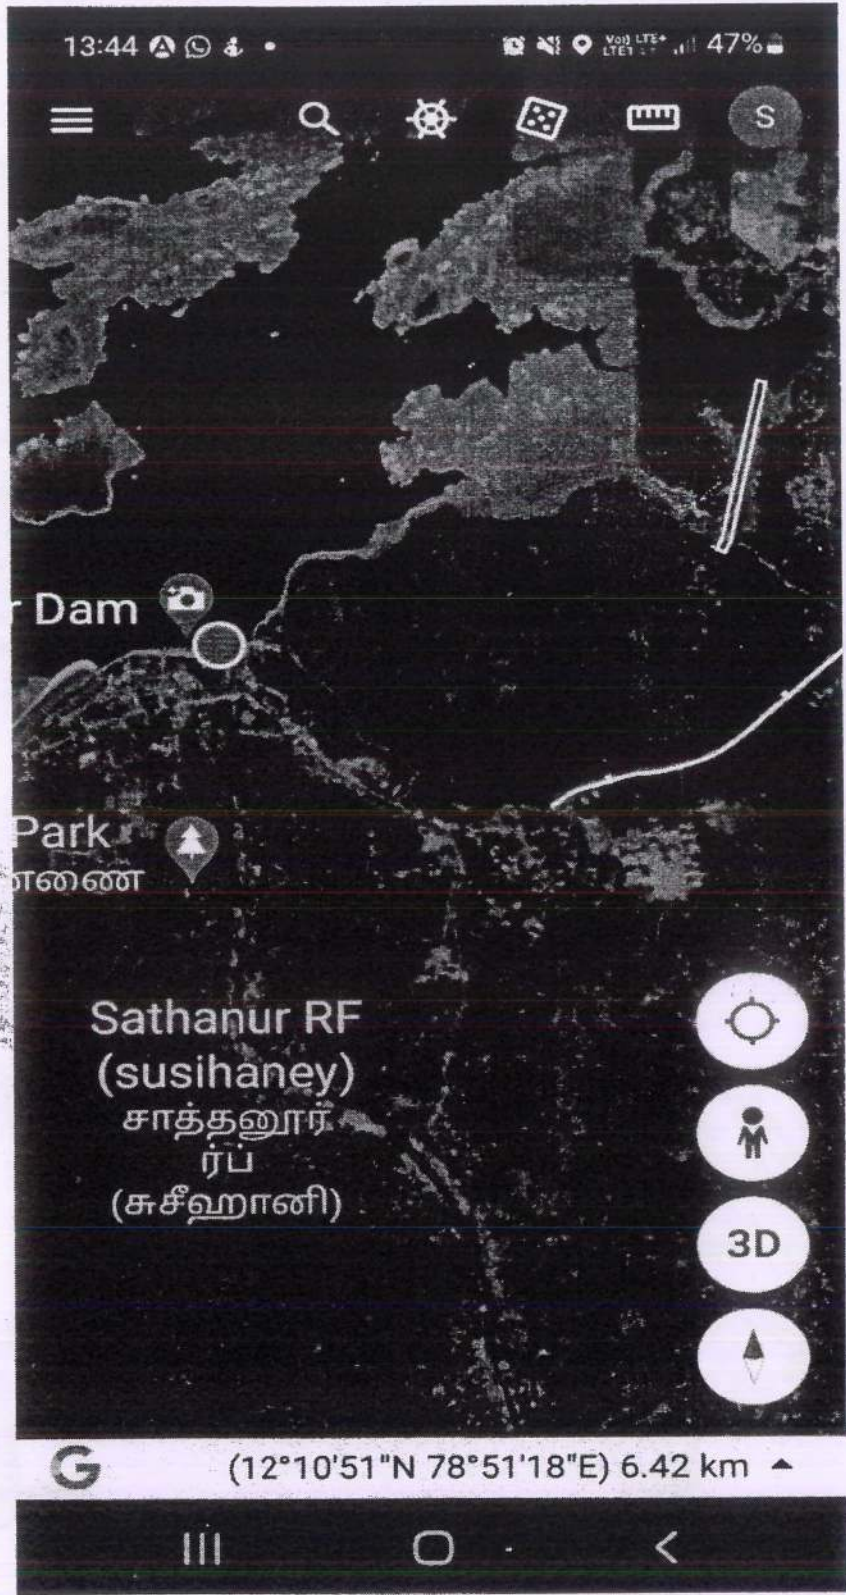
Google image of proposed Fuse Plug Site

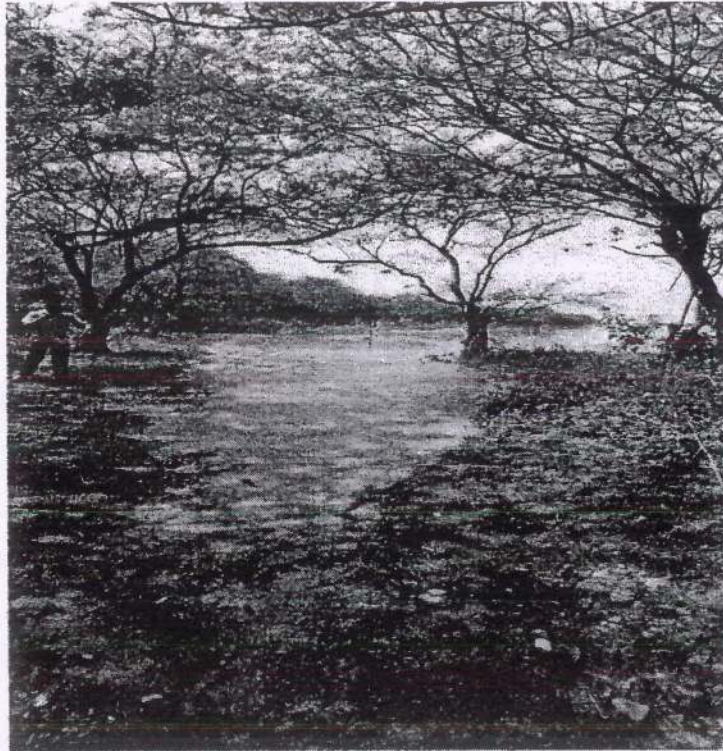
Annexure-III

During the visit, it is seen that the dam is at full reservoir level (FRL). The water is seen to be leaking out of the dam through the natural gradient from the proposed site for construction of Fuse Plug. Photos showing the spill of water from the dam is submitted as **annexure-III**. And it is also seen that the water is being overflowing from the existing spillway, saddle and other outlets. At present there is no proposal from the User Agency to construct any channel to divert or connect this excess water to the main river. If it is allowed to go through the natural gradient and also through the existing walk way, it might cause huge damage to the trees present in the RF area. We may have to seek opinion from the State Government on this issue of excess water causing damage to the existing trees in the RF area. There is no contingency plan either proposed or submitted along with the proposal.

Water is at present over flowing from the propose fuse plug area. The dam is at full capacity

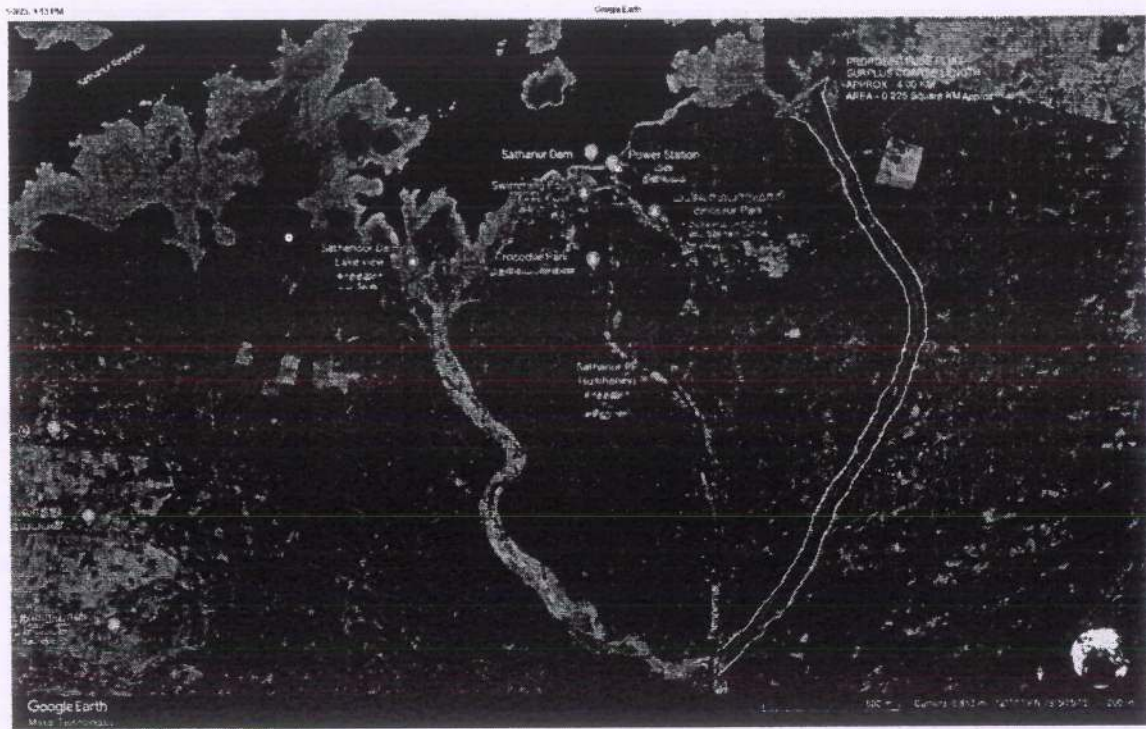
**Annexure-IV**

pathway, worked out based on the gradient, through which the excess water is expected to be discharged is shown on Google map is submitted as **annexure-IV**. The area which is going to be affected due to this voluminous discharge needs to be worked out and the expected damage to the trees in RF need to be worked out.
