**SITE INSPECTION REPORT OF DEPUTY DIRECTOR, SRIVILLIPUTHUR -
MEGAMALAI TIGER RESERVE (SMTR), SRIVILLIPUTHUR**

I inspected the area proposed for diversion on 09.01.2022 along with Forest Range Officer, Saptur; two Foresters (Saptur and Maharajapuram section) and two forest guards (Saptur beat IX and VIII). The area requested by user agency for laying 11 KV HT XLPE underground Electric Cable towards Electrification of Arulmigu Sundara Mahalingam Swamy Thirukkovil from Vazhaithoppu pathway to Arulmigu Sundara Mahalingam Thirukkovil area across Saptur R.F is 0.28 ha. The proposed underground electric cable pass through Saptur beat IX and X and Watrap beat IV for a distance of 5.61 km. It is proposed that of the total 5.61 km, 2.27 km falls in plain land, 2.63 km in rocky area, 0.46 km stream area and 250 m elephant area.

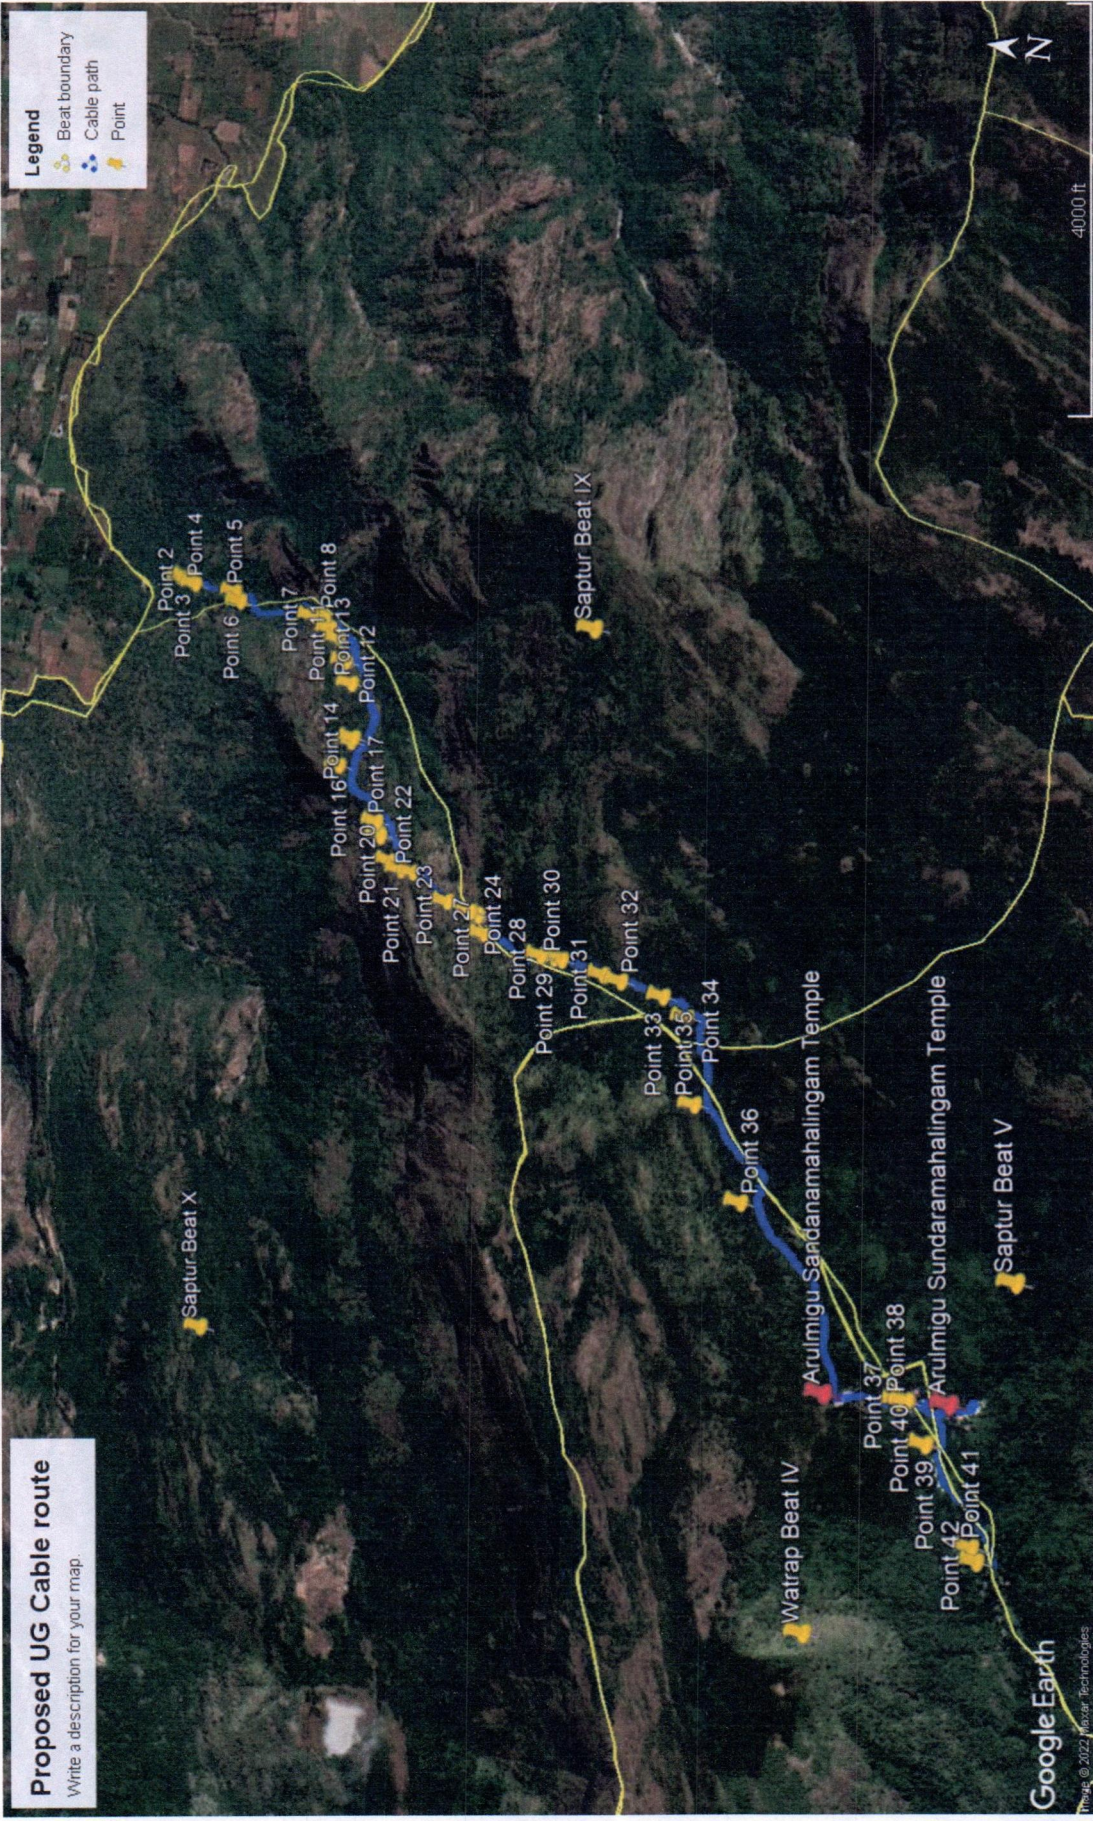
Map 1: Map showing area requested by user agency for laying 11 kV HT XLPE underground Electric Cable towards Electrification of Arulmigu Sundara Mahalingam Swamy Thirukkovil

After this point, starts a place called Pallakku mudangi, which is almost 70° slope. Then at an altitude of 747 m the cable path crosses a stream called Kuzhiratti odai in Kuzhiratti mottai which has montane grassland. This stream falls down from an altitude of 950 m and cable path crisscross this stream three times before takes the diversion towards a place called Koyya kanal. This entire stretch is rock portion and the Kuzhiratti stream in this portion runs only on rock for almost 9 to ten months in a year. In this particular stretch cable remain under water completely at three locations for at least 9 months. Most importantly this stretch lies in the heart of Nilgiri Tahr habitat. Tahr uses this place for drinking water and move between hillocks. They move between hills called Sengaliparai and Kathadi mottai via Kambatthu mottai, Kuzhiratti mottai and Tiruge kallu (technically, paths connecting these hills form Nilgiri tahr corridor). Among these, electric cable passes through Kathadi mottai and Kuzhiratti mottai and Tiruge kallu for almost 2.5 km which is prime nilgiri tahr habitat in Saptu Reserve Forest (map 1 and table 2).
