**Subject:** Proposal for seeking prior approval of the Central Government under Section 2 of the Forest (Conservation) Act, 1980 for diversion of 397.8863 ha forest land in favour of SJVN Ltd. for construction of Sunni Dam Hydroelectric Project (382 MW) within the jurisdiction of Shimla, Kotgarh and Karsog Forest Divisions, in District Shimla and Mandi, Himachal Pradesh (ONLINE PROPOSAL NO. FP/HP/HUD/31019/2017) – regarding.

LUHRI-II/SUNNI DAM HYDRO ELECTRIC PROJECT

**DESIGN, NUMERICAL MODELING, KINEMATIC ANALYSIS, SLOPE STABILITY &  
PROTECTION WORKS INCLUDING SLOPE HEALTH MONITORING**

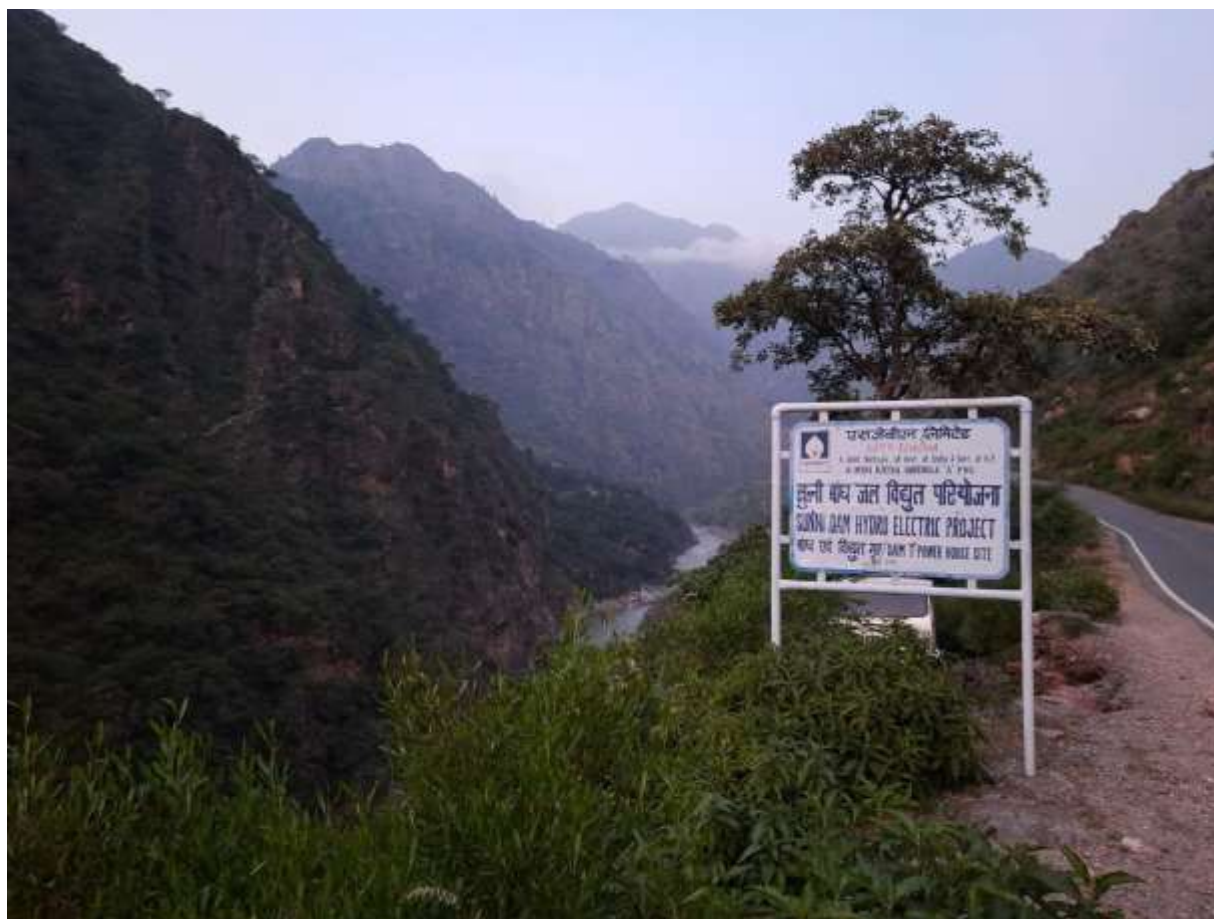
Figure 2 View of Sunni Hydroelectric Power Project

- Concrete gravity dam 95 m high above deepest foundation level and 178 m long,
- Two level spillways consisting of 6 bays of 8.5 m x 15 m (H) sluice and 1 no. of 8.5 m x 3 m (H) surface spillway; intake on right bank;
- 3 Nos of pressure shaft bifurcating to six units of underground powerhouse.
- The proposed installed capacity of this Project is 382 MW and design energy is 1382 MU.

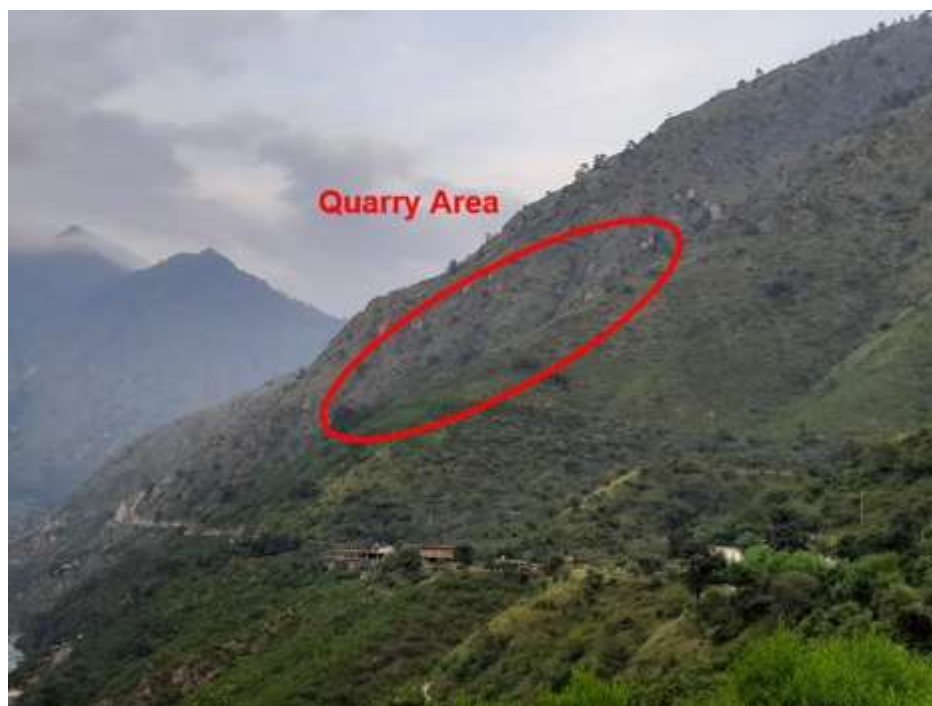
**Figure 3 General Area of Quarry Site along right bank of River Satluj**

The project site is located at 58 km from Shimla and can be reached from state highway 13 or main district road 22 via Khaira, nearest village to the site which is 13 km from Seoni, tehsil of Shimla District. The area of the site is 10.3264-hectare on the hillside of right bank of river Satluj. The site extends from an elevation of EL 798 m near the river bank, to EL 912 m towards the hilltop.

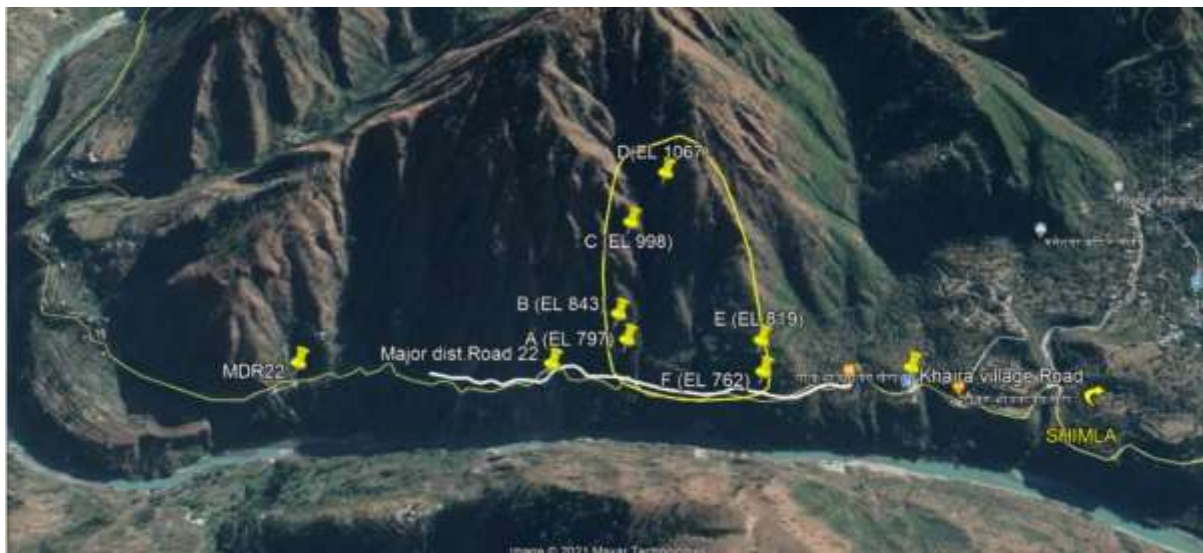
**Figure 4 Quarry Site with boundaries on Google Earth Pro**

For detailed approach longitudes and latitudes of quarry site are given in table and marked up on Google Earth along with elevations. Figure displays clear locations and approach road to the site.

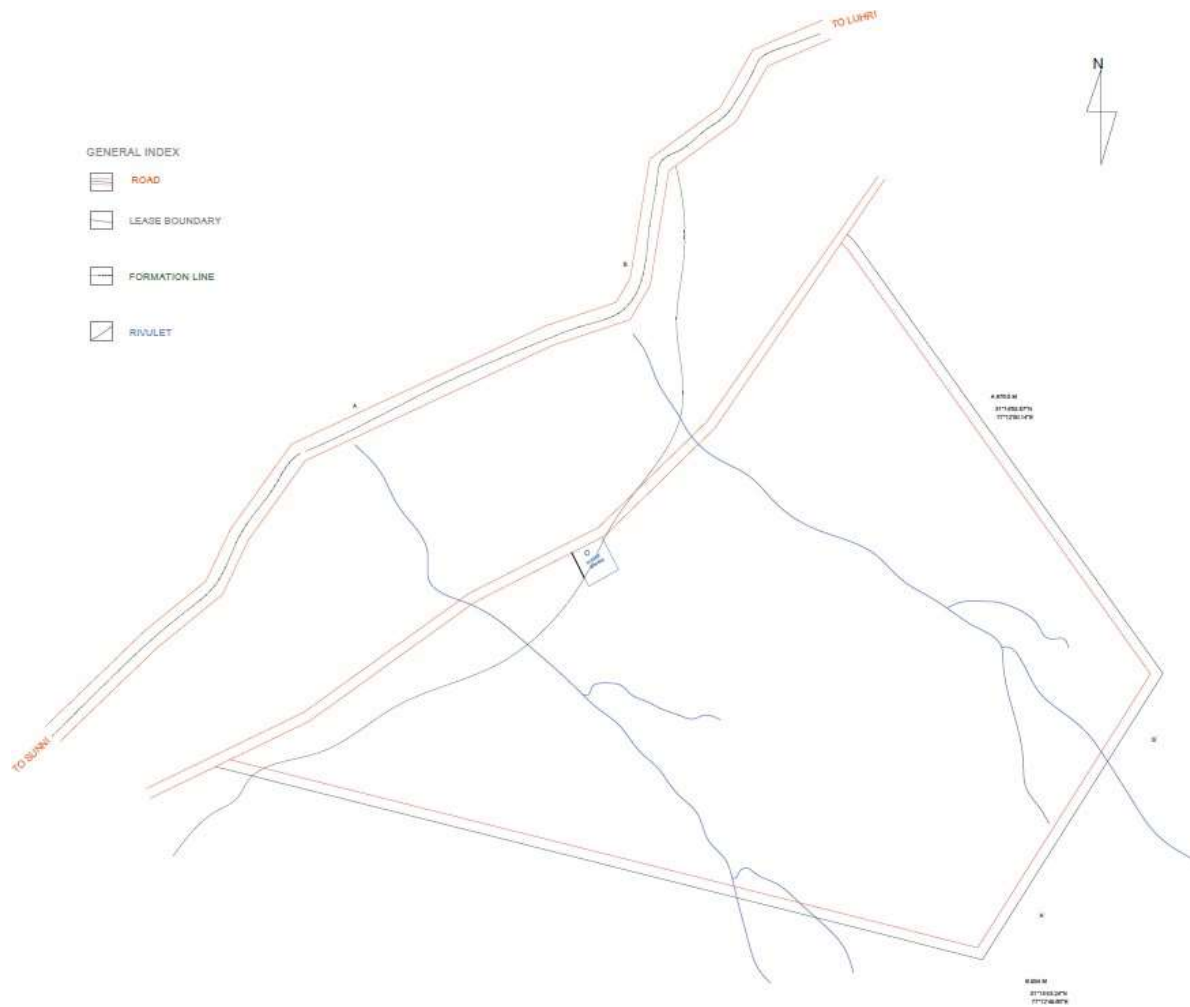
Figure 9 Dendritic Drainage Pattern

The river and other water channels follow the slope of the terrain, hence forming Dendritic drainage pattern. Two water channels pass across the quarry area. They have boulders and gravels in its bed. Figure shows the drainage pattern of the channels.

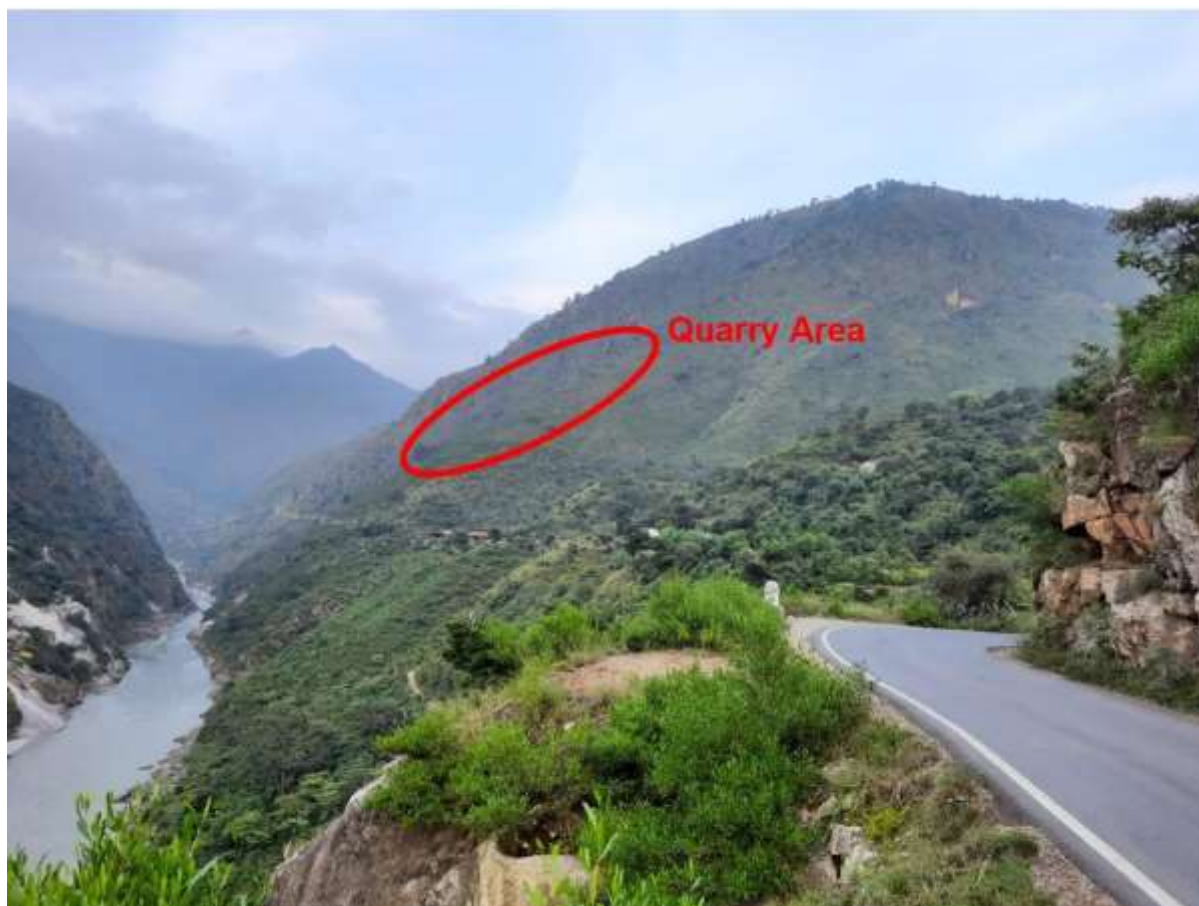
**Figure 11 Absence of Landslide Event in the vicinity of Quarry Site**

The various in-situ tests carried out by SJVN in detail show that the joints of rock in the east of quarry area dip into hill side, therefore, are least susceptible to slide. Even so, the mining plan includes that no excavation works during the monsoon season when the wet rock is most susceptible to slide.

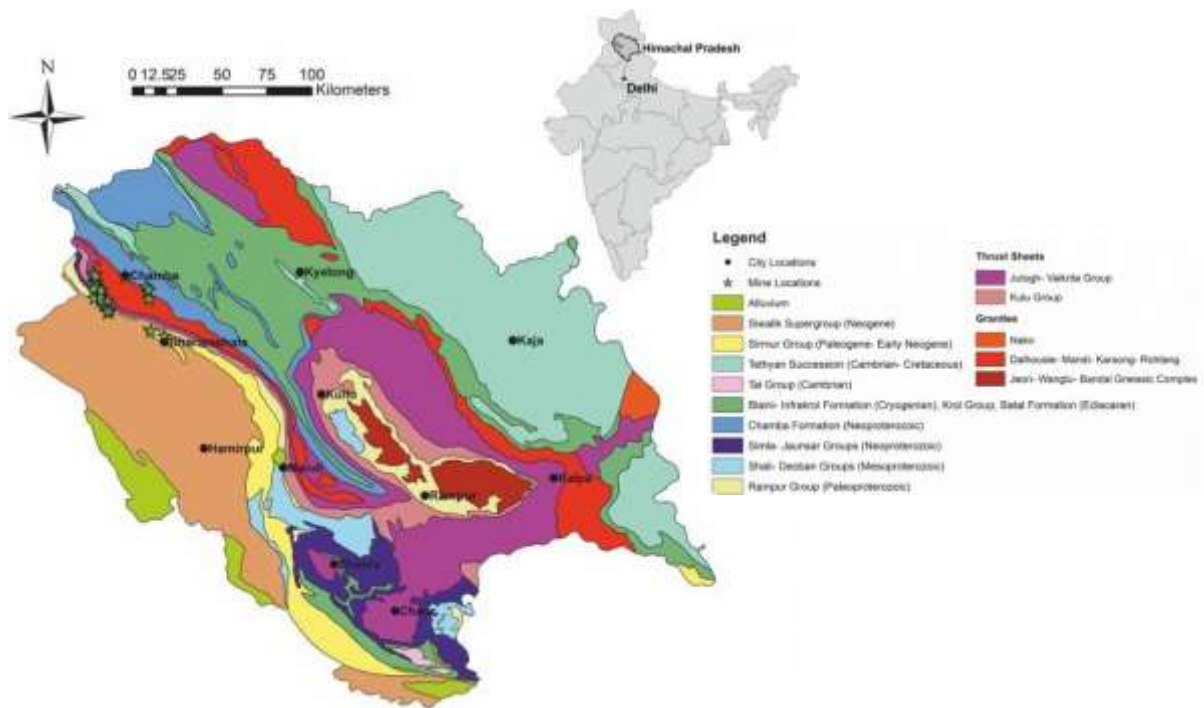
**Figure 14 Geological Formation in the state of Himanchal Pradesh**

Within these formations, the project site has presence of Shali group all across the area. The shali group further has various rock formations out of which: Ropri, Khaira, Khatpul, Sorgharwari, Tattapani, Makri, Parnali, Bandala formations are present in the region of Shimla district. Only the Khaira and Khatpul are exposed in the quarry portion and, Sorghawari and Tattapani Formations of the Shali Group are exposed around the site. The formations in the quarry site are from the Neoproterozoic period.

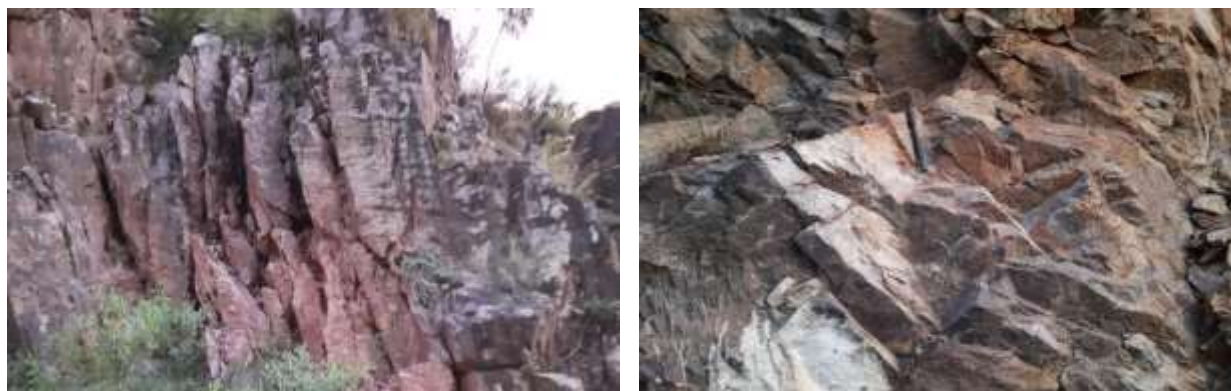
**Figure 16 Stable Khaira and Khatpul Formations at quarry site**

**Khaira Formation:** The Khaira Formation comprises red to gray medium to fine grained, locally coarse-grained quartzarenite/quartzite. Locally thin red shale bands are present in the quartzarenite/quartzite. The bedding features include cross bedding, ripple marks and syneresis mud cracks. The Khaira Formation represents a beach environment of deposition, possible a sand barrier island in a warm and arid climate.

**Khatpul Formation:** It is made up of grayish blue dolostone, cherty at places with thin but persistent red shale bed at its base. Locally red coloured dolostone bands are also present. The basal part of the dolostone is contains siliceous oolites, obviously as replacement of the calcareous oolites. Also present are gray dolomitic limestone, dolomitic breccias. Stromatolites are exclusively developed in the Khatpul Formation.

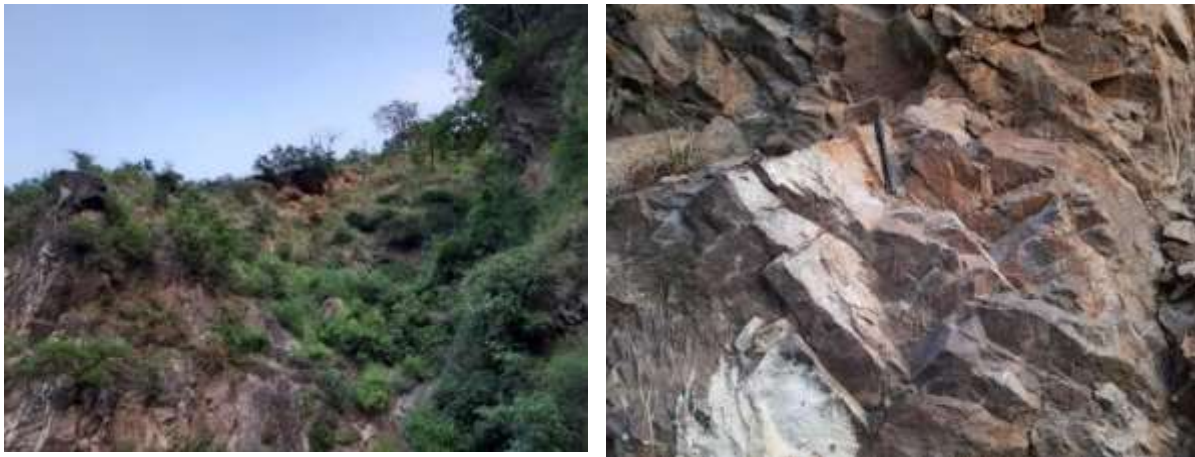
**Figure 17 Presence of Khatpul Formation**

Khaira formation of Shali group is of thickness 380 m displaying Mainly pink and purple color and also white quartzarenite. Khaira formation at base of the hill on the right bank of river Satluj is displaying pink color rock formation. Whereas Khatpul formation of the shali group is of 300m thickness with Massive dolomite with sporadic quartzite. Khatpul formation is observed near the hilltop of site area.

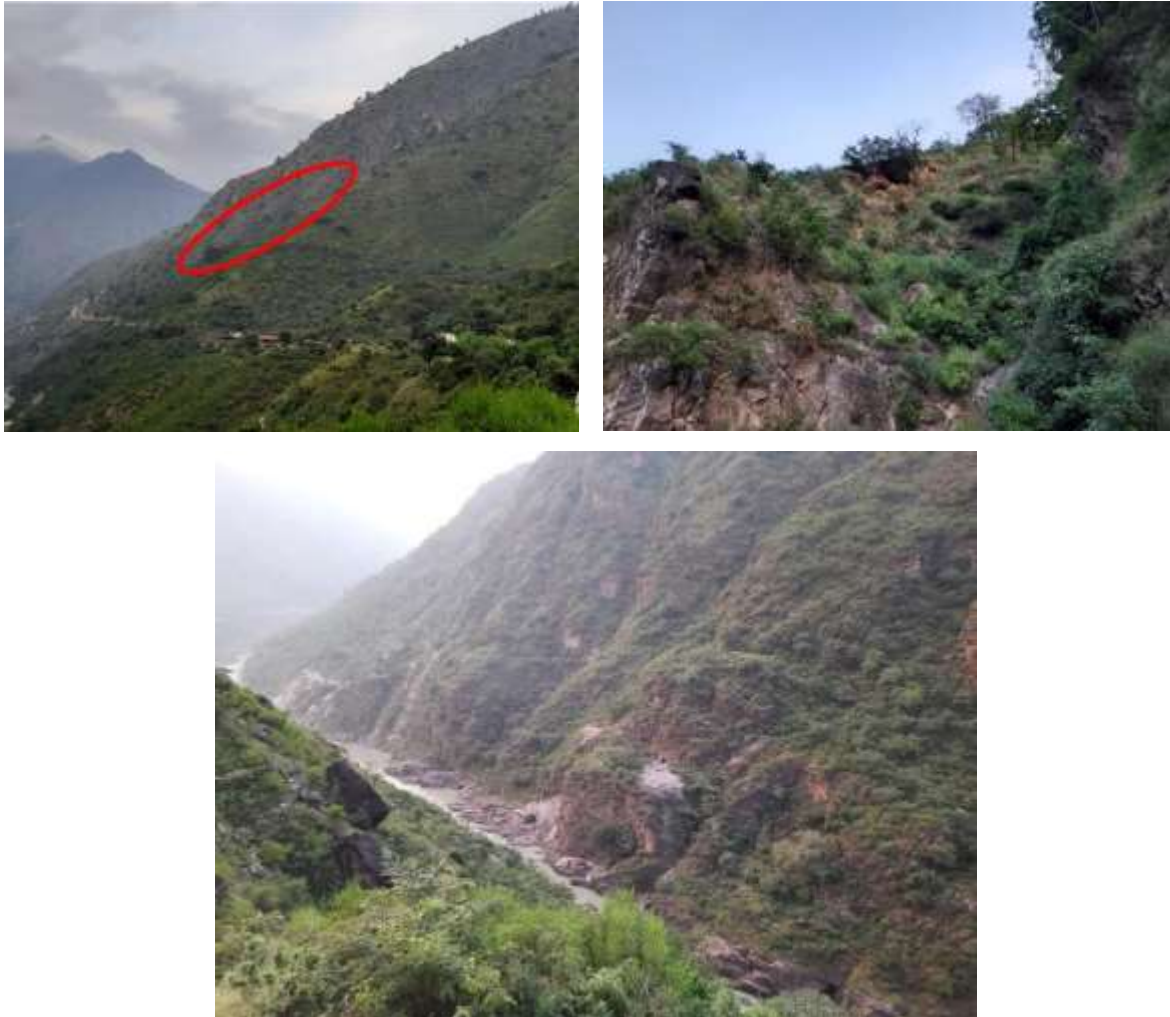
**Figure 20 Soil and Vegetation Cover near Site**

During site visit it was observed that the soil and vegetation cover in the region is minimal and mostly covered in bushes. This will save the amount of wastage and less harm to the regional environment will happen. Large portions of the site are exposed with khatpul formation, which means that the excavated material can be used to the maximum and less wastage will occur.

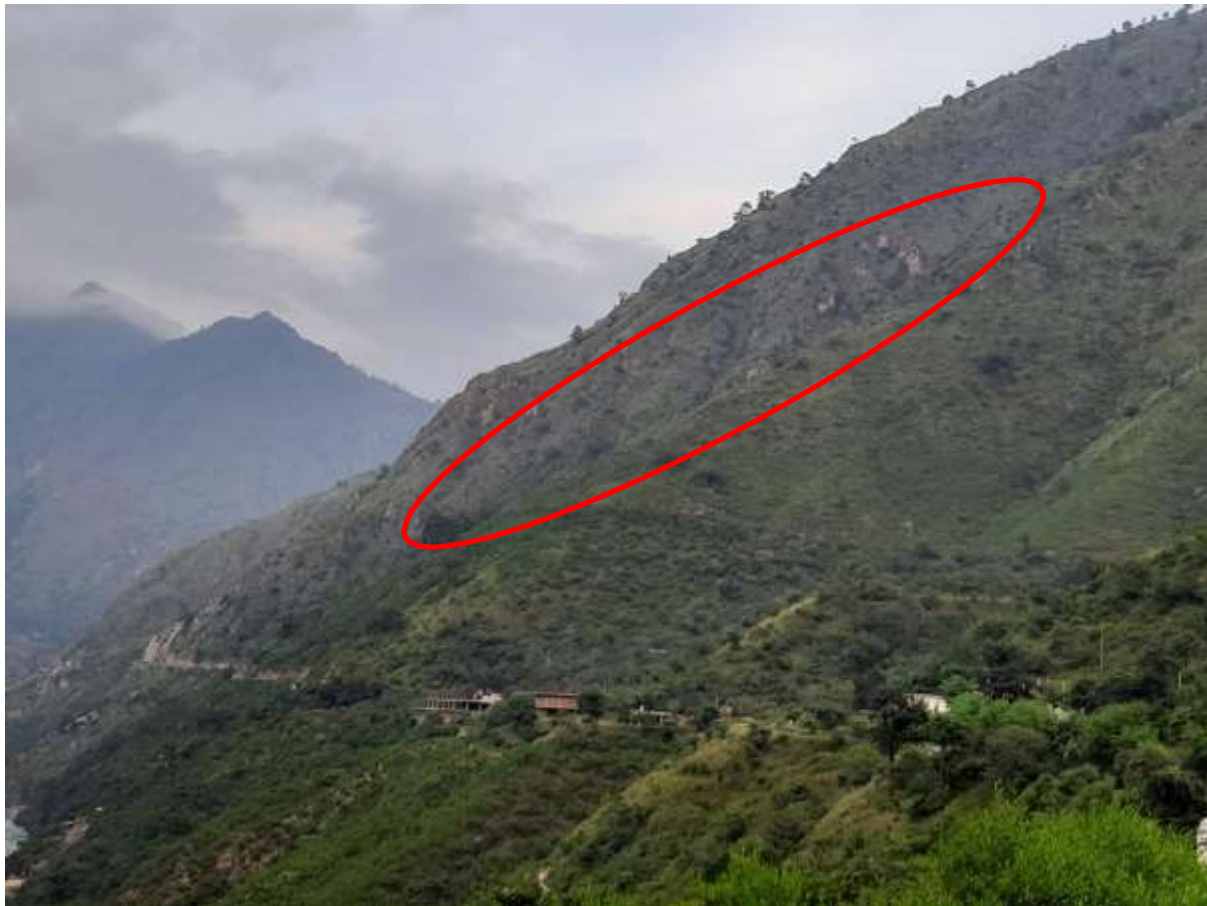
**Figure 24 Catchment area and Quarry site**

For the preliminary hydrological design, the reports available on geology and hydrology are considered. No springs are found in the catchment area or near the quarry site. The area is free of snowfall. The expected source of water is thus limited only to rainfall. The area is experiencing mild rainfall with a maximum of 301mm of rain during monsoon in 2014. The slopes are around 25° to 35° on North – West direction. This slope makes the water runoff easier and reduces the effect of permeability and porosity on dolomite. The natural water channels drain the whole water in the catchment area to the river below. The chances of water

penetrating to the rock is less in this case. The interaction of water with dolomite is less and the complexities arising due to this can be ignored. However, to have a stable slope, proper drainage design is recommended to make the rainwater run off to the river.

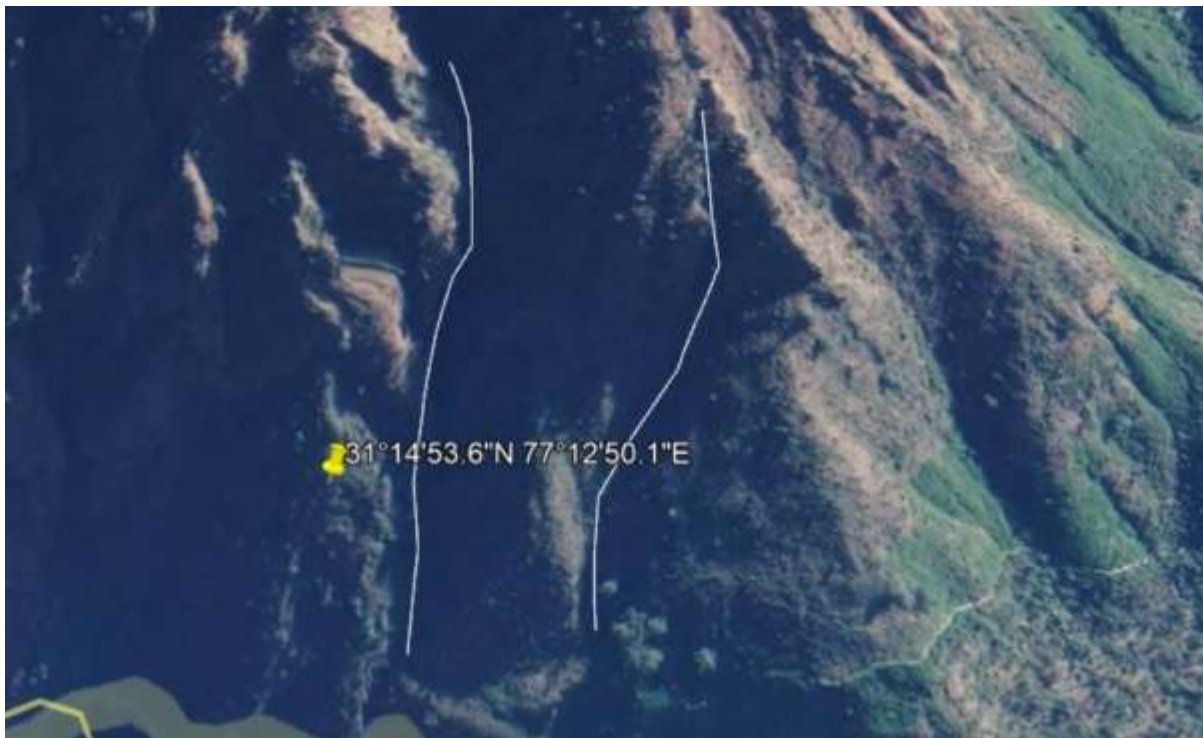
**Figure 25 The natural drains on the Quarry slopes**

There are 2 natural drains in the catchment area which takes the rainwater to the river below. The steep slopes make it easy for the water to drain easily. The proposed quarry will cut both the drains thus disturbing the natural flow. The concepts and failure mechanisms that underlie slope stability analysis hold on both natural slopes and man-made slopes. This can be lessened with the introduction of catchwater drain networks with proper slope. Details design of the drain shall be carried out and the same should ensure the runoff quickly. The lack of presence of springs in the area makes it suitable for quarry.

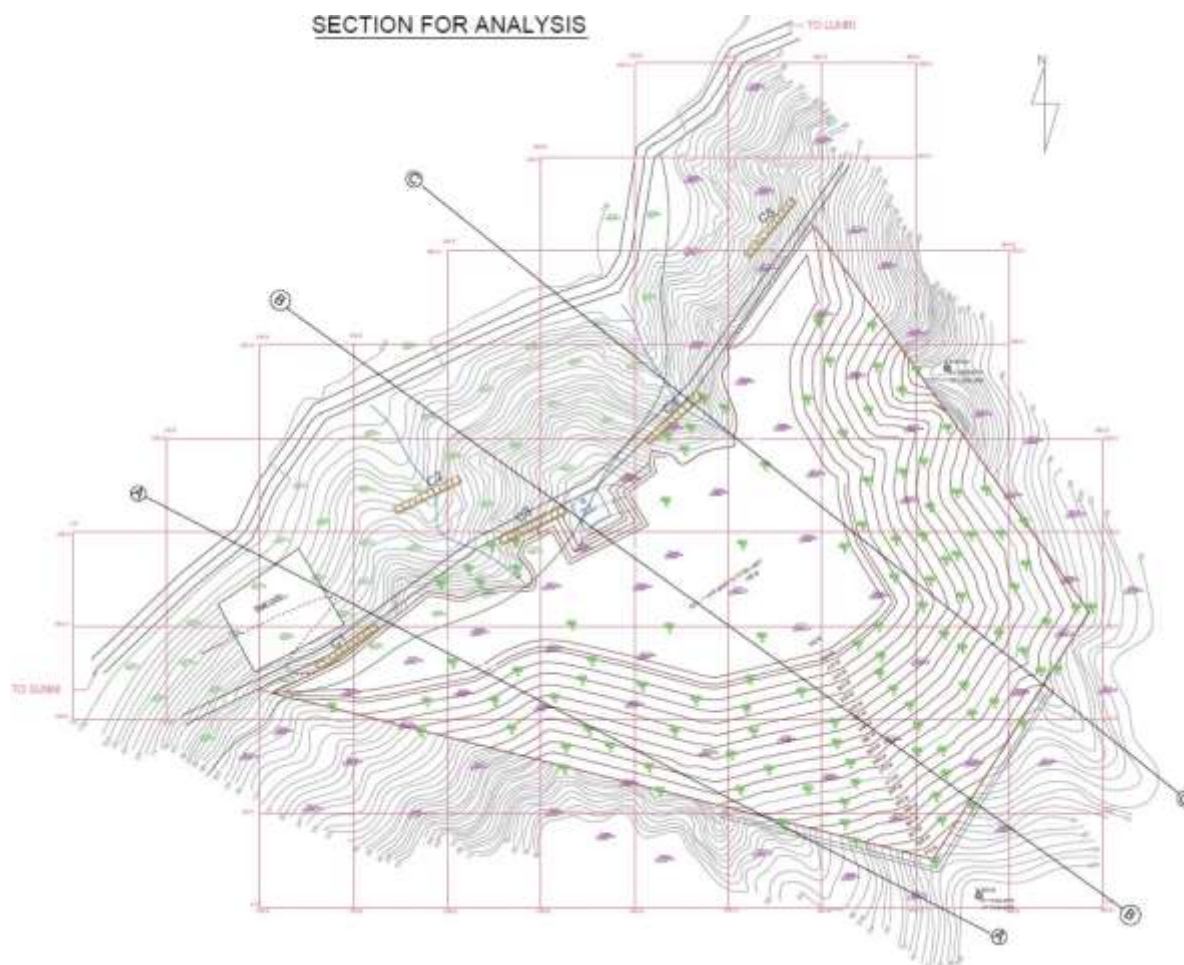
**Figure 29 Sections for Phase 2 Analysis**

Kinematic analysis of the slopes after excavation are carried out using Dips. The joint data provided in table above for the right bank of dam area is used for this analysis. 3D geological log provided for the right bank of dam axis and the joint details provided for the right bank geology are considered for the data. A stereo net is produced using the data and is been checked for planar, wedge, and toppling failure.

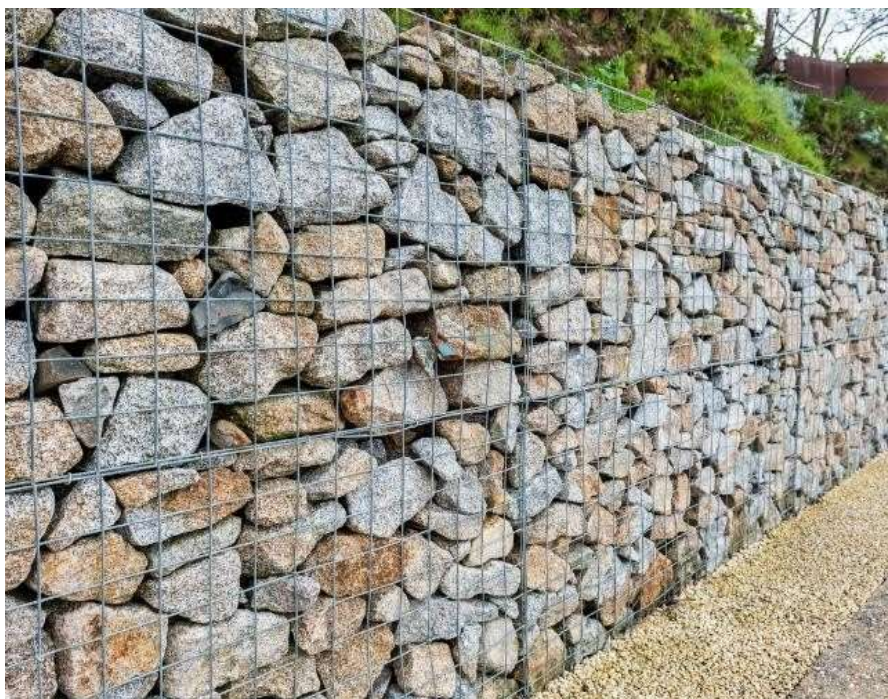
**Figure 51 Typical Gabion Wall**

The proposed support system to stabilize the probable weak area is gabion walls. Gabions walls shall be adopted at the bottom most slope of the proposed benches, where the chance of failure is highest and possibility of rolling stone from above. The technical specification for gabion walls is provided in the section below.
