Geological Report in regard to for constructing motorable road from Jeori Rest house to Nawaru, District Shimla (Km 0/000 to 2/341)

INTRODUCTION

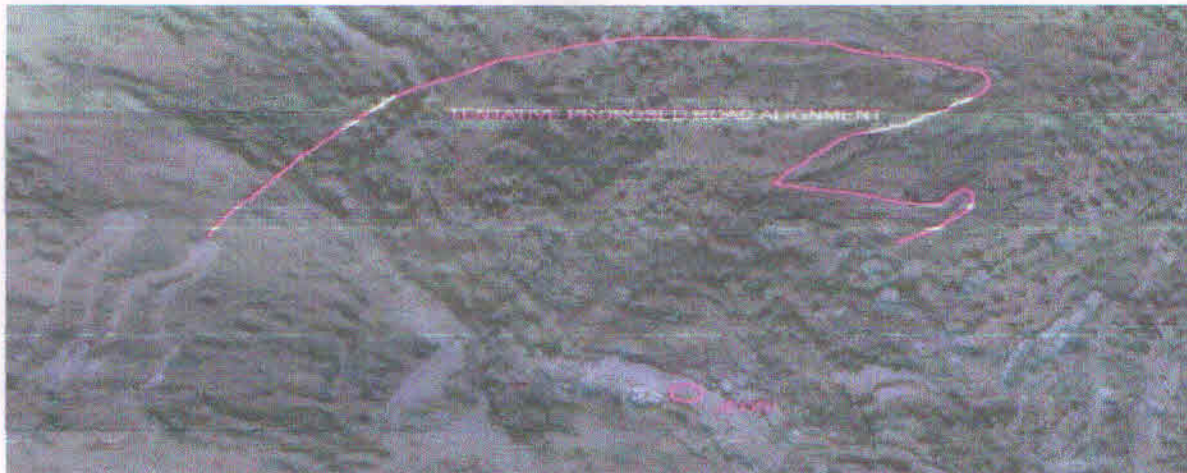
Tentative Proposed road alignment

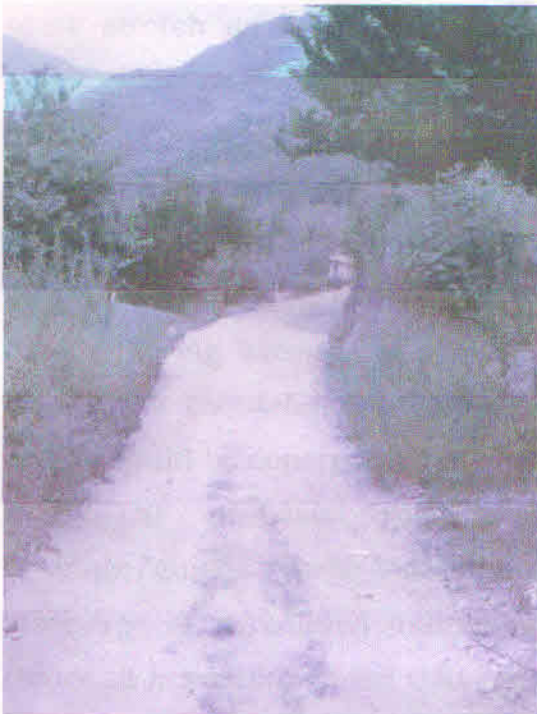
The proposed road alignment has generally moderate slope and lies in the intervening valleys of Rampur-Sarahan geo-morphological division of Shimla District. At some places where the slope is steep, bed rocks are very well exposed along road cutting and nalla cutting.

The proposed road will cover two villages i.e Nawaru and Nawara. The rocks in the area are of Sarahan Group of rocks. The places with flat and gentle hill slope are covered with the overburden material. These deposits are found mixed with sandy, silty and clayey soil. The weathering and disintegration of the upper portion of the rocks has resulted in the formation of the soil cover. As a result of percolation of rain water into shattered bed rocks caused weathering of rocks. It contains large quantity of clayey matrix along their foliation planes. Most of flat surfaces and gentle slopes are covered with

debris/overburden material (silt & clay).The slope/ridge where bed rocks are not exposed is covered with soil/overburden of variable thickness. The sloping hill slope also exhibits presence of thick matter of soil, unconsolidated debris.

Proposed road alignment
village Nawara-Nawaru

Based on surface studies made in the field, it is inferred that the hill slope along which the proposed road alignment is proposed appears to be stable on Geological point of view. However, following recommendations are considered absolutely essential for long term safety of the road and stability of the hill slopes.

1. As already discussed, the road alignment partly passes through soil and partly through bed rock. At present the hill slope is considered stable and there is no apprehension of any land sliding, if it remains in its natural configuration. However, at some points when cutting of hill slope is carried out for construction of road, it will render the existing hill slope steep and vertical in certain stretches. When the material is incompetent and back height becomes more it has the tendency to attain the angle of repose through minor land slips/slumping which is a common phenomena in hilly terrain. It is therefore, suggested that properly

designed retaining structures are required to be constructed along such vulnerable locations.

2. The road alignment is mostly passing through thick overburden/debris in some stretch as discussed earlier. The hill slope covered with such material is stable when it is in dry state but when there is a saturation of soil due to rain water, its stability is profoundly disturbed. It is therefore, suggested that proper disposal of water towards uphill side and road side may be ensured particularly in the area affected with slow creep movement to minimize the percolation of water into the soil and also to check soil erosion of the freshly cut hill slopes.

3. During excavation of road, waste/muck shall be generated which will be dumped at the defined sites for the purpose. It is suggested that proper retaining walls should be constructed to check the flow of waste material/muck.

4. The proposed road alignment passes through some small dried drainage/gullies. These locations are very prone to the landslides and due to high discharge of percolated and snowmelt water which can cause damage to road. Hence, it is recommended that proper side drains and cross drains may be provided and the water from the side drains be diverted to the nearby natural drainage for safety of the road.
