**T-15P1 Alternative Main and Escape Tunnel Portal  
Geological Site Assessment**

**Construction of Tunnels, Bridges, Yards and Formation Works  
from Chainage 101+310 to 117+365 (FLS) Under Package-8 in  
Connection with New BG Line between Rishikesh and  
Karnaprayag (125km) in the State of Uttarakhand, India.**

This report aims to describe the "T15P1 Alternative Main and Escape Tunnel Geological Site Assessment" due diligence performed based on the route analysis which are performed at the pre-design and design stages of the project, previous Geological, Geotechnical, Hydrogeological and Geophysical studies, Additional Geological-Geotechnical Site Investigations during Site Supervision stage, and conclusions of the assessment and presents an Executive Summary.

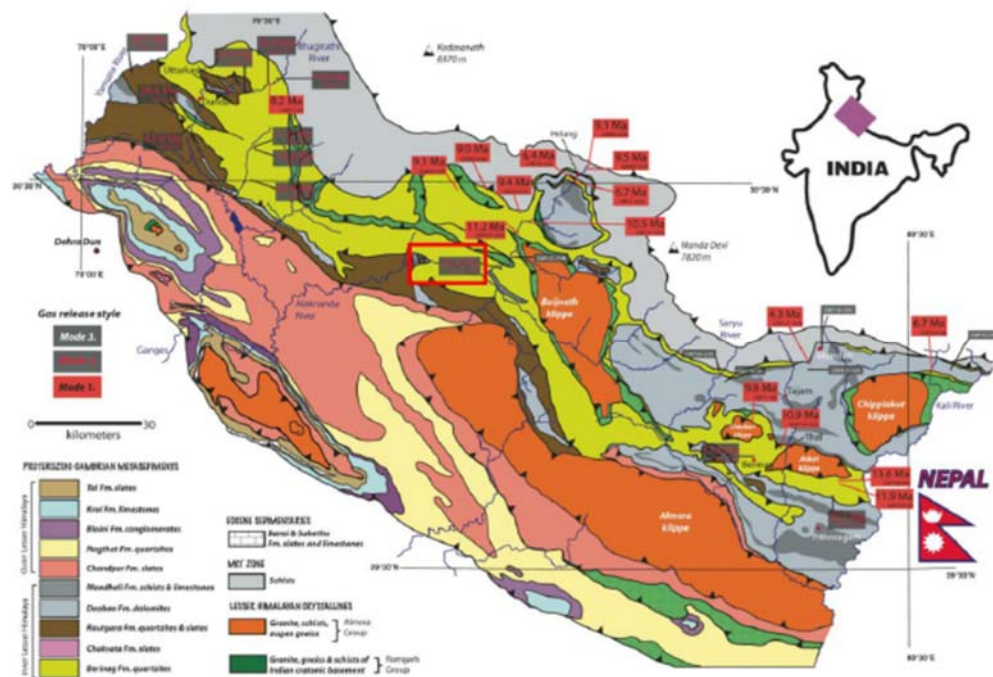
Figure 1 Geological overview [35]: Map view with the area of Package 8 marked with a red rectangle

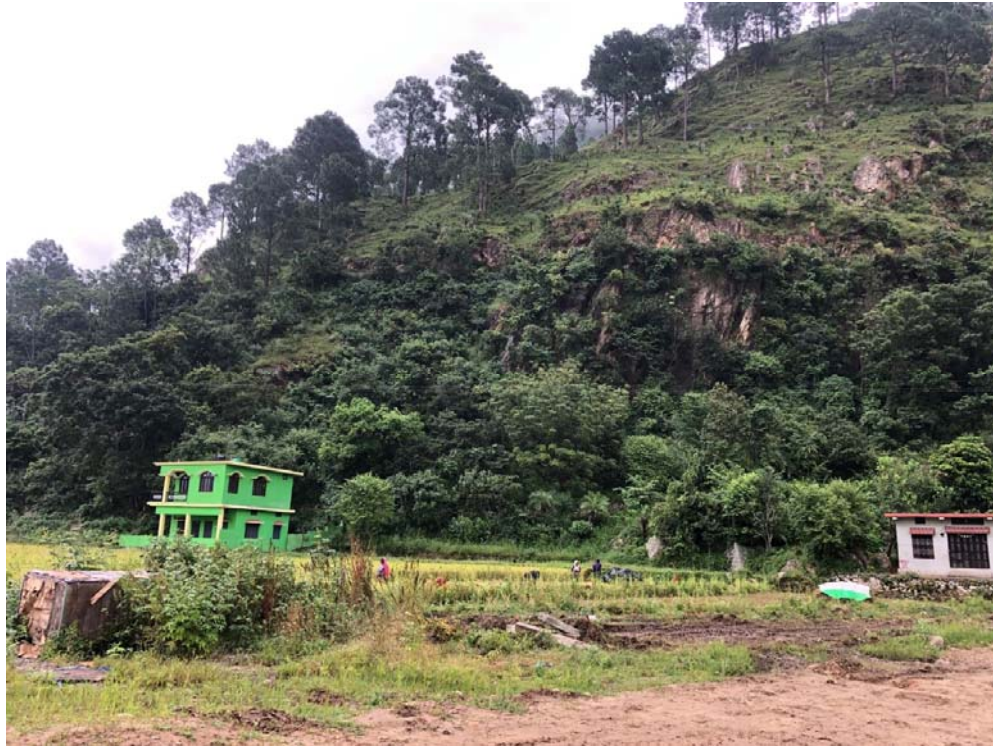
Figure 2,3,4 represents the topographical feature of Tunnel 15- P1 Portal.

Figure 2 General View of the T-15 P1 (Main tunnel Portal)

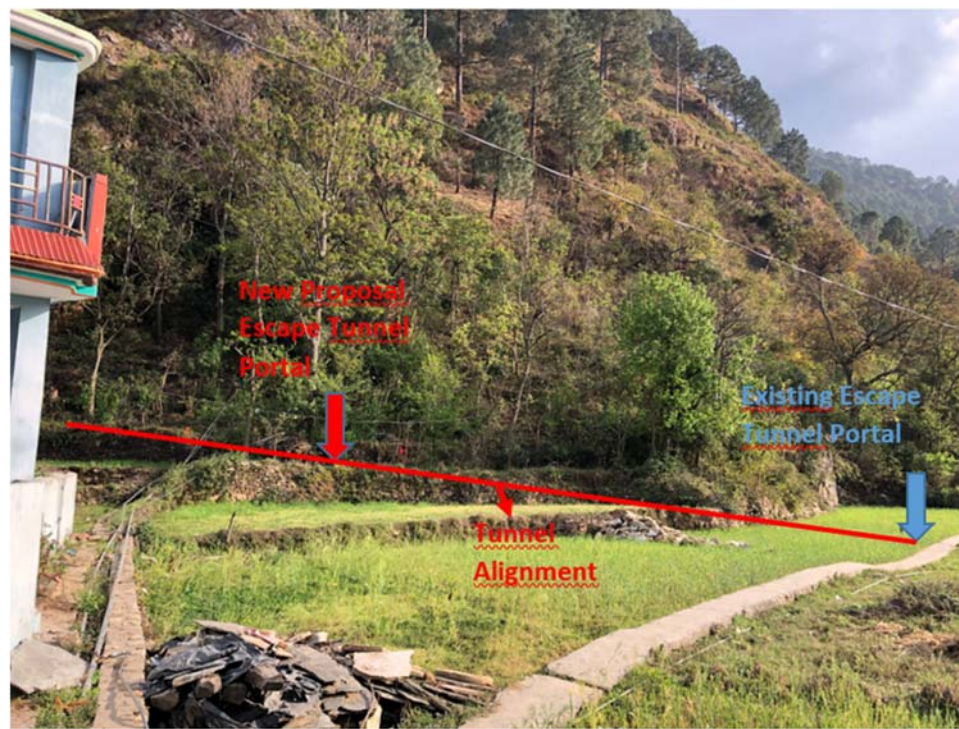
The alternative Escape Tunnel Portal of Tunnel 15 (Portal 1) is proposed at same tunnel alignment but around 20-25m inside to the tunnel. As topography of the Escape Portal, it is mostly flat area. The portal area is covered with slope wash/Alluvial terrace deposits. The material consists of boulder and cobbles of Quartzite & Metabasics with pebbles of subrounded fragments mixture of brown color silty sand and soil.

Figure 3 General View of the T-15 P1 (Escape Portal)

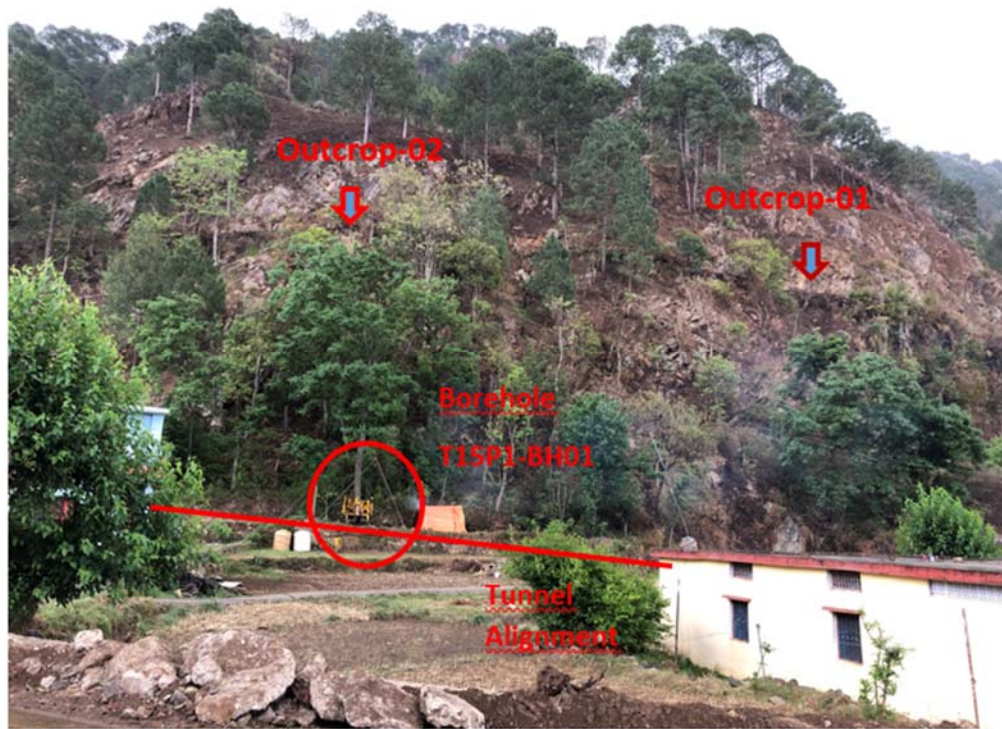
During site supervision works additional borehole T15P1-BH01 has been drilled on the alternative escape portal location to check the geological conditions and rock depth. T15P1-BH1 executed up to depth 20.00 meter and bed rock encountered at the depth of 2.00 meter. The bed rock up to 6.50m underlying the alluvial terrace part is slightly weathered. The bed rock up to 6.50m is Whitish color, medium grained, medium strong, slightly weathered to fresh, coated with Feo, after 6.50m-20.00m fresh, strong, joint surfaces stained Quartzite Rock. Low grade metamorphic rock of Garhwal Group. Depends on the borehole data, stratigraphic projection can be made as follows;

Figure 4 General View of the T-15 P1 New Site Geological Investigations.

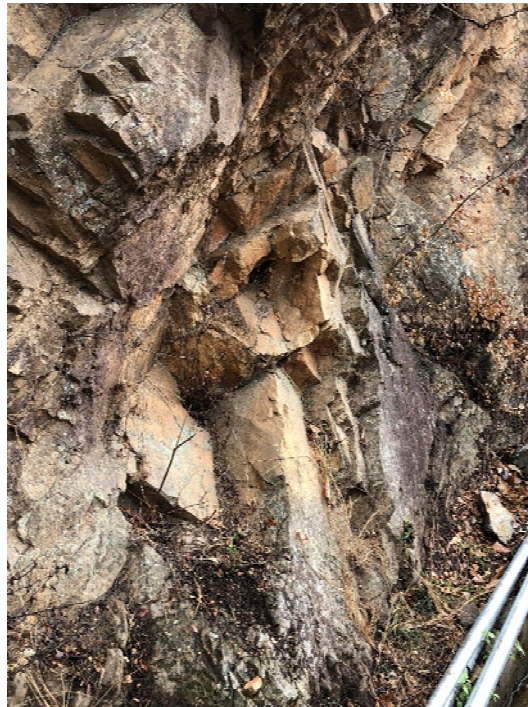
Figure 5 Outcrop-01 above the Main Tunnel Portal,

The rock outcrops are observed at two different locations. The rock mass is fresh to slightly weathered, strong rock, medium grained, stained in nature.

The orientation and other empirical properties of the major discontinuities have been determined and presented at the Table 1 outcrop-01 above Main tunnel and Table 2 outcrop-02 above escape tunnel area. This outcrop details given as an attachment with outcrop survey map.

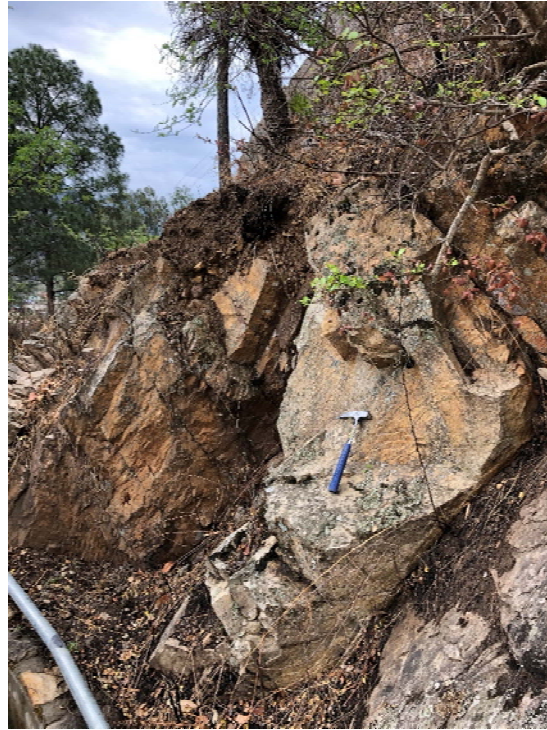
Figure 6 Outcrop-02 above the Escape Tunnel Portal

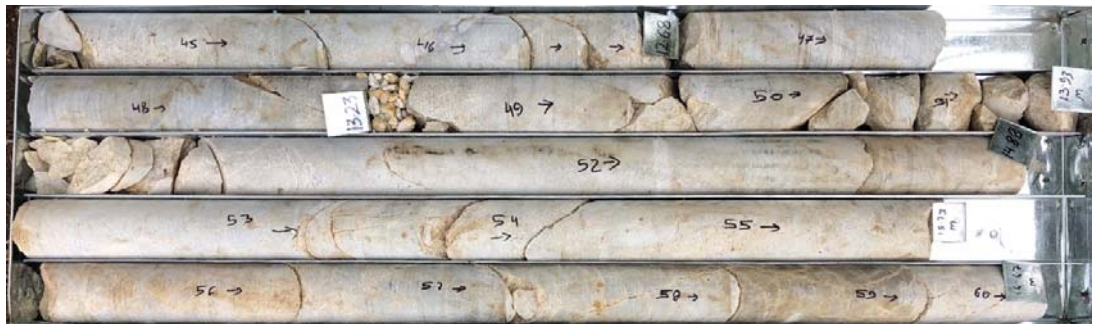
Figure 7 Quartzite photo from Borehole T15P1-BH1.

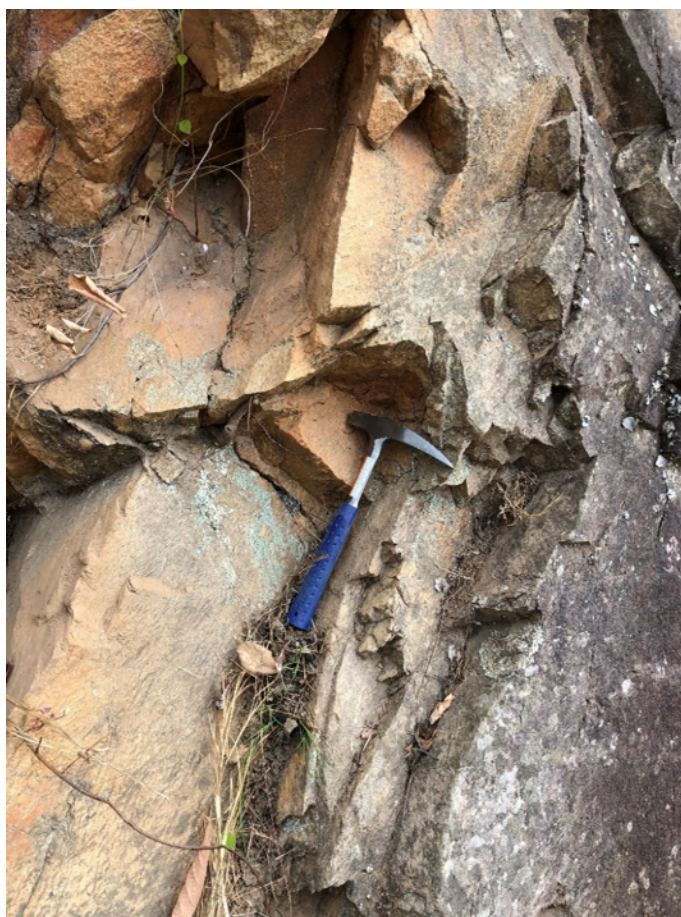
<b>Outcrop Survey Form</b>					<b>Date:</b>	21.04.2021	
<b>Project:</b>	PK-08				<b>Outcrop No:</b>	T15OC-01	
<b>Coordinates:</b>	E		N		<b>Weather:</b>	Sunny	
	317221		3353404		<b>Logged by:</b>	S.TEKES	
<b>Location</b>	T15 Portal Area (Above to MT)						
<b>Lithology:</b>	Quartzite				<b>Formation:</b>	Garhwal Group	
<b>Colour:</b>	<b>Weathering:</b>	<b>Grain Size:</b>		<b>Strength:</b>			
Yellowish white	Fresh to slightly	Medium		Very strong			
<b>Joint Set</b>	<b>Dip Amount (°)</b>	<b>Dip direction (°)</b>	<b>Spacing cm</b>	<b>Persistence (m)</b>	<b>Roughness</b>	<b>Aperture (mm)</b>	<b>Filling</b>
J1	70	310	60-200mm	3-10m	Slightly rough	0.1-1 mm	surface stained
J2	50	035	60-500mm	3-10m	Slightly rough	0.1-1 mm	surface stained
J3	60	200	200-600mm	3-8m	Slightly rough	0.1-1 mm	surface stained
J4	28	030	60-200mm	3-10m	Slightly rough	0.1-1 mm	surface stained

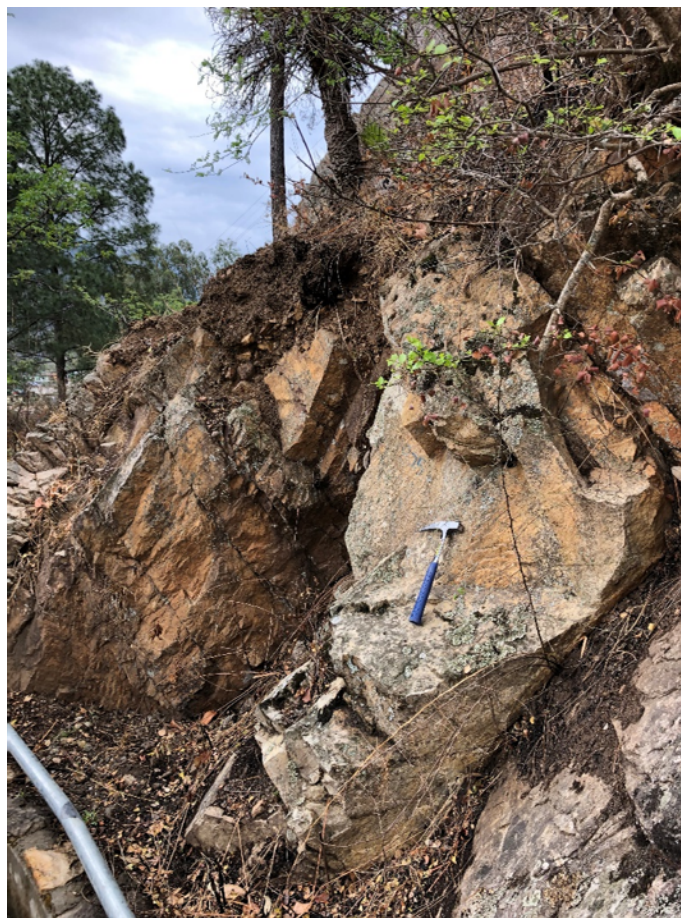
Outcrop Survey Form					Date:	21.04.2021		
Project:		PK-08			Outcrop No:		T15OC-02	
Coordinates:		E		N	Weather:		Sunny	
		317219		3353440	Logged by:		S.TEKES	
Location		T15 Portal Area (close to ET)						
Lithology:		Quartzite			Formation:		Garhwal Group	
Colour:		Weathering:		Grain Size:	Strength:			
Yellowish white		Fresh to slightly		Medium	Very strong			
Joint Set	Dip Amount (°)	Dip direction (°)	Spacing cm	Persistence (m)	Roughness	Aperture (mm)	Filling	
J1	47	015	60-200mm	1-3-10m	Slightly rough	0.1-1 mm	surface stained	
J2	60	090	200-800mm	1-3m	Slightly rough	0.1-1 mm	surface stained	
J3	62	178	20-400mm	1-3m	Slightly rough	0.1-1 mm	surface stained, soft filling >5mm	
J4	77	325	60-200mm	1-3m	Slightly rough	0.1-1 mm	surface stained

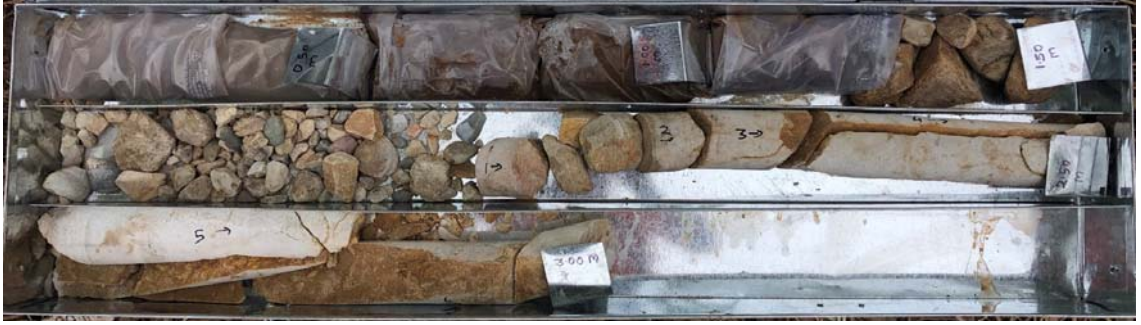
Sondaj No / Borehole No : T15P1-BH1-Escape T  
Sandık No / Box No : 1 / 5  
Derinlik / Depth : 0.00 m. - 3.00 m.

# of Blows										
m		m		15	30	45	%	%	%						
1		1.00					20	-						Overburden Consist of Medium to Fine grained, boulder and cobbles of Quartzite&Metabasics with pebbles of subrounded fracments mixture of brown color silty sand wash out during drilling.

1.50					50	-							
2							55	11							
		2.50												Whitish color,medium grained,fresh-slightly weathered, medium strong,Quartzite,slightly rough,joint surfaces stained	
3		3.00					90	0

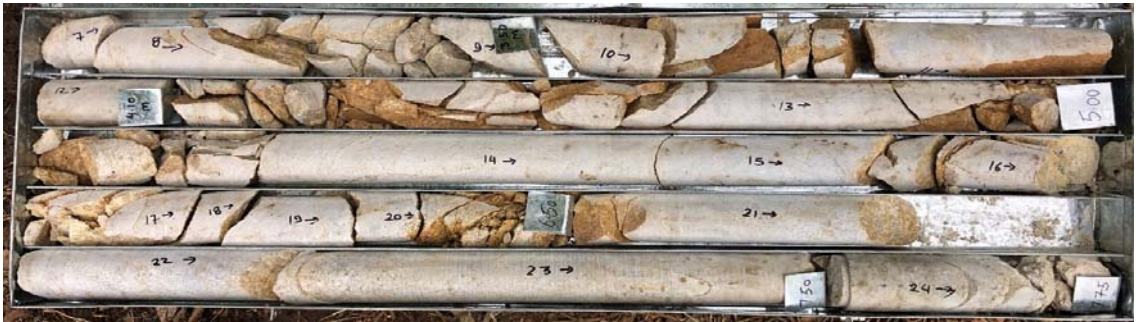
Sondaj No / Borehole No : T15P1-BH1  
Sandık No / Box No : 2 / 5  
Derinlik / Depth : 3.00 m. - 7.75 m.

3.50					80	28							
4		4.10					97	53							
							78	0							
5		5.00												Vertical-subvertical joints,surfaces stained. 6.35-6.50m crushed material	
6							87	41

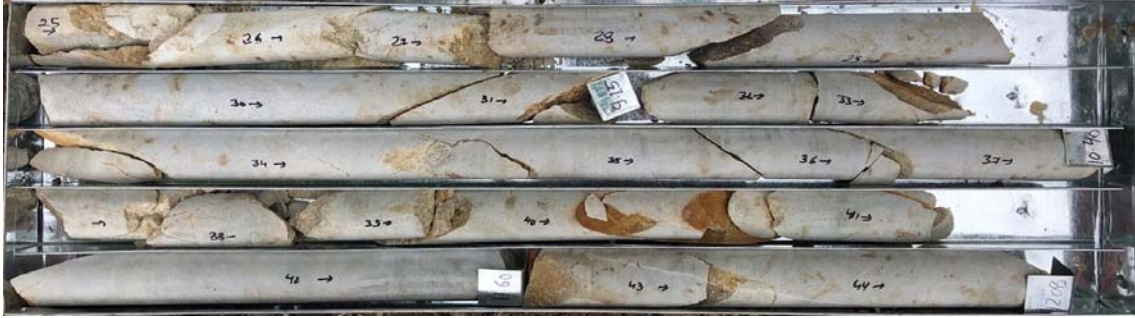
Sondaj No / Borehole No : T15P1-BH1-Escape T  
Sandık No / Box No : 3 / 5  
Derinlik / Depth : 7.75 m. - 12.08 m.

6.50												Whitish color,medium grained,fresh,strong rock,Quartzite,slightly rough,joint surfaces stained	
7							95	80							
		7.50					80	0							
8		7.75													
							96	64							
9		9.15													
							92	80							
10		10.40													
11							92	48						Joint set 1;50-55° surface staining,slightly rough,moderately spacing Joint set 1;70-75° surface staining,slightly rough,wide spacing

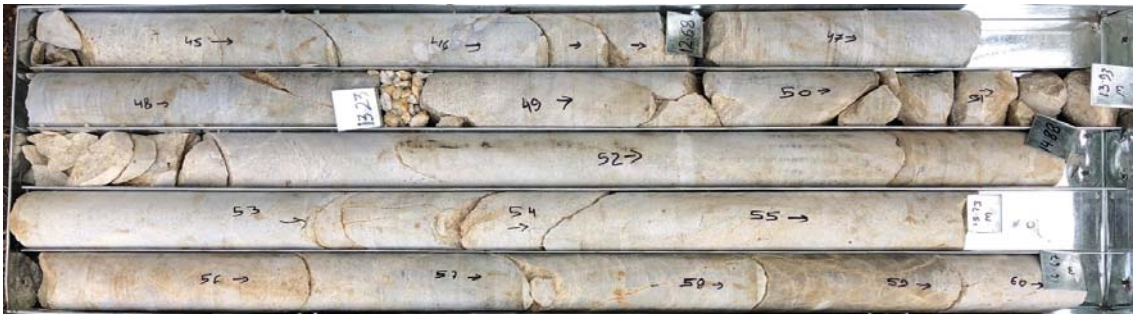
Sondaj No / Borehole No : T15P1-BH1  
Sandık No / Box No : 4 / 5  
Derinlik / Depth : 12.08 m. - 16.67 m.

11.60					94	63							
12		12.08					87	67							
		12.68					95	78							
13		13.23					79	39							
14		13.93													
							89	77							
15		14.88

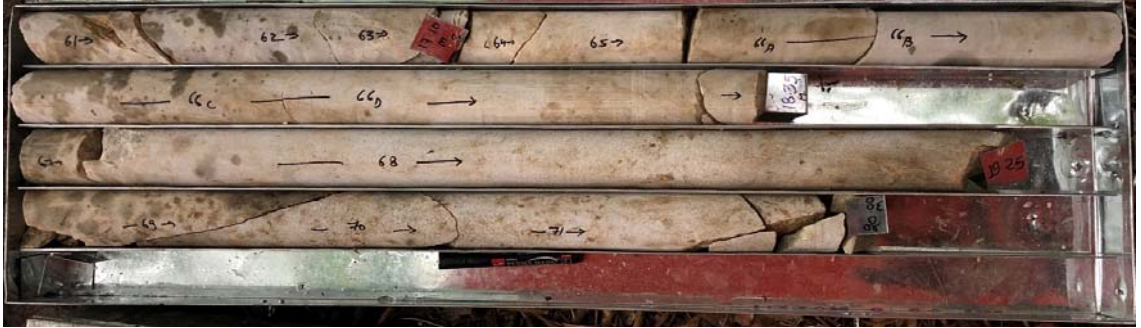
Sondaj No / Borehole No : T15P1-BH1-Escape T  
Sandık No / Box No : 5 / 5  
Derinlik / Depth : 16.67 m. - 20.00 m.

# of Blows												
m		m			15	30	45	%	%	%							
16		15.00 15.73						100	80					Whitish color,medium grained,fresh,strong rock,Quartzite,slightly rough,joint surfaces stained  Joint set 1;50-55° surface staining,slightly rough,moderately spacing Joint set 1;70-75° surface staining,slightly rough,wide spacing			
17		16.67 17.10						97	90								
18								93	81								
19		18.35						99	92								
20		19.25						94	89								
21		20.00						100	84								
22																	
23																	
24																	
25																	
26																	
27																	
28																	
29																	
30																	
31																	
32																	
33																	
34		34.00

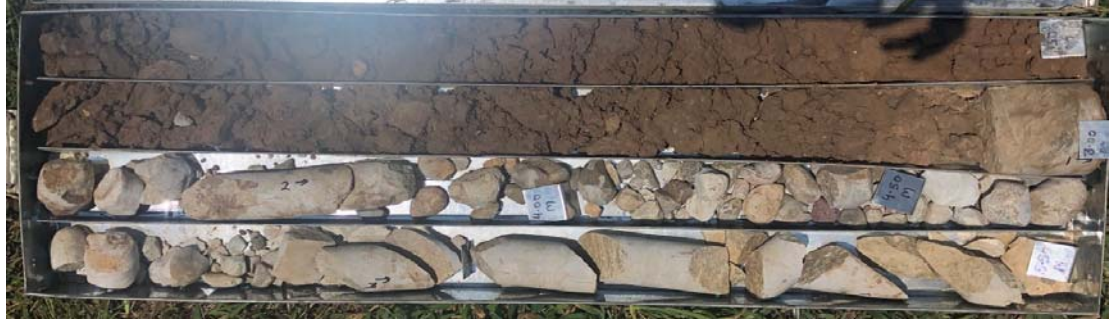
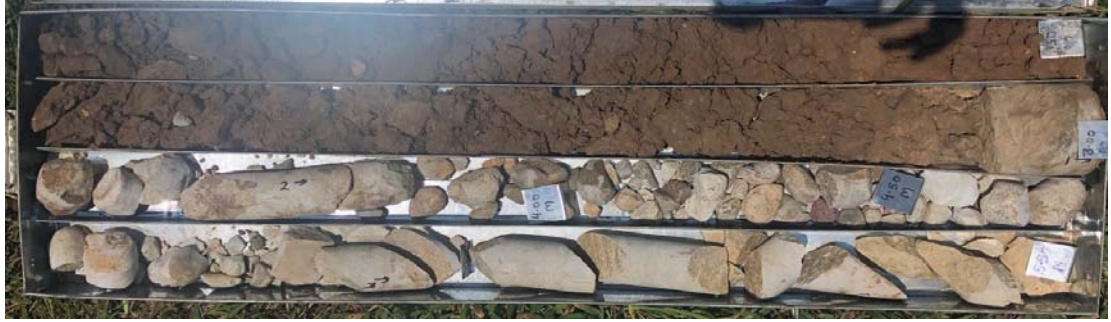
Sondaj No / Borehole No : T15P1-BH2  
Sandık No / Box No : 1 / 4  
Derinlik / Depth : 0.00 m. - 5.50 m.

# of Blows										
m		m		15	30	45	%	%	%						
1		1.50					-	-						Hand excavation Top Soil.	
2							-	-							
3		3.00					41	-						Overburden Consist of Medium to Fine grained, boulder and cobbles of Quartzite&Metabasics with pebbles of subrounded fracments mixture of brown color silty sand wash out during drilling.	
4		4.00					28	-

4.50					70	-							
5		5.00					86	24							
		5.50													
6							75	19						Whitish color,medium grained,fresh-slightly weathered, medium strong,Quartzite,slightly rough,joint surfaces stained

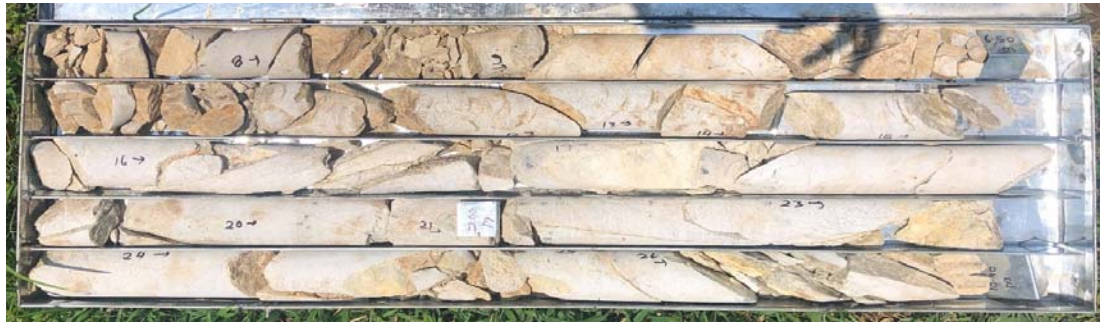
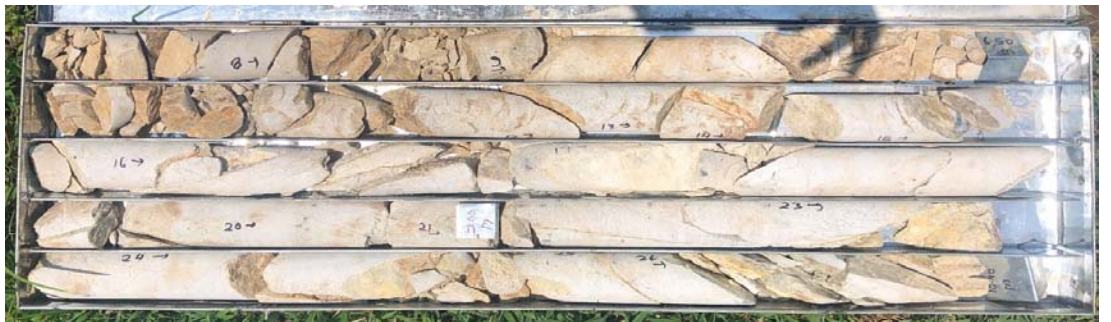
Sondaj No / Borehole No : T15P1-BH2  
Sandık No / Box No : 2 / 4  
Derinlik / Depth : 5.50 m. - 10.40 m.

6.50													
7		7.30					81	31							
8							88	29							
		8.50													
9		9.00					86	68							
10		10.40					90	32						Joint set 1;75-80° surface staining,slightly rough,close to mod. spacing	
11		11.60					88	32							
12							83	42						Quartz band

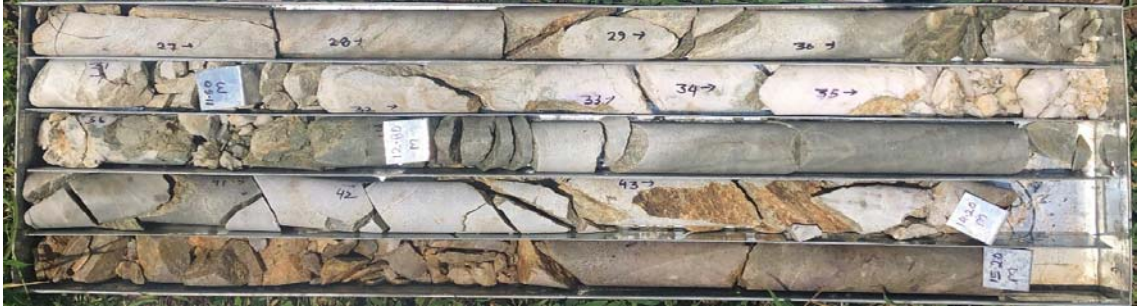
Sondaj No / Borehole No : T15P1-BH2  
Sandık No / Box No : 3 / 4  
Derinlik / Depth : 10.40 m. - 15.20 m.

12.80													
13															
							101	42						Greenish color,medium grained,fresh-slightly weathered, medium strong,Sandstone-Quartzite,slightly rough,joint surfaces stained

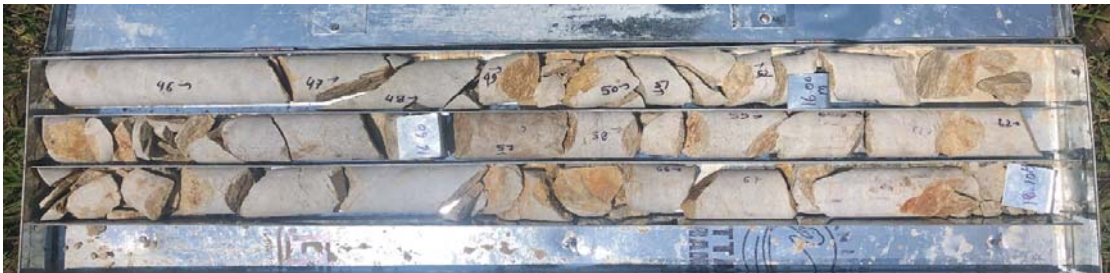
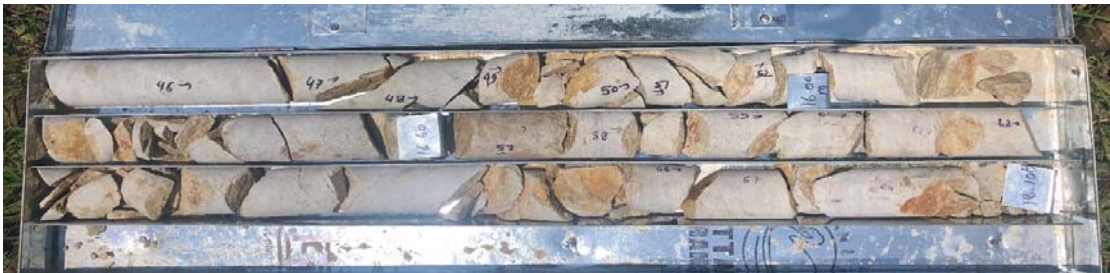
Sondaj No / Borehole No : T15P1-BH2  
Sandık No / Box No : 4 / 4  
Derinlik / Depth : 15.20 m. - 18.10 m.

# of Blows										
					15	30	45								
16		15.20						94	41					Whitish color,medium grained,fresh-slightly weathered, medium strong,Quartzite,slightly rough,joint surfaces stained  Joint set 1;40-45° surface staining,slightly rough,60-200mm spacing	
17		16.00						85	-						
18		16.60						95	26						
19		18.10												18.10 (End of hole)	
20															
21															
22															
23															
24															
25															
26															
27															
28															
29															
30															
31															
32															
33															
34		34.00

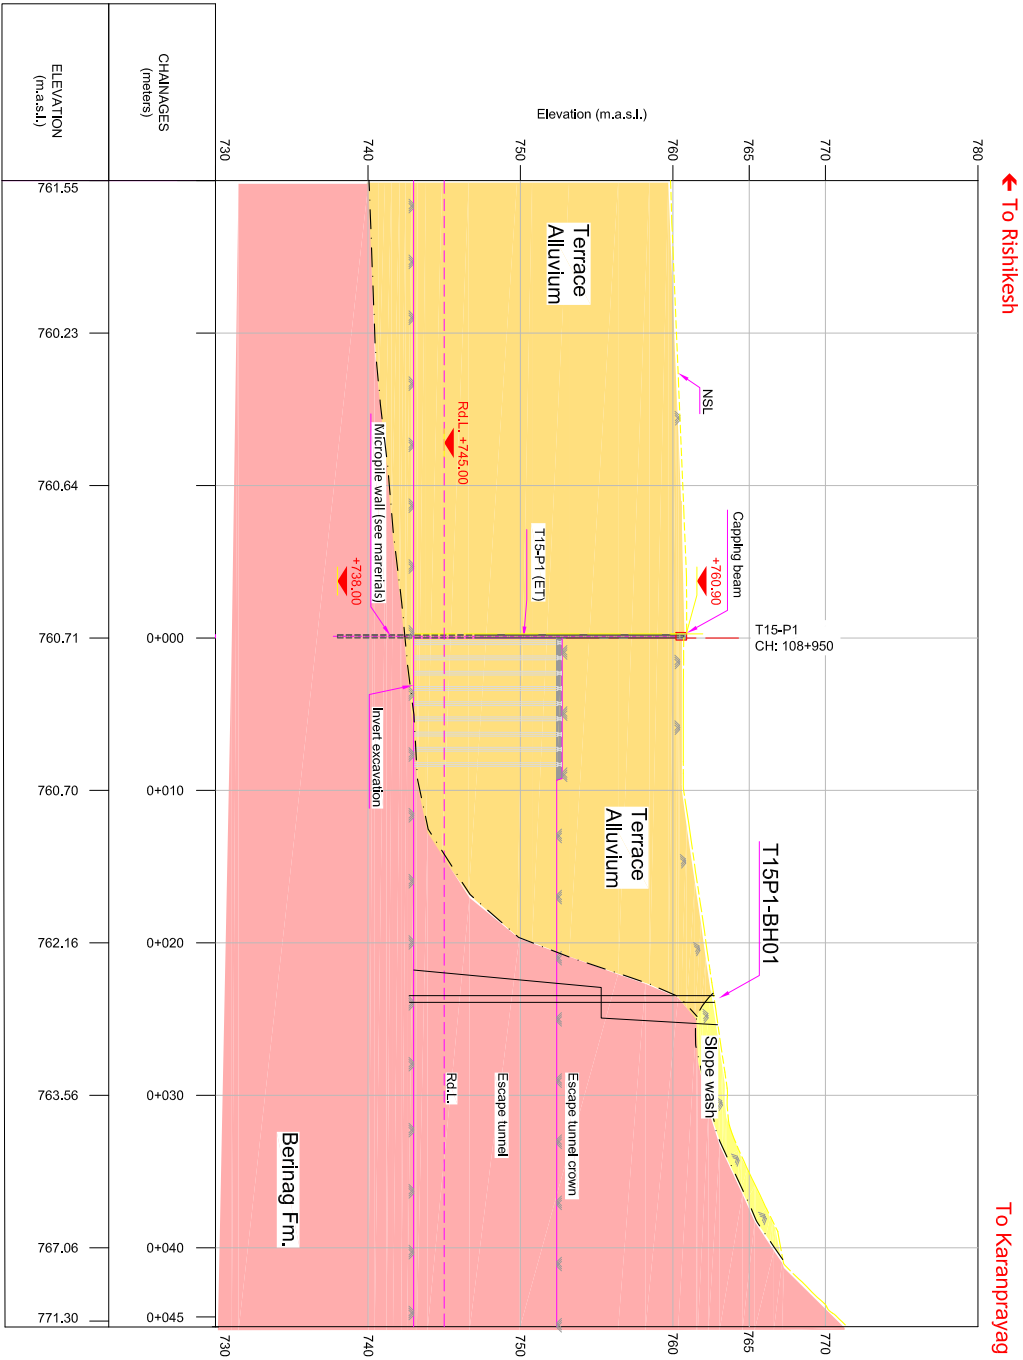
LONGITUDINAL SECTION B-B, ALONG ESCAPE TUNNEL  
(1:250)

LONGITUDINAL SECTION ALONG ESCAPE TUNNEL
