परियोजना का नाम :- जनपद नैनीताल के अन्तर्गत विकास खण्ड रामगढ मे नथुवाखान सुयालबाडी मोटर मार्ग छीमी से मटेला होते हुए तोला भुमियाँ देव मन्दिर तक मोटर मार्ग का नव निर्माण

भू-वैज्ञानिक की आख्या

Geological Assessment for construction of 4.0 Km long alignment corridor proposed from Km 67 of Nathuakhan-Suvalbari motor road to Chimi-Matela village upto Tola Bhumiya Mandir, District- Nainital.

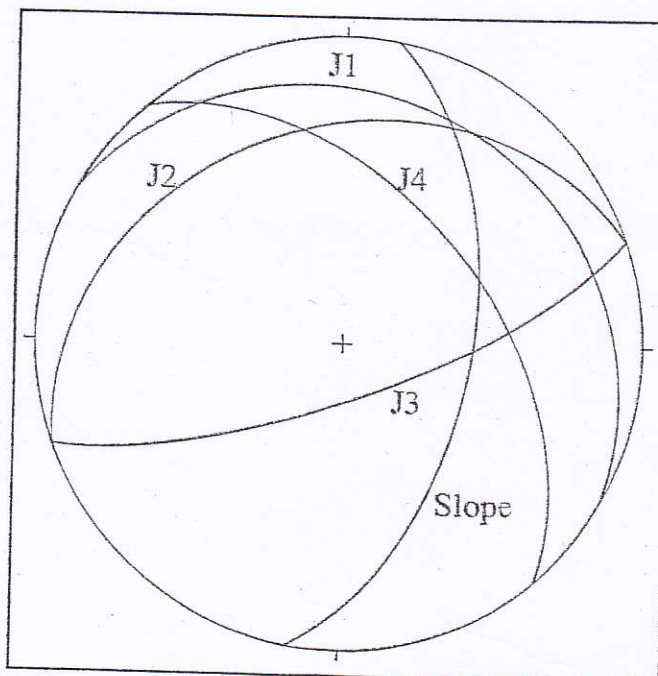
Figure 1 Stereographic projection of joints and slope data observed

From the above stereographic projection (Fig 1) it is clear that a small wedge is forming by the intersection of joints Joint J3 & J4 which can be fail until unless if there is a

releasing surface such as tension crack on the slope as it is parallel to the slope face. Thus joints do impact on the stability of the area. At the starting point a debris slide is observed other than this site looks stable and quite competent from the stability point of view.

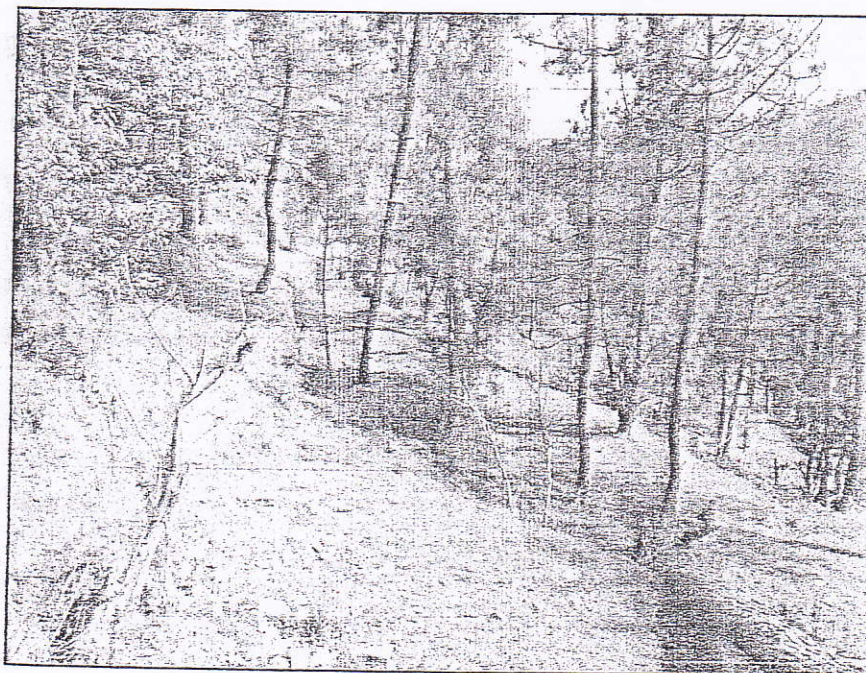
Topography of the area overall is gentle to moderately steep. Area is covered with dense forest. Some manmade terraces were also observed which are mostly cultivated. Starting portion of the area is much steeper and is mostly covered with forest than the rest of the km's which falls on the terraces from where the alignment has been proposed (Fig. 3). Majority of area passes through cultivated terraces. Slope angle varies from place to place. Slope angle ranges from 25°-75° and slope direction varies from N130°-360°. Hydrological conditions are mainly dry, except in rainy season. One prominent nala is observed at the site which constitute of cobble and pebbles. The carrying capacity of nala

Figure 3 General topography of the area

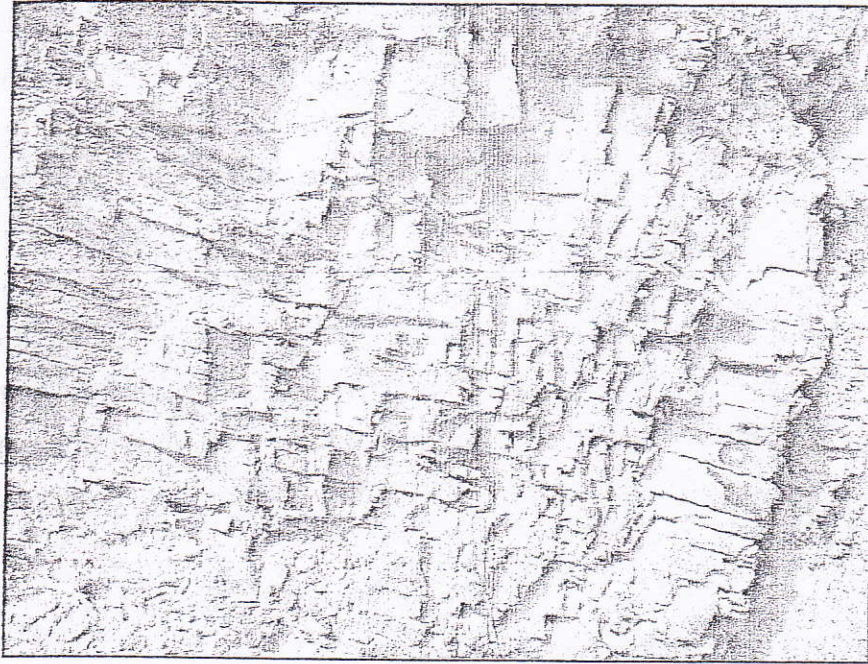
Rock type in the area is quartzite (Fig. 4), which is hard and compact in strength. At some places the rock is highly sheared and weathered. High grade of deformation is there and near to the starting point schist outcrop were also observed. Three sets of joints has been observed in quartzite at the site which are as follows-

Figure 4 Weathered micaceous Quartzite outcrop along the starting point
