- Sub: (i) Diversion of 4.2 ha of forest land (PH & Barrage Quarry of 0.5 ha and Muck Access Road of 3.7 ha) in respect of Heo Hydro Electric Project (240 MW) being developed by M/s Heo Hydro Power Pvt. Ltd in West Siang District of Arunachal Pradesh.

- (ii) Diversion of 55.70 ha of forest land (Surface forest land = 47.10 ha, River Bed = 5.90 ha, Underground area = 2.70 ha) for construction of (240 MW) Heo Hydro Electric Project being developed by M/s Heo Hydro Power Pvt. Ltd in West Siang District of Arunachal Pradesh.

- (iii) Diversion of 91.70 ha of forest land (Surface forest land = 79.10 ha, River Bed = 9.30 ha, Underground area = 3.30 ha) for construction of Pauk Hydro Electric Project (145 MW) in West Siang District of Arunachal Pradesh by M/s Pauk Hydro Power Private Ltd.

**REPORT OF THE SITE VISIT OF TATO-I HEP, HEO HEP AND PAUK HEP CARRIED OUT BY
REGIONAL OFFICE SHILLONG .**

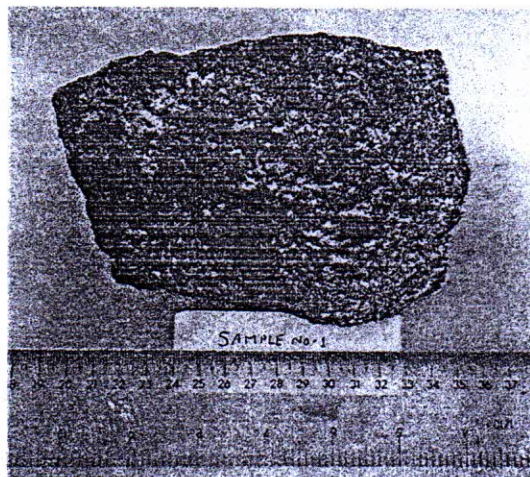
Fig.-1: Rock sample-1

It is a greenish to greyish white rock which is medium to coarse grain having low to medium specific gravity. The rock gives profuse effervesces with dilute hydrochloric acid. The chief mineral which is identified in the hand specimen is calcite. The rock is slightly weathered and has thin encrustation of ferruginous material (Fig-1).

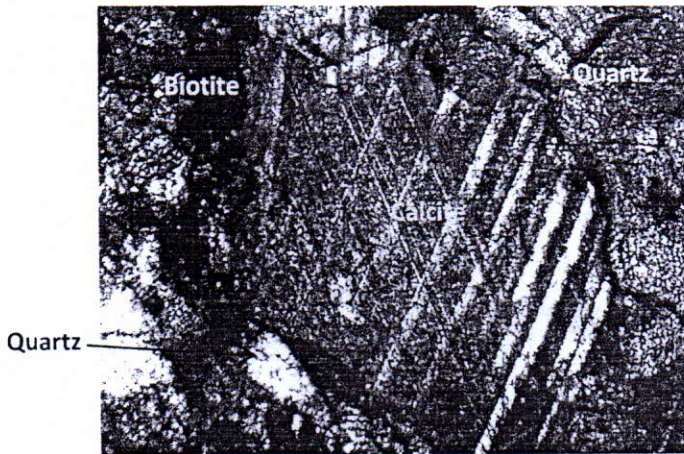
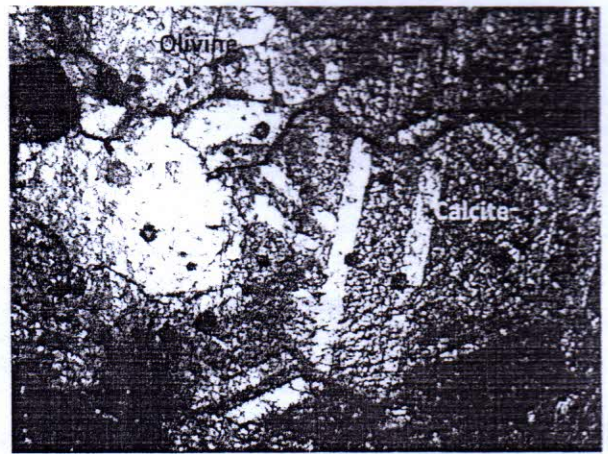
Fig.-2 Mgf: X40

It consists of calcite, quartz, biotite/chlorite, olivine and magnetite. It is a coarse grain rock which is characterized by granoblastic texture. Calcite is identifiable due to polysynthetic twinning. Quartz grains are present as scattered grains throughout the rock and they have sharp boundaries with calcite. Biotite grains are profusely altered. Olivine is identifiable due to its high relief. Magnetite is present as irregular grains that occupy the weathered portion in biotite (Fig-2 & 3).

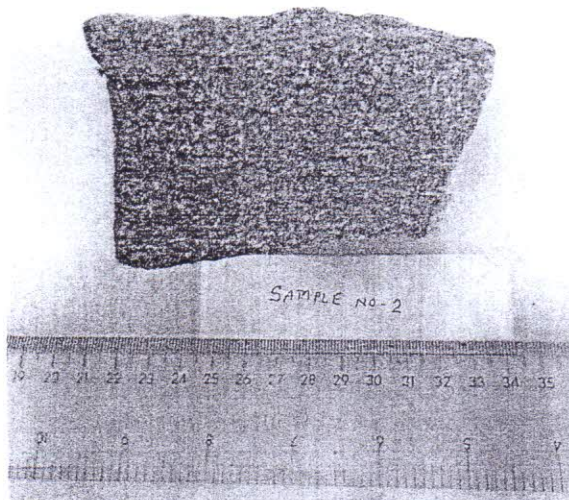
Fig.-4: Rock sample-2

It is a grayish white, medium to coarse grain rock having medium specific gravity. It gives profuse effervesces with dilute hydrochloric acid. Calcite is the main mineral which could be identified in the hand specimen. The rock is slightly weathered in the upper surface and has thin encrustation of ferruginous material (Fig-4).

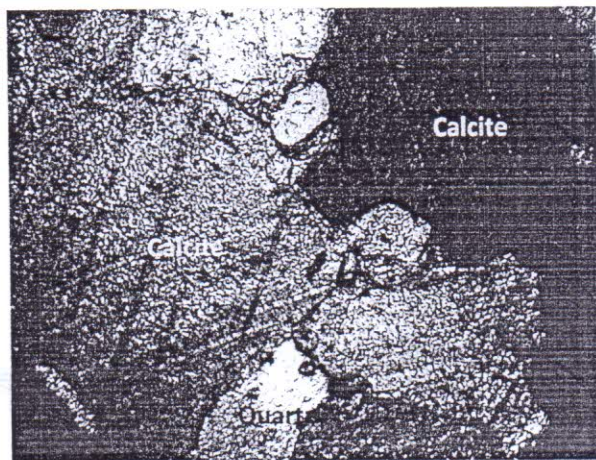
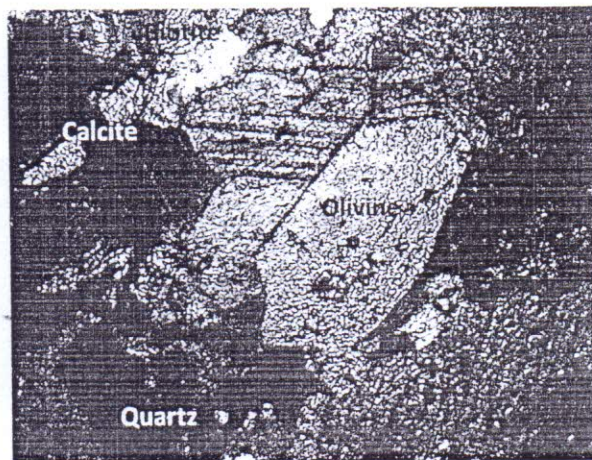
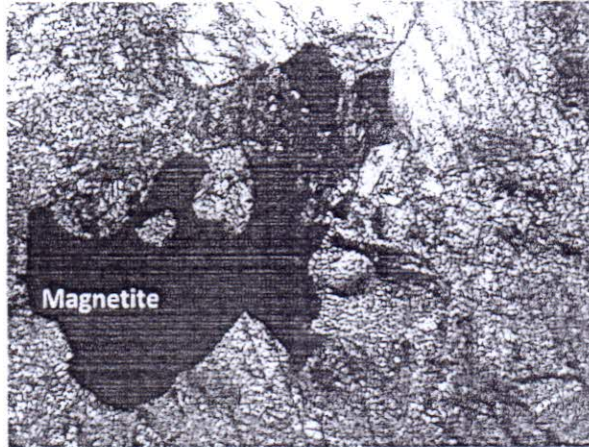
Fig.-5 Mgf: X40

The given rock consists of calcite, quartz, biotite/muscovite, olivine and magnetite. It is a coarse grain rock and exhibit granoblastic texture. Calcite is the predominant mineral and identifiable due to polysynthetic twinning. Quartz grains are present as scattered grains throughout the rock. Mica (both biotite and muscovite) present in the form of flakes. At places biotite grains are altered to chlorite. Olivine is identifiable due to its high relief. Magnetite present as scattered grains throughout the rock (Fig-5 to 7).

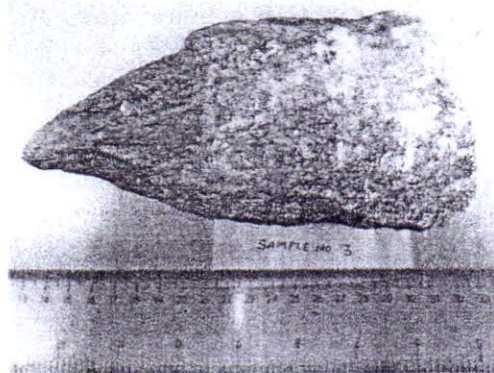
Fig.-8: Rock sample-3

It is a greyish white, medium to coarse grain rock. The rock shows saccaroidal texture. It gives profuse effervesces with dilute hydrochloric acid. Identifiable mineral in the hand specimen is calcite (Fig-8). The rock is slightly weathered in the upper surface. The rock is hard and compact and has medium specific gravity.

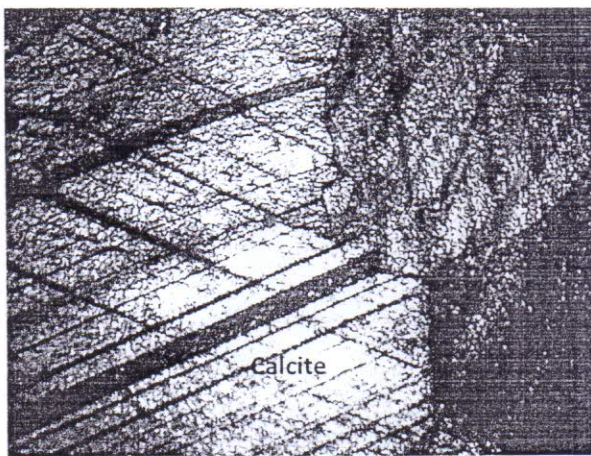
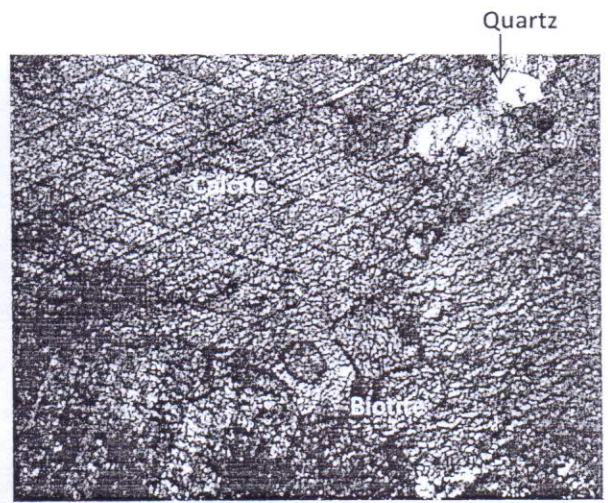
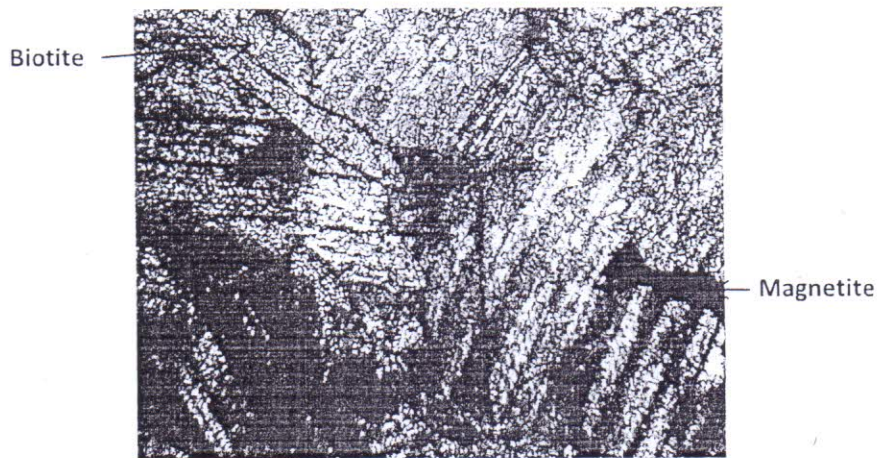
Fig.-9 Mgf: X40

It mainly consists of calcite with minor amounts of quartz, biotite/muscovite and magnetite/iron oxide. It is a coarse grain rock which is characterized by granoblastic texture. Calcite is identifiable due to polysynthetic twinning. Quartz grains are present as scattered grains. Biotite and muscovite present as flakes throughout the rock. At places biotite is altered to chlorite. Magnetite present as irregular grains throughout the rock (Fig-9 to 11).

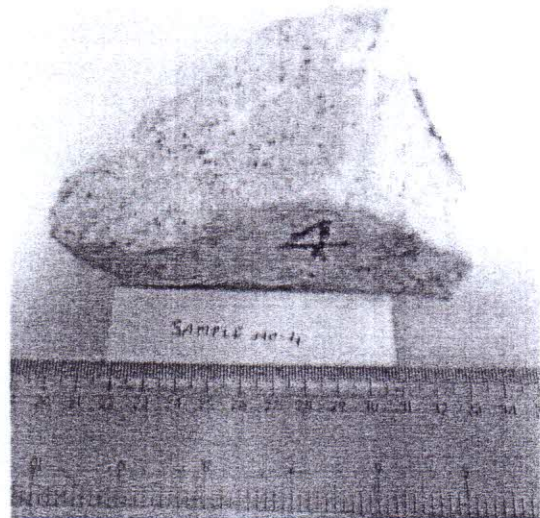
Fig.-: 12 Rock sample-4

It is a yellowish white, medium to coarse grain, iron stained rock. It gives effervesces with dilute hydrochloric acid. The rock shows saccharoidal texture (Fig-12). The chief mineral which is identified in the hand specimen is calcite. The rock also have subordinate amount of ferruginous minerals. It is hard and compact and has medium specific gravity.

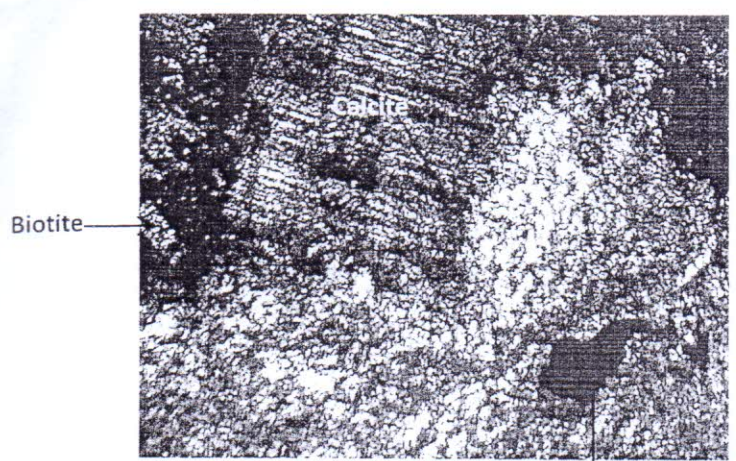
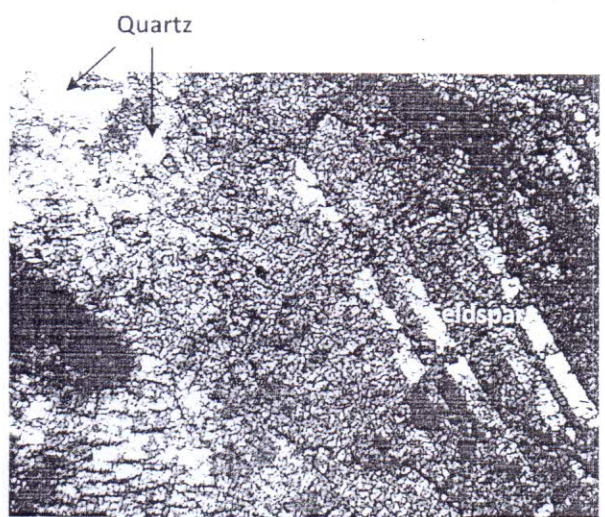
Fig.-13 Mgf: X40

It consists of calcite, quartz, muscovite/biotite, feldspar, chlorite and magnetite/iron oxide. It is fine to medium grained rock where individual grains are identifiable. Most of the quartz grains are present as replacing partially or completely calcite grains. The rock is weathered and flakes of muscovite occupy as clusters at different places of thin section. Some of the grains of calcite are pseudomorph which have retained the structure of calcite but have been replaced volume by volume by quartz/ feldspar (Fig-13 & 14).

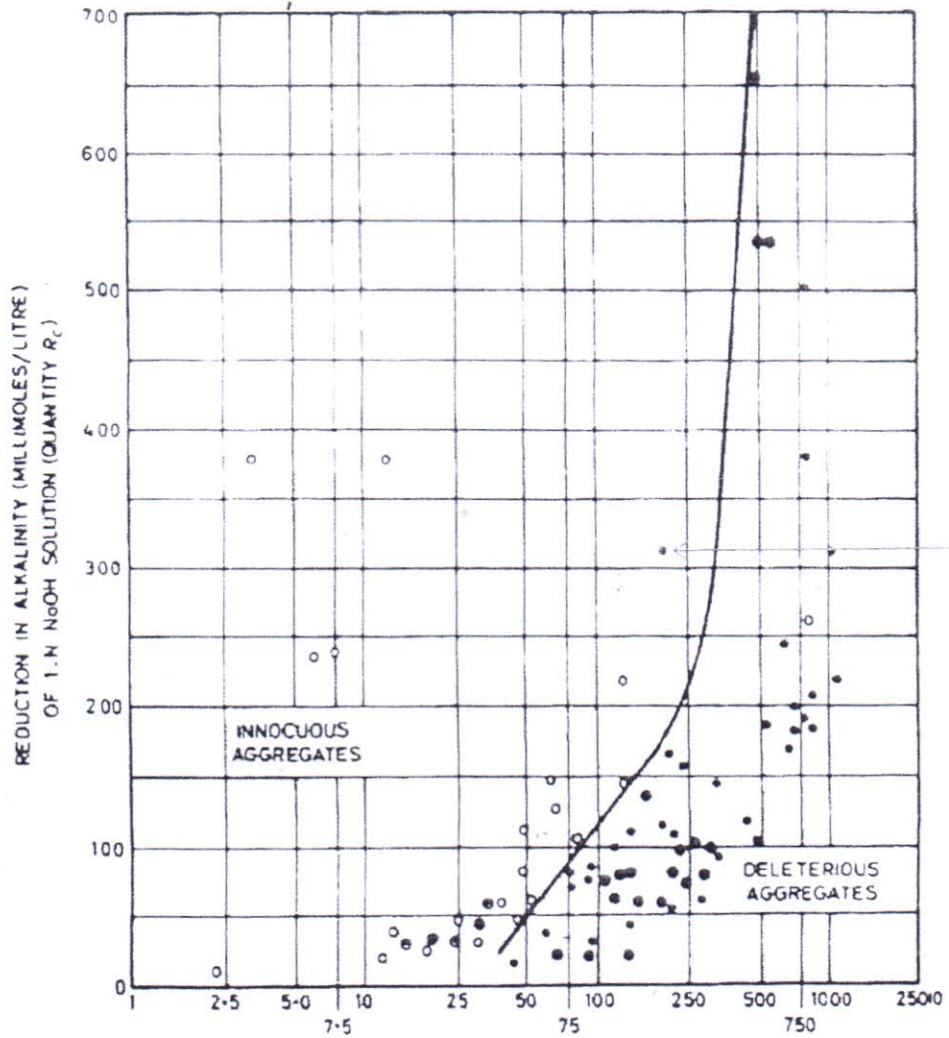
ANNEXURE-A
 POTENTIAL AGGREGATE REACTIVITY BY CHEMICAL METHOD
 (COARSE AGGREGATE)

Gapo Village
 Area in West
 Siang Distt.

SILICA DISSOLVED FROM 300 TO 150 MICRONS SIZE AGGREGATE
 MATERIAL (MILLIMOLES/LITRE) BY 1.1N NaOH SOLUTION (QUANTITY S₂)

- Aggregates causing mortar expansion more than 0.1 percent in a year when used with a cement containing 1.38 percent alkalis.
- Aggregates causing mortar expansion less than 0.1 percent in a year under same conditions.
- ⊗ Aggregates for which mortar expansions data are not available but which are indicated to be deleterious by petrographic examination.
- ⊙ Aggregates for which mortar expansion data are not available but which are indicated to be innocuous by petrographic examination.
- Boundary line between innocuous and deleterious aggregates.

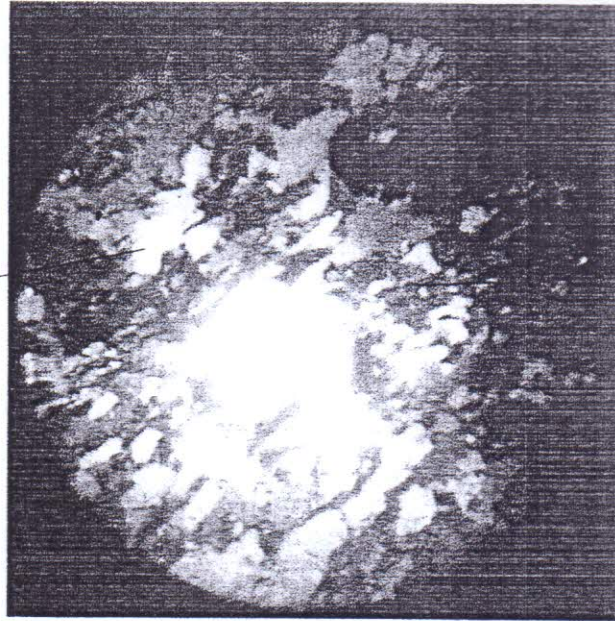
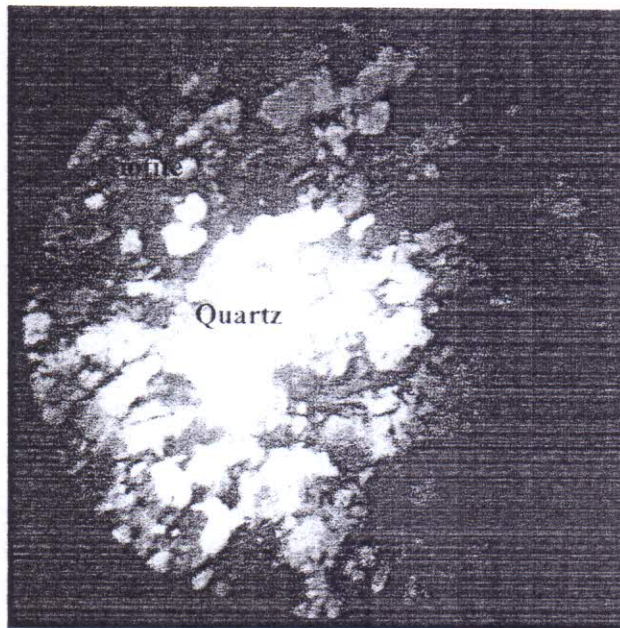
Fig.-2 Mgf: X40

It consists of quartz grains which range in size from medium to coarse, flakes of biotite. Most of the grains of quartz are sutured. Feldspar grains are identifiable due to their cleavage and twinning. At places flakes of biotite are in preferred orientation which defines the foliation of the rock. The rock is deformed and at places strained lamellae in quartz have been observed. At places there are minute grains of quartz around coarse grains of quartz. At places flakes of biotite are present around the boundary of the quartz grain.

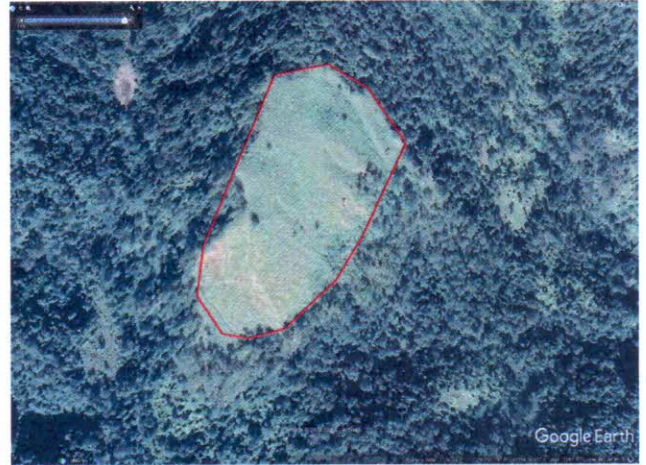
The proposed CA site of 8.40 ha

As per the observation of DSS, the proposed CA site includes 4.16 ha of Moderately Dense Forest and the remaining part is under Open Forest. However, the CA site proposed on the top of hill may be considered as degraded land as seen on Google earth satellite imagery dated 06.12.2017.

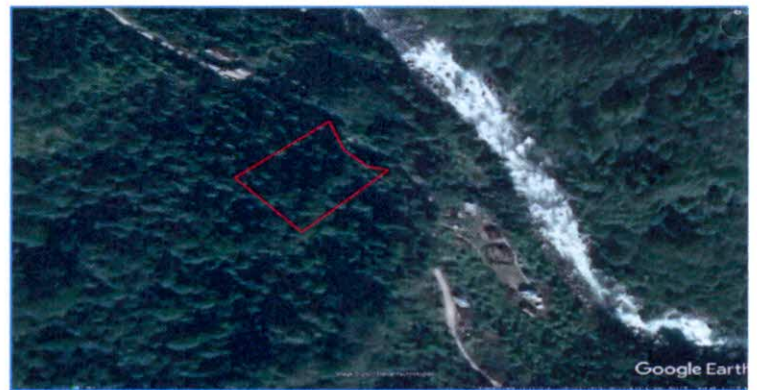
Tato-I PH Quarry (0.5 ha)

The aggregate score of the grid is found to be above 70. Therefore, per DSS rule No.-2, the proposed area has been labelled as Inviolable.

The Forest Cover Map in DSS shows that the entire proposed quarry site falls under Open Forest. Based on visual interpretation of Google Earth satellite imagery dated 23.11.2018, the area proposed on the extreme slope surface (30 degree gradient) is covered with tall trees.

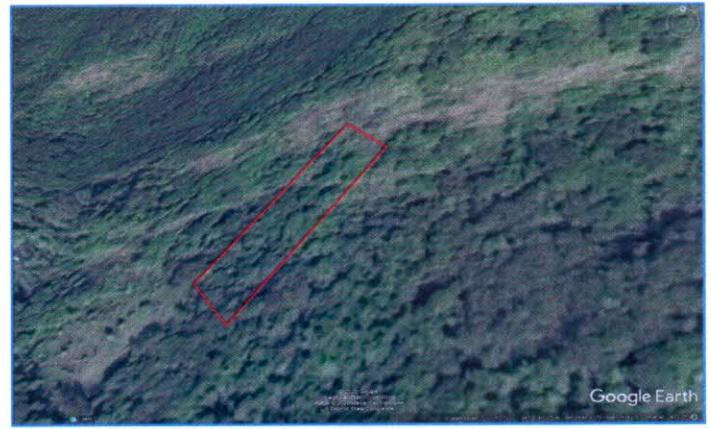
Tato-I Intake Quarry (0.3 ha)

In view of the above mentioned table, the aggregate score of grid is found to be above 70. Therefore, the proposed quarry site has been considered as Inviolable in accordance with DSS rule No.-2.

As per the Forest Cover Map, the proposed quarry site comprises 0.29 ha of Open Forest and 0.01 ha of Moderately Dense Forest. On the other side, the Google Earth satellite imagery dated 19.11.2012 shows that the quarry site proposed on steep slope (more than 40 degree gradient) has been covered with vegetation.

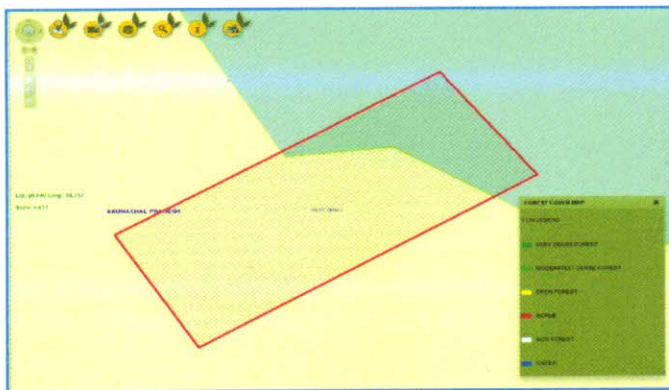
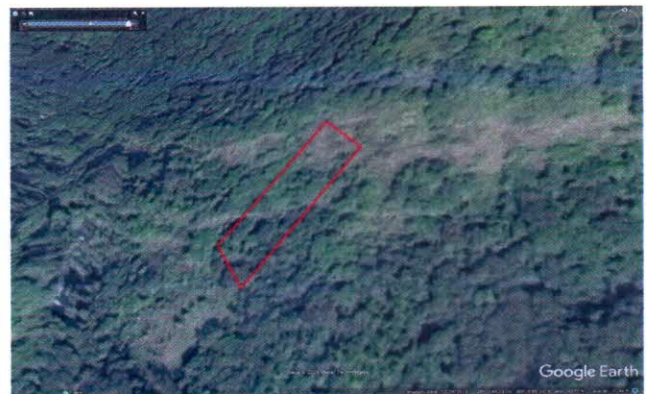
Heo PH Quarry (0.3 ha)

Based on four parameters (FCM, FTM, BR, LI) of DSS rule No.-2, the proposed quarry site has been considered as Inviolate. The score value of each layer is mentioned below.

As per the observation of Forest Cover Map, the proposed quarry site includes 0.23 ha of Open Forest and 0.07 ha of Moderately Dense Forest. The Google Earth satellite imagery dated 19.11.2012 shows that the quarry site proposed on steep slope (more than 40 degree gradient) has been covered with vegetation.

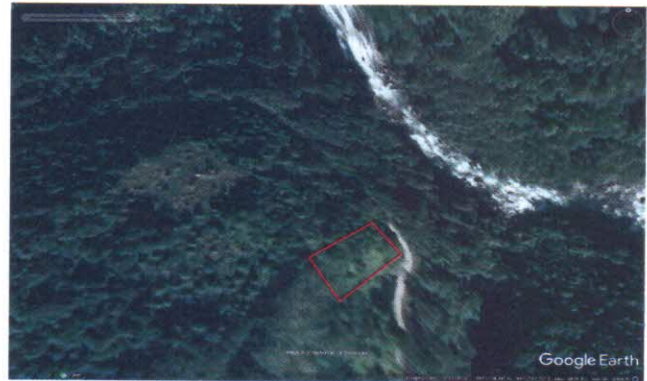
Heo Barrage Quarry (0.3 ha)

The aggregate score of four parameters of a grid is found to be above 70. Therefore, this proposed quarry site has been considered as Inviolable in accordance with DSS rule No.-2.

As per Forest Cover Map , the entire quarry site falls under Moderately Dense Forest.

Based on visual interpretation of Google Earth satellite imagery dated 23.11.2018, the quarry site proposed on the extreme slope surface (30 degree gradient) is covered with vegetation.

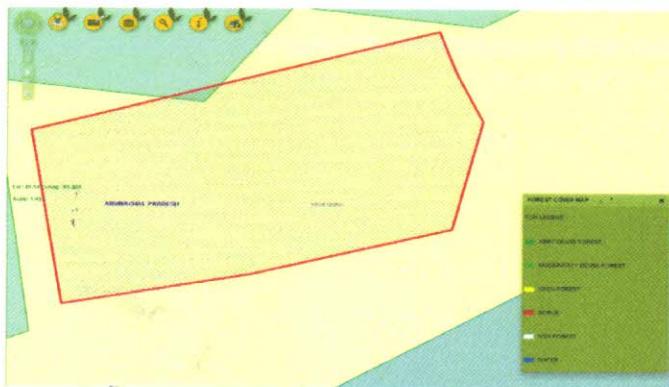
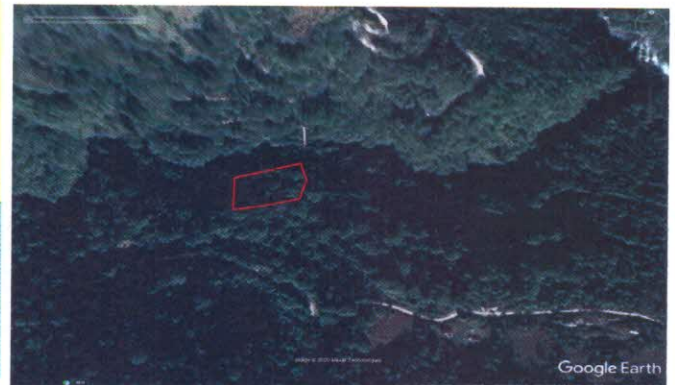
Heo Barrage Quarry from Pauk HEP (0.5 ha)

Based on four parameters (FCM, FTM, BR, LI) of DSS rule No.-2, the proposed quarry site has been considered as Inviolable. The score values are mentioned below.

The Forest Cover Map of DSS shows that the entire quarry site falls under Open Forest. However, as per the observation of Google Earth satellite imagery dated 23.11.2018, the quarry site is proposed on the forested slope.

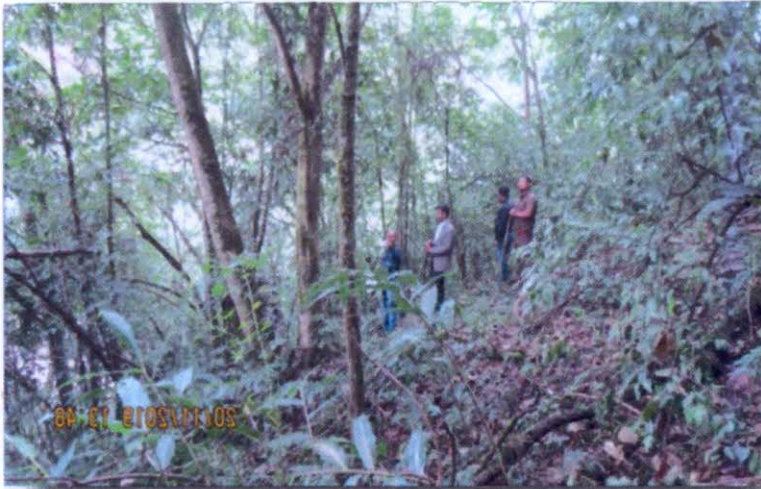
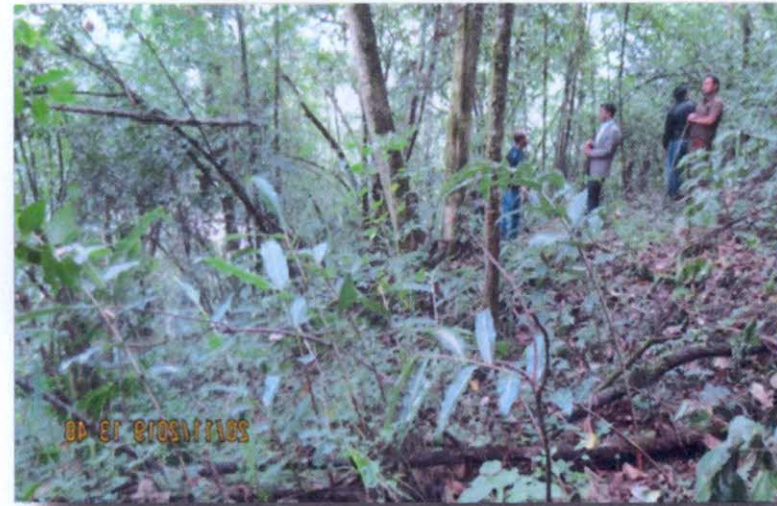
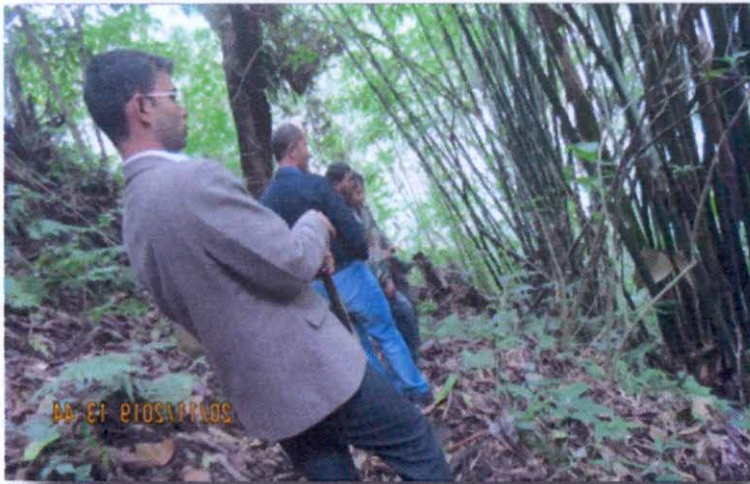
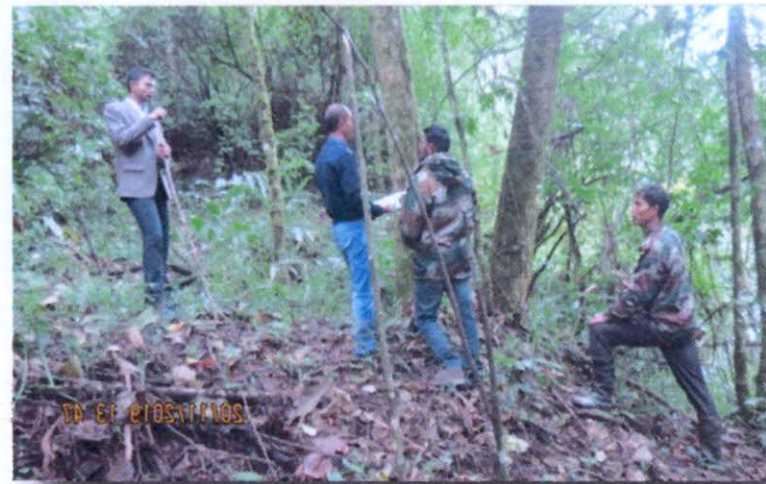
Photographs showing the muck Dumping site (2.0ha) proposed for Heo HEP in Hiri Village.

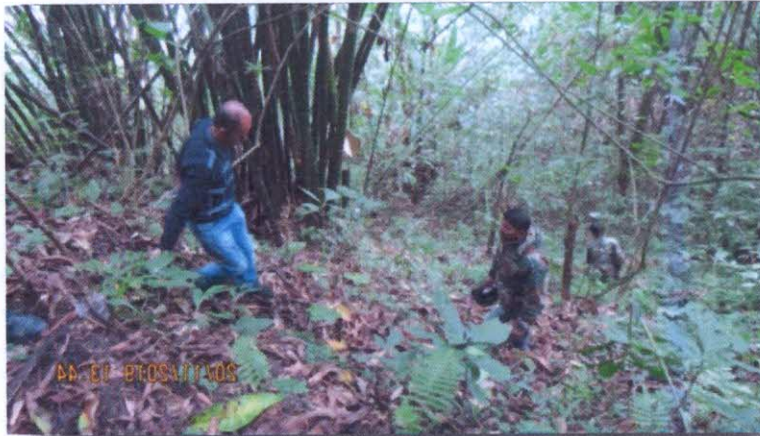
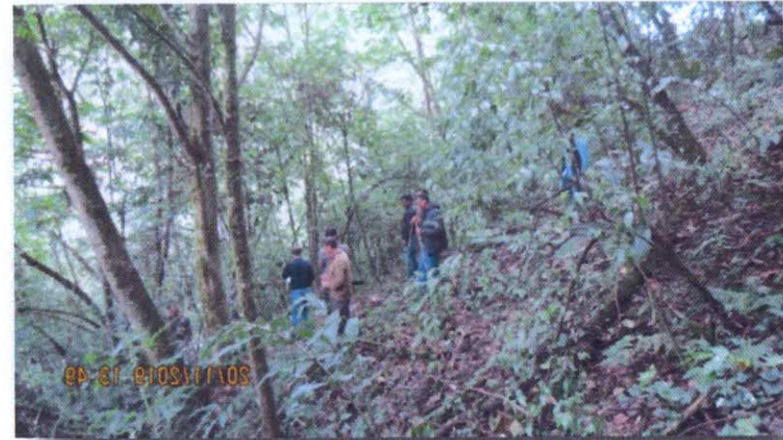
Photographs showing the muck access road (3.7 ha) in Hiri Village for the proposed HeoHEP shifted/deleted from Pauk Hydro Power Project.

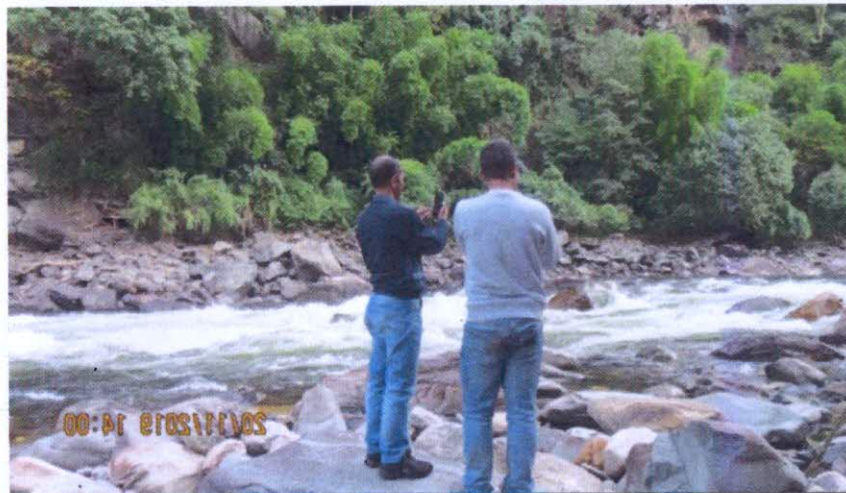
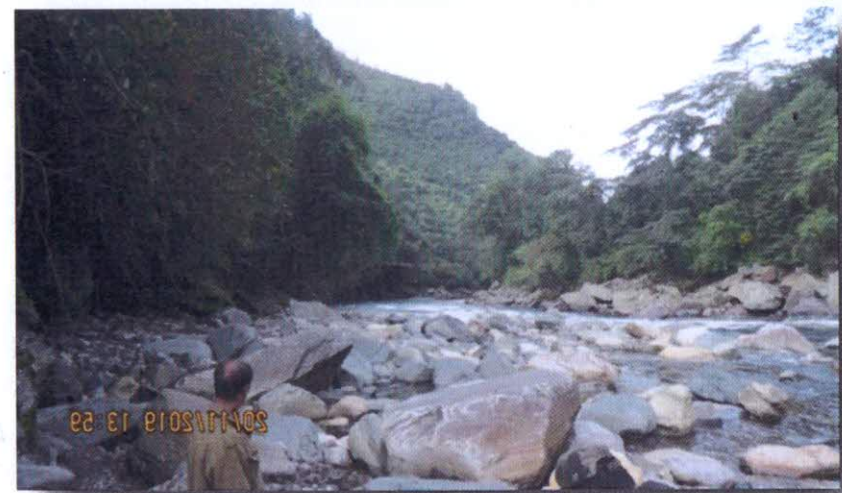
Photographs of river Yargap ("Shi"-local name) below the Muck Dumping site 2.0ha) and Muck Access road (3.7 ha) in Hiri Village for the proposed Heo HEP.

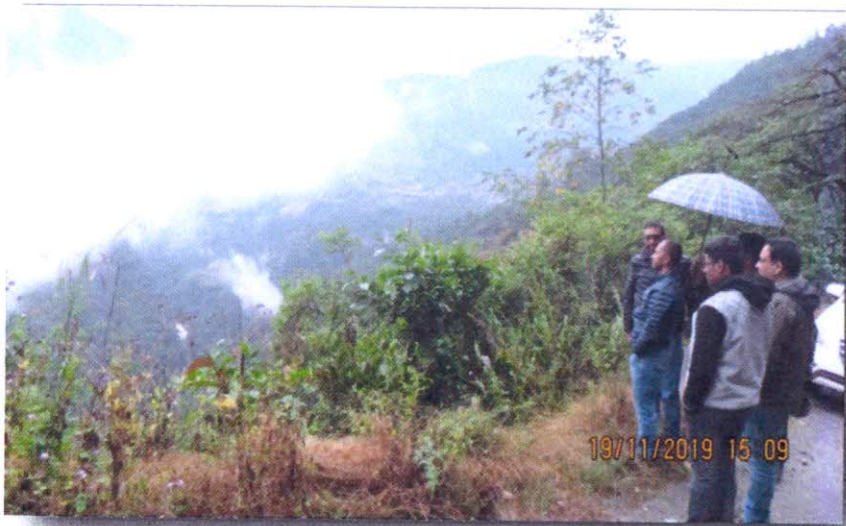
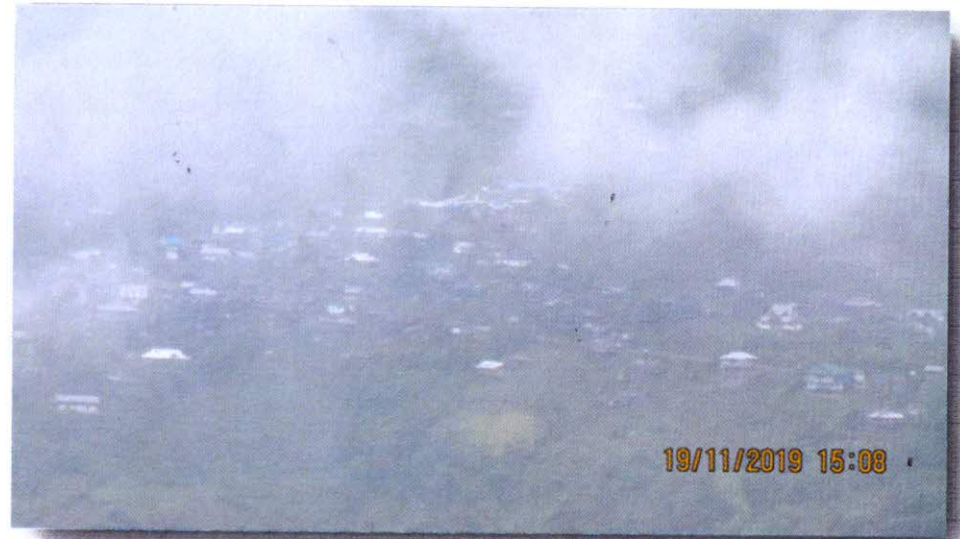
View of Tato village where old quarry proposed to be abandoned (could not be visited)

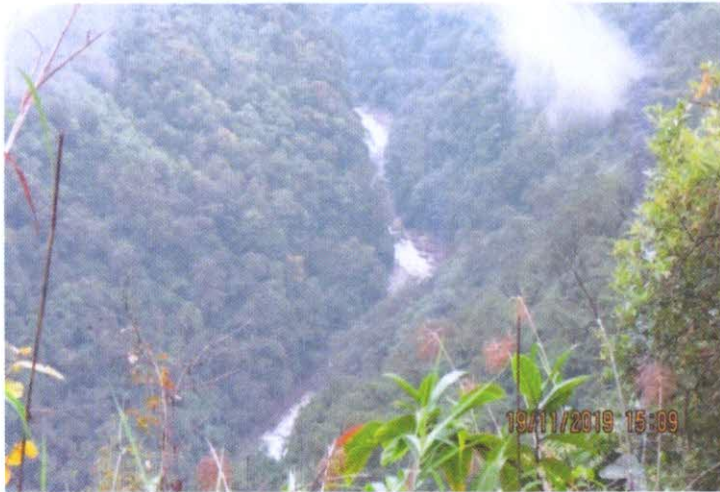
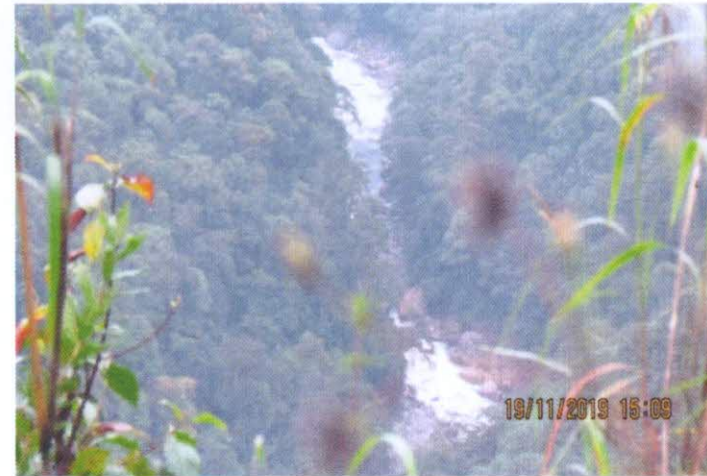
Location of earlier proposed quarry site in Heyo village for Tato-I HEP.

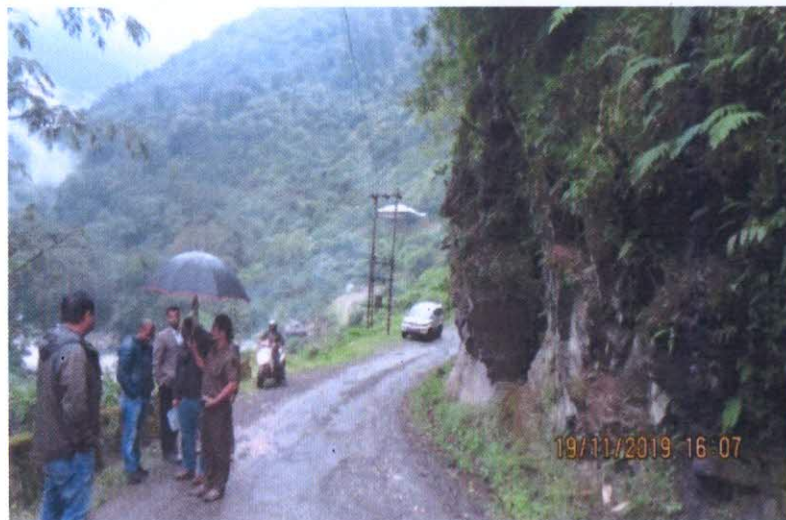
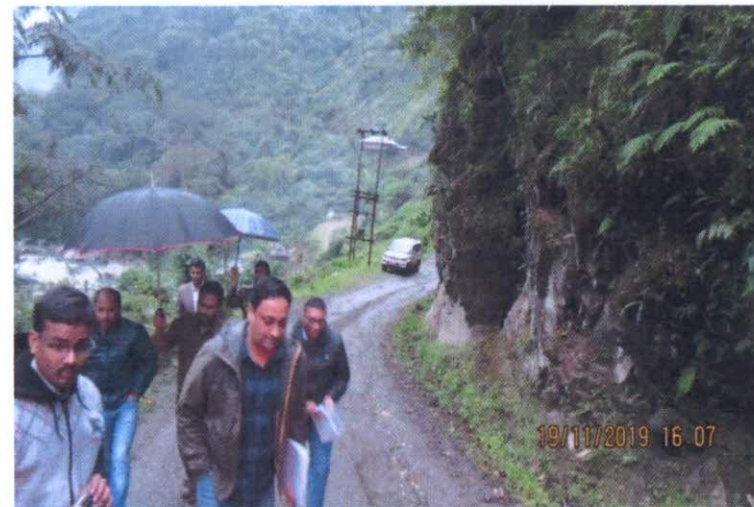
Location of Quarry site(0.5ha) in Padusa village for Tato-I HEP shifted from earlier proposed quarry site in Heyo village.

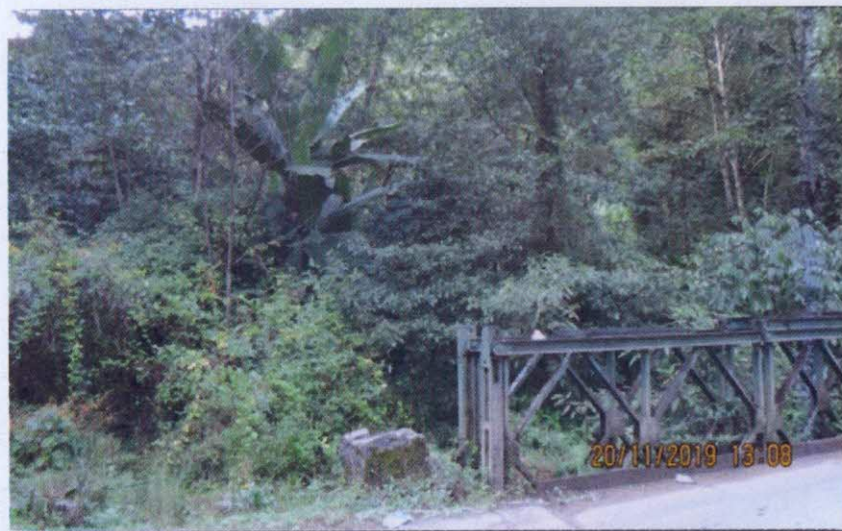
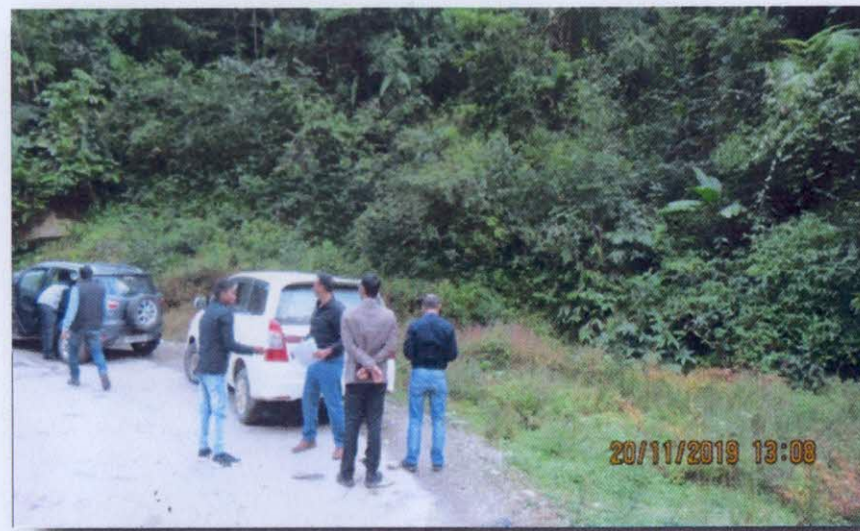
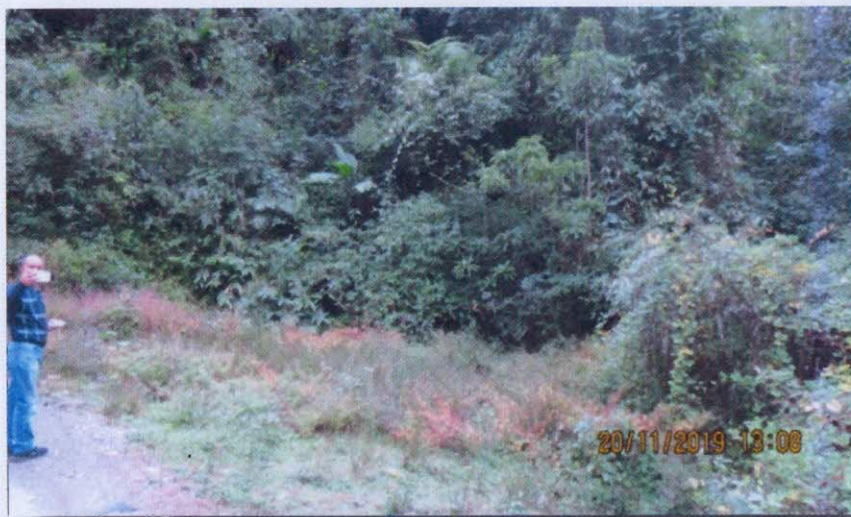
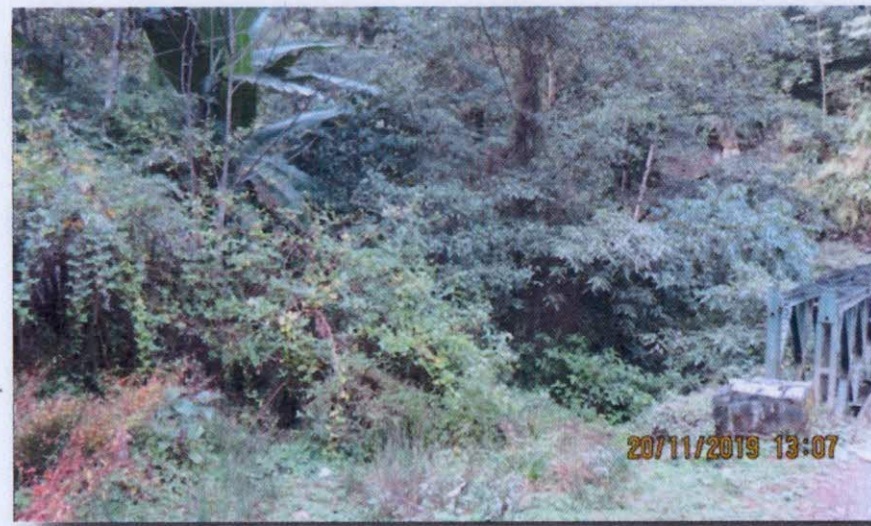
Proposed location of quarry site(0.5ha) near to Saechu Nahla shifted from Pauk HEP and added to Heo HEP.
