Geological Assessment of 5.2 Km long alignment from Sahid Inder Singh Bargali motor road to Khanshyu motor road, Okhalkanda Block, District- Nainital.

Pravin Joshi
25/06/2019

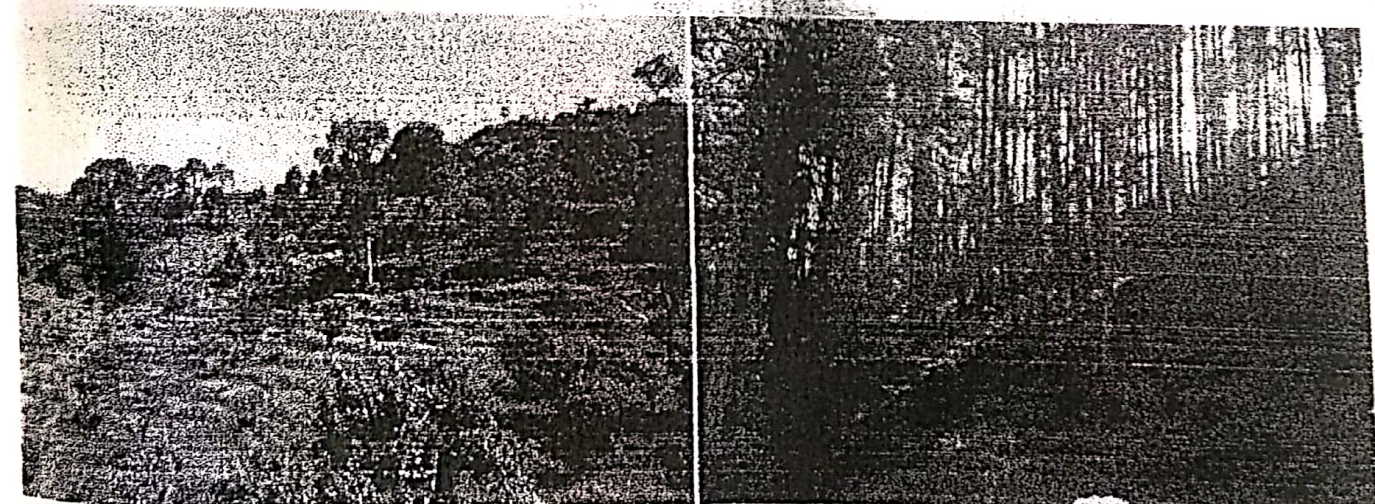
Rock type in the area is Phyllitic Quartzite and Augen Gneiss, which is hard and compact in strength. Quartzite is more deformed, fractured and weathered than the gneiss. Strength of the rock is estimated with manual test. At some places the rock is highly sheared and weathered. High grade of deformation is observed at the starting point, rocks are highly deform and weak. Four sets of joints have been observed at the site (Table- I). Joint J1 is very closely spaced then the other joint sets. The filling in-between joint plane is clay. Joint sets recorded from the outcrop are as follows-

Figure 2 Phyllitic Quartzite and Augen gneiss outcrop observed along the proposed alignment
