GEOMORPHOLOGICAL & GEOLOGICAL STUDY OF  
HALAIPANI SMALL HYDRO ELECTRIC PROJECT  
(16 MW)  
ANJAW DISTRICT, ARUNACHAL PRADESH

M/S HALAIPANI HYDRO PROJECT PRIVATE LIMITED

M/S GREJ ENGINEERS PRIVATE  
LIMITED

JANUARY 2024

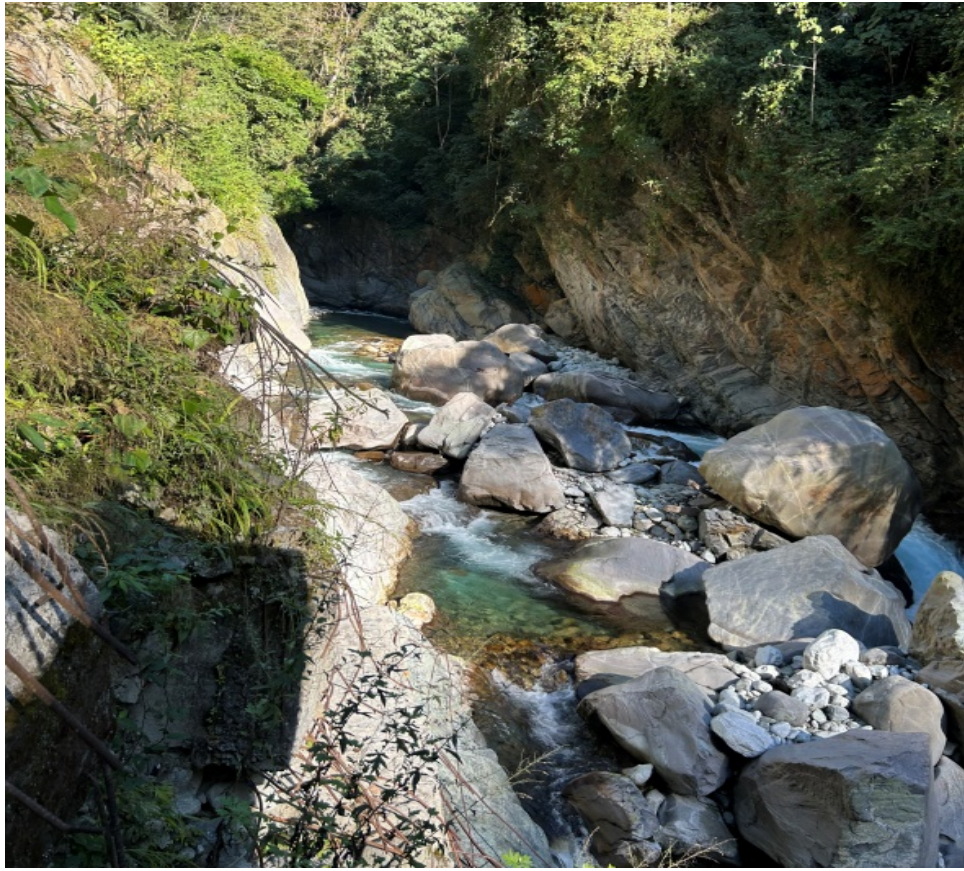
River born materials are kind of loose large boulders, cobbles, pebbles, sand and silt found in the river bed as well as along the banks of the Halai River (Fig. 6 & 7). These materials are continuously modified during floods and in case of cloudburst or landslide. The large boulders and cobbles are observed throughout the river bed. These boulders are mostly made up of granite, diorite, gneiss and other volcanic rock. The size of these boulders may vary from few cm to 7-10m.

Fig. 6 A view of river born sediments at Barrage Location

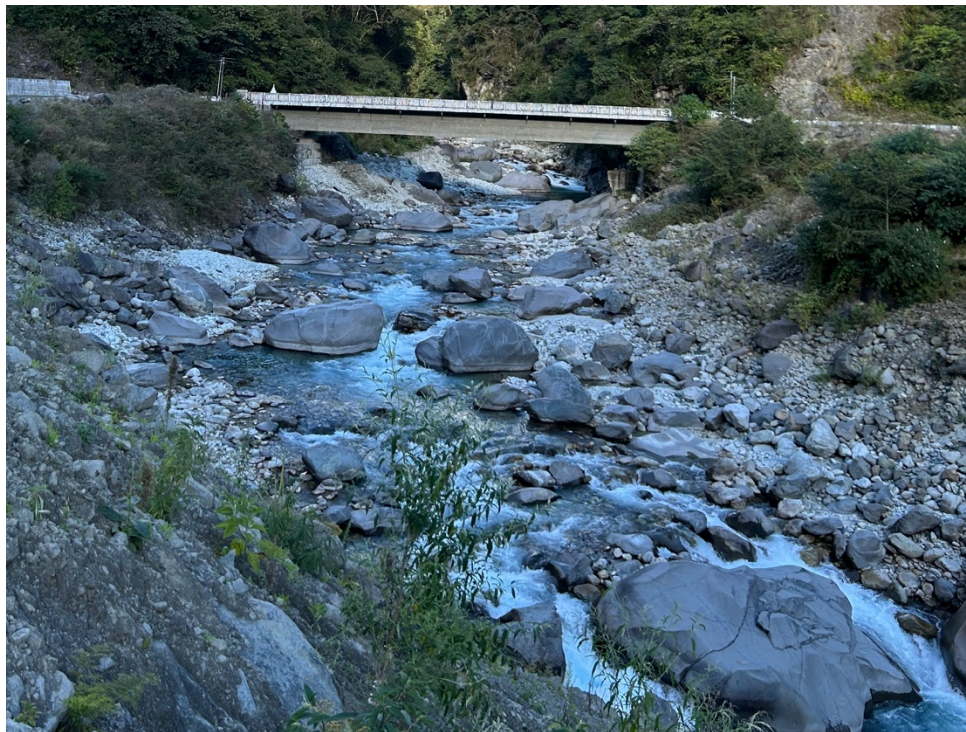
Fig. 7 A view of river born materials near Power House Location

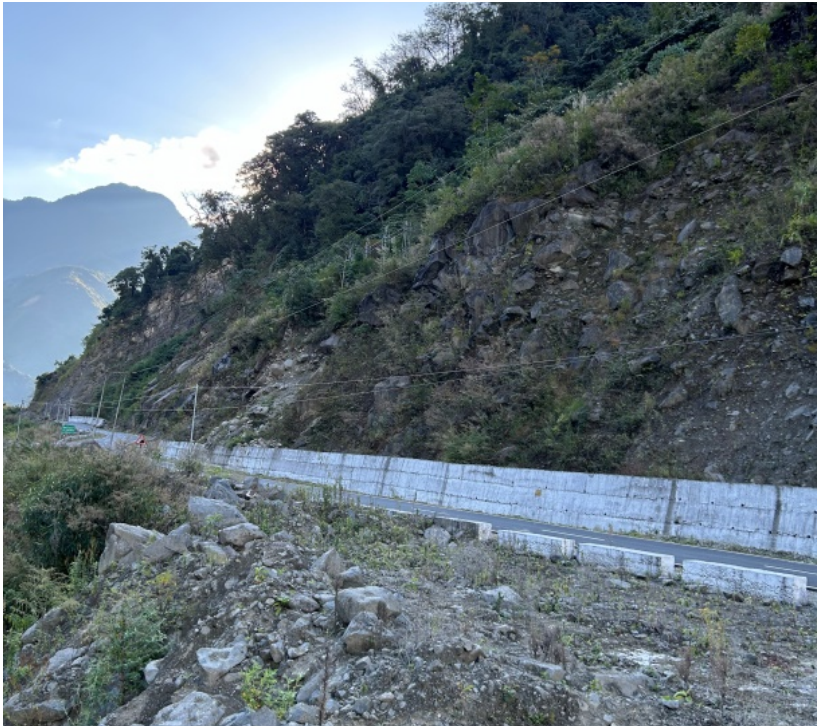
Debris Deposit constitutes sandy, gritty soil as heterogeneous mixture having large numbers of huge boulders, gravels and pebbles generally angular to sub-angular gravel and finer sandy-silty matrix (Fig. 8 & 9). Rock boulders are mainly of granite, diorite, gneiss and amphibolite, schist mixed with insitu soil. Areas having these deposits are fairly stable and have forest cover with large tracts of cultivated slopes. The general slope of hill face made up of debris throughout the area is about 40°- 60°. In general, thickness of this deposit may vary as 3-5m in depth whereas in the slide portion exposure depth increases upto 7-10m.

Fig. 8 View showing the debris deposit noted near the Penstock Alignment

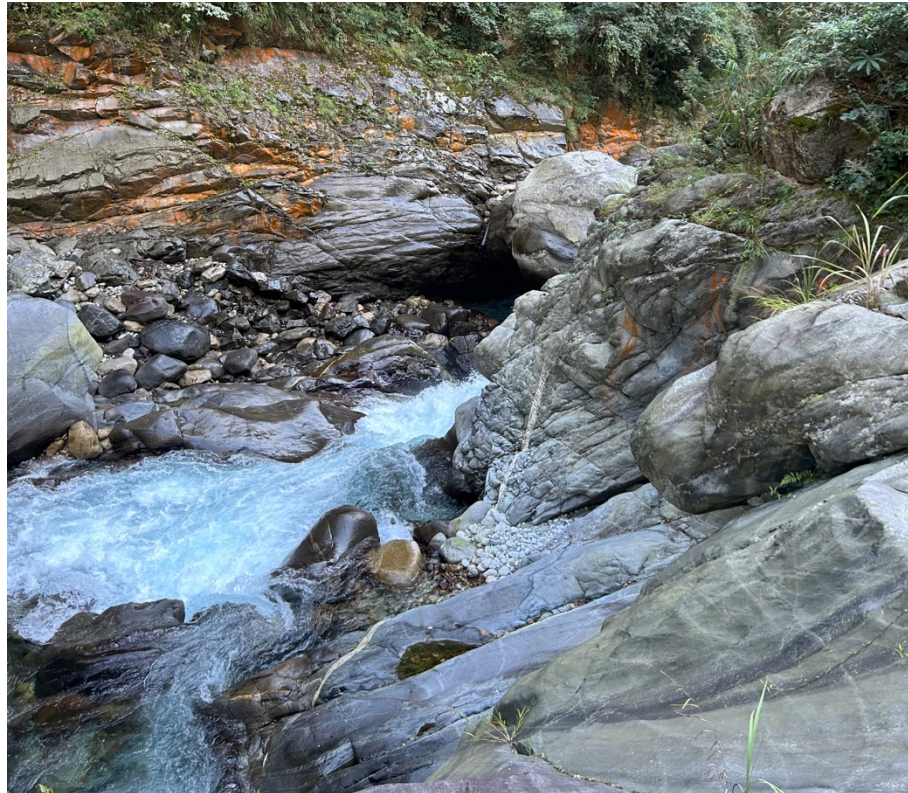
The main rock unit observed in the project area is diorite, leucogranite and granitic gneiss which are very hard, solid, jointed along foliation plane (Fig. 10). Mineralogically, these are composed of quartz, Feldspar, plagioclase, hornblende, tourmaline and biotite. Intrusions of diorite and Pegmatite veins are also noted in the Granitoid body on the right bank of Halai River near Barrage area (Fig. 11). There are three sets of joint are noted in the area which are closely spaced and persist for substantial distance (Fig. 12).

Fig. 10 A View of gneissic rock exposed below the Intake which is hard and solid

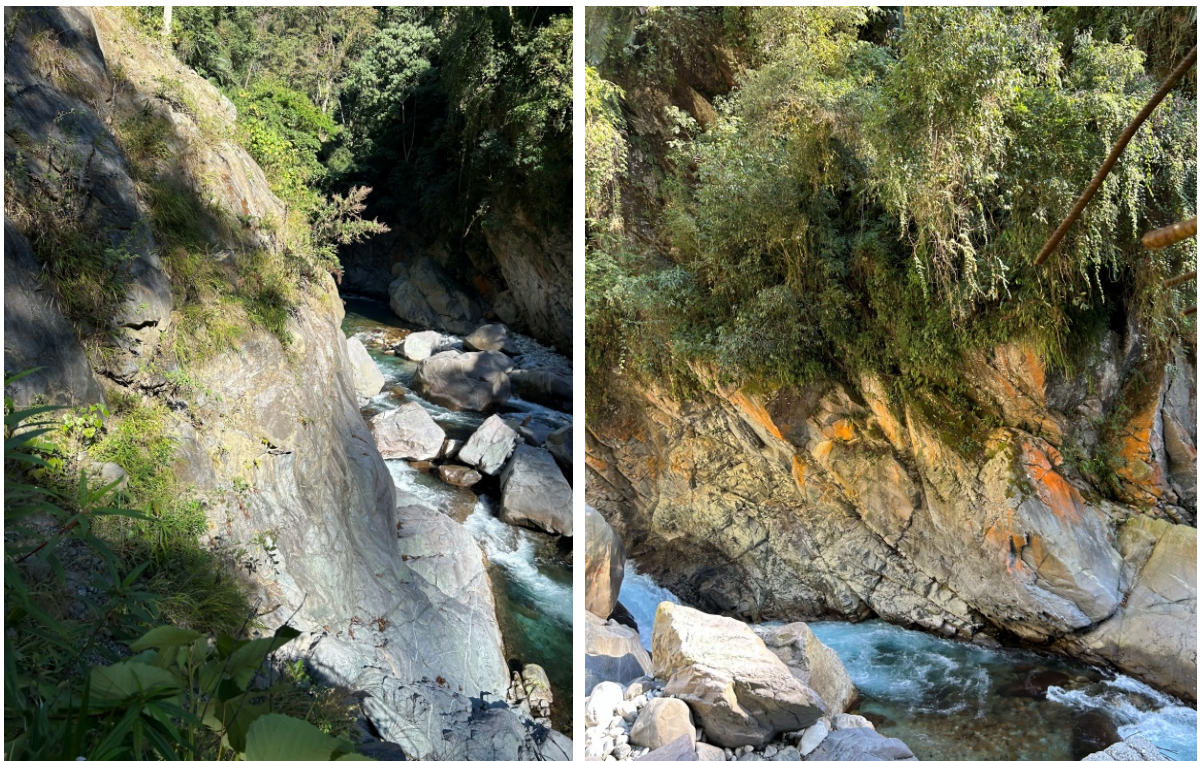
Fig. 11 A View showing rock exposure on the (a) Right Bank (b) Left Bank

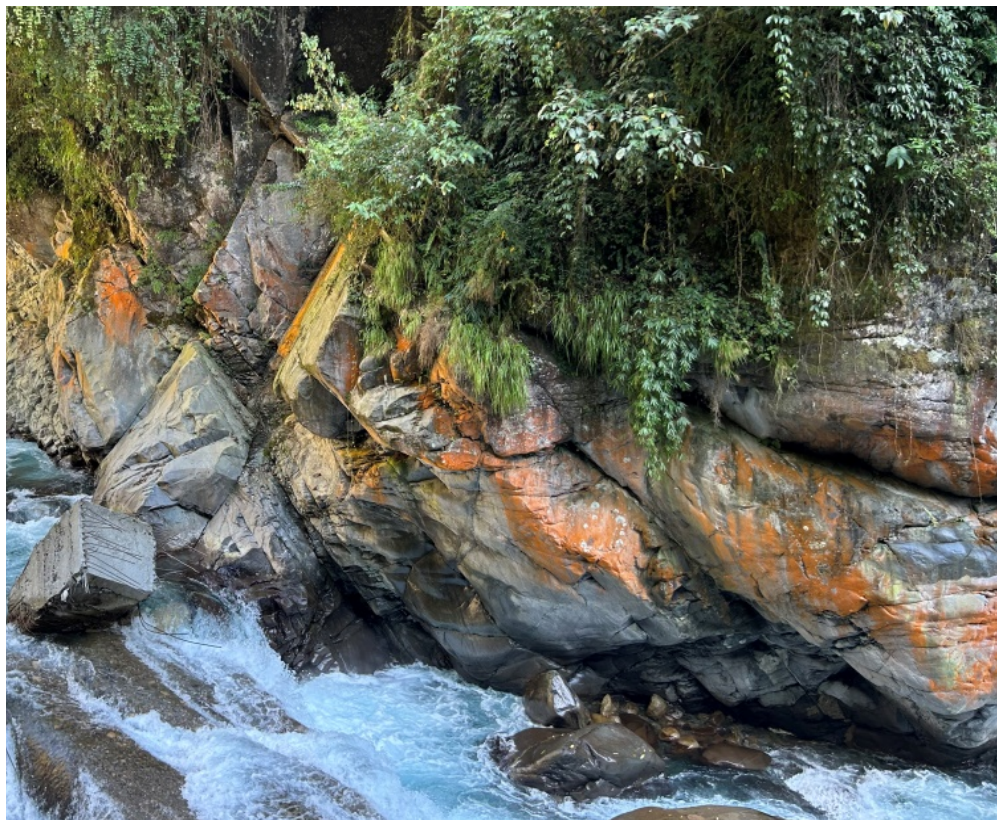
Fig. 12 A View of jointed granodiorite on the left bank of Halai River
