विषय :- जनपद चम्पावत में लोहाघाट के रामीप कोलीढेक में बहुउद्देशीय कृत्रिम जलाशय (झील) के निर्माण हेतु 4.50 है० वनभूमि का सिंचाई विभाग को प्रत्यावर्तन (ऑनलाईन सं०- FP/UK/IRRI 34614/2017)।

### Kolidhek Artificial Lake Project

District : Champavat (Uttarakhand)

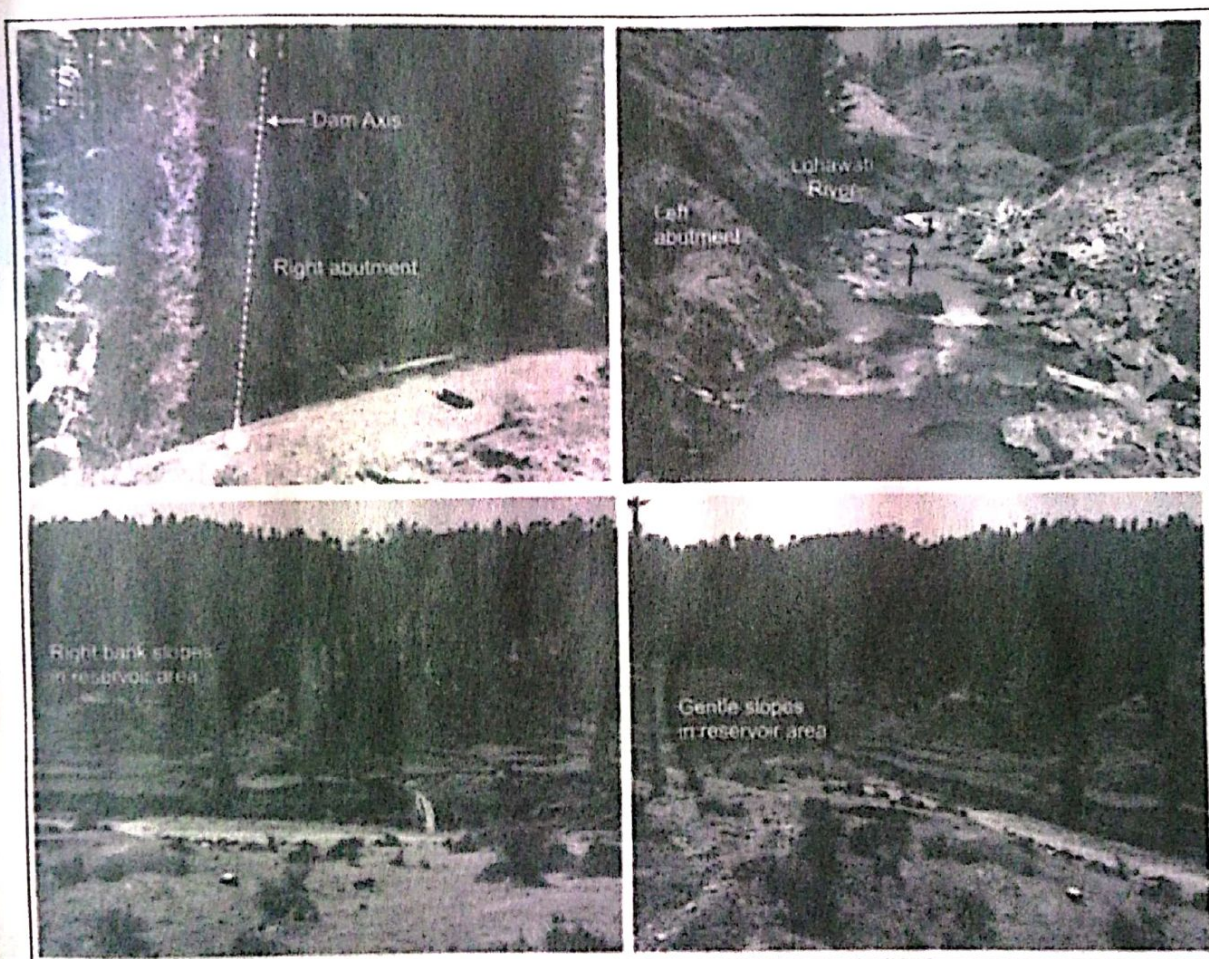
Plate 1 View of dam site and reservoir area

The proposed reservoir slopes of the Kolidekh project are mostly gentle along the left and right bank of the river (Plate 1). The slopes are mostly terraced and are covered by agricultural and barren lands. The right bank slopes near to the dam site and in the middle portion of the reservoir are partly covered by the forest land. The left bank slopes are relatively gentle, terraced and are covered by barren lands around the dam site, in the middle portion and in the uppermost portion of the reservoir (Fig.1).

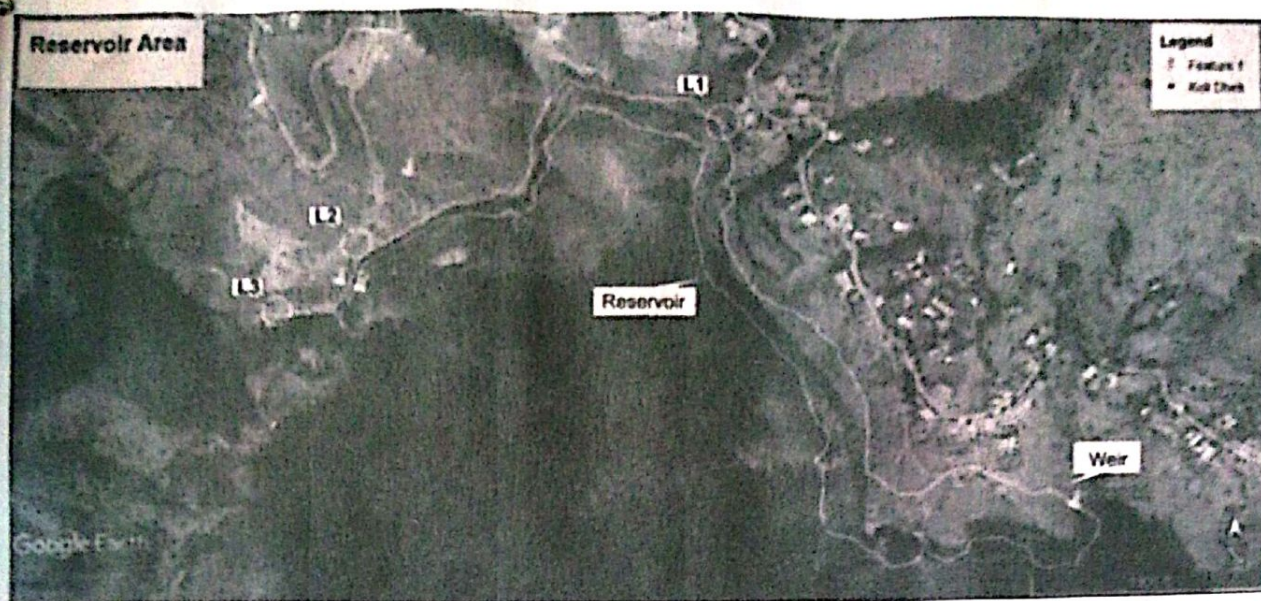
**Fig.1 Reservoir area of Kolidekh artificial lake project as seen through Google Earth image**

The middle portion of the left bank and the upper middle portion of the right bank slopes are covered by the agricultural lands. Since most of the lands on the either banks of the reservoir are terraced and gently inclined slopes, the slopes in general are considered to be stable under anticipated adverse conditions. The slopes along the river banks in the lower most reaches are generally rocky and form steep sections of low height. In these sections possibility of isolated rock failure may exist wherever kinematic conditions would be satisfied. However, such small failure may not have a potential to generate destructive waves that may adversely affect the stability of the project. Moreover, these steeper rock slope sections would be partially or fully submerged under reservoir water. A horizontal thrust would be exerted by the reservoir water which may improve the stability of the slope. Further, during reservoir operation rising and drawdown may bring changes in the material properties, particularly changes in the shear strength that may affect the stability of the slope section within the fluctuating zones. The rising of reservoir will saturate the overburden material and the rock mass sections and on the same time a horizontal thrust will also be provided by the reservoir. During drawdown minor changes are expected that may possibly destabilize the slopes. However, it will depend on the slope inclination, slope material, landuse, kinematic conditions and the shear strength properties of the slope material.
