परियोजना का नाम:-नीरगढ कक्ष संख्या-04 में स्थित 0.101 हे0 वन भूमि लीज संख्या-56 के 30 वर्षों

NOTE ON GEOLOGICAL FEASIBILITY  
OF  
LEASE NO.56,

FOR  
YOGIRAJ RAMANAND TRUST,

AT  
NEERGARH, KHAND 4,  
TEHSIL- NARENDRA NAGAR  
DISTT.-TEHRI GARHWAL,  
UTTARAKHAND

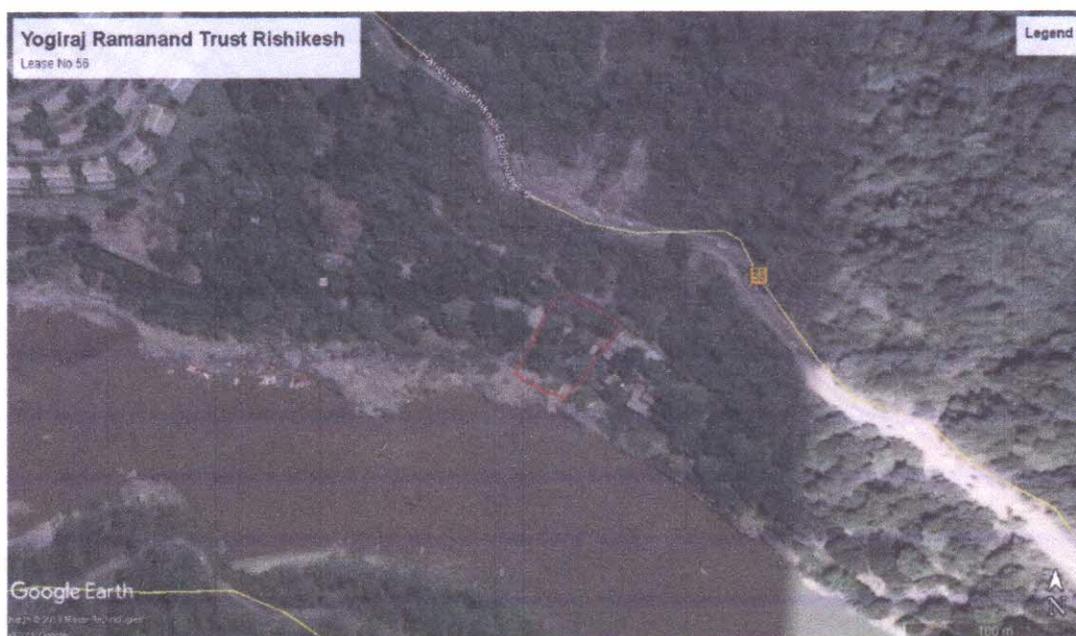
Figure 1: Satellite Imagery of the area.

KainGeotech, Dehradun was assigned by the client to conduct a preliminary geological examination at the lease no 56, Area of 0.101 ha., of Yogiraj Ramanand Trust, Neergarh, Khand 4, Tehsil – Narendra Nagar, Distt.- Tehri Garhwal Uttarakhand (figure 1). Rishikesh is located in the foothills of the Himalayas in northern India, it is known as the "*Gateway to the Garhwal Himalayas*" and "*Yoga Capital of the World*". The site was visited by Mr. K Sati (Geologist) on 6<sup>th</sup> August 2019, in the presence of Mahant Shri Ajay Nathwani. The proposed location of the land and other details were provided by the owner.
