REPORT ON
SUBSIDENCE PREDICTION AND MANAGEMENT
FOR
DHAU NORTH BLOCK
WESTERN COALFIELDS LIMITED

JUNE 2014

MINING LABORATORY(UMD)
CENTRAL MINE PLANNING & DESIGN INSTITUTE LTD.
GONDWANA PLACE, KANKE ROAD
RANCHI – 834 031

Job No. : 4101730

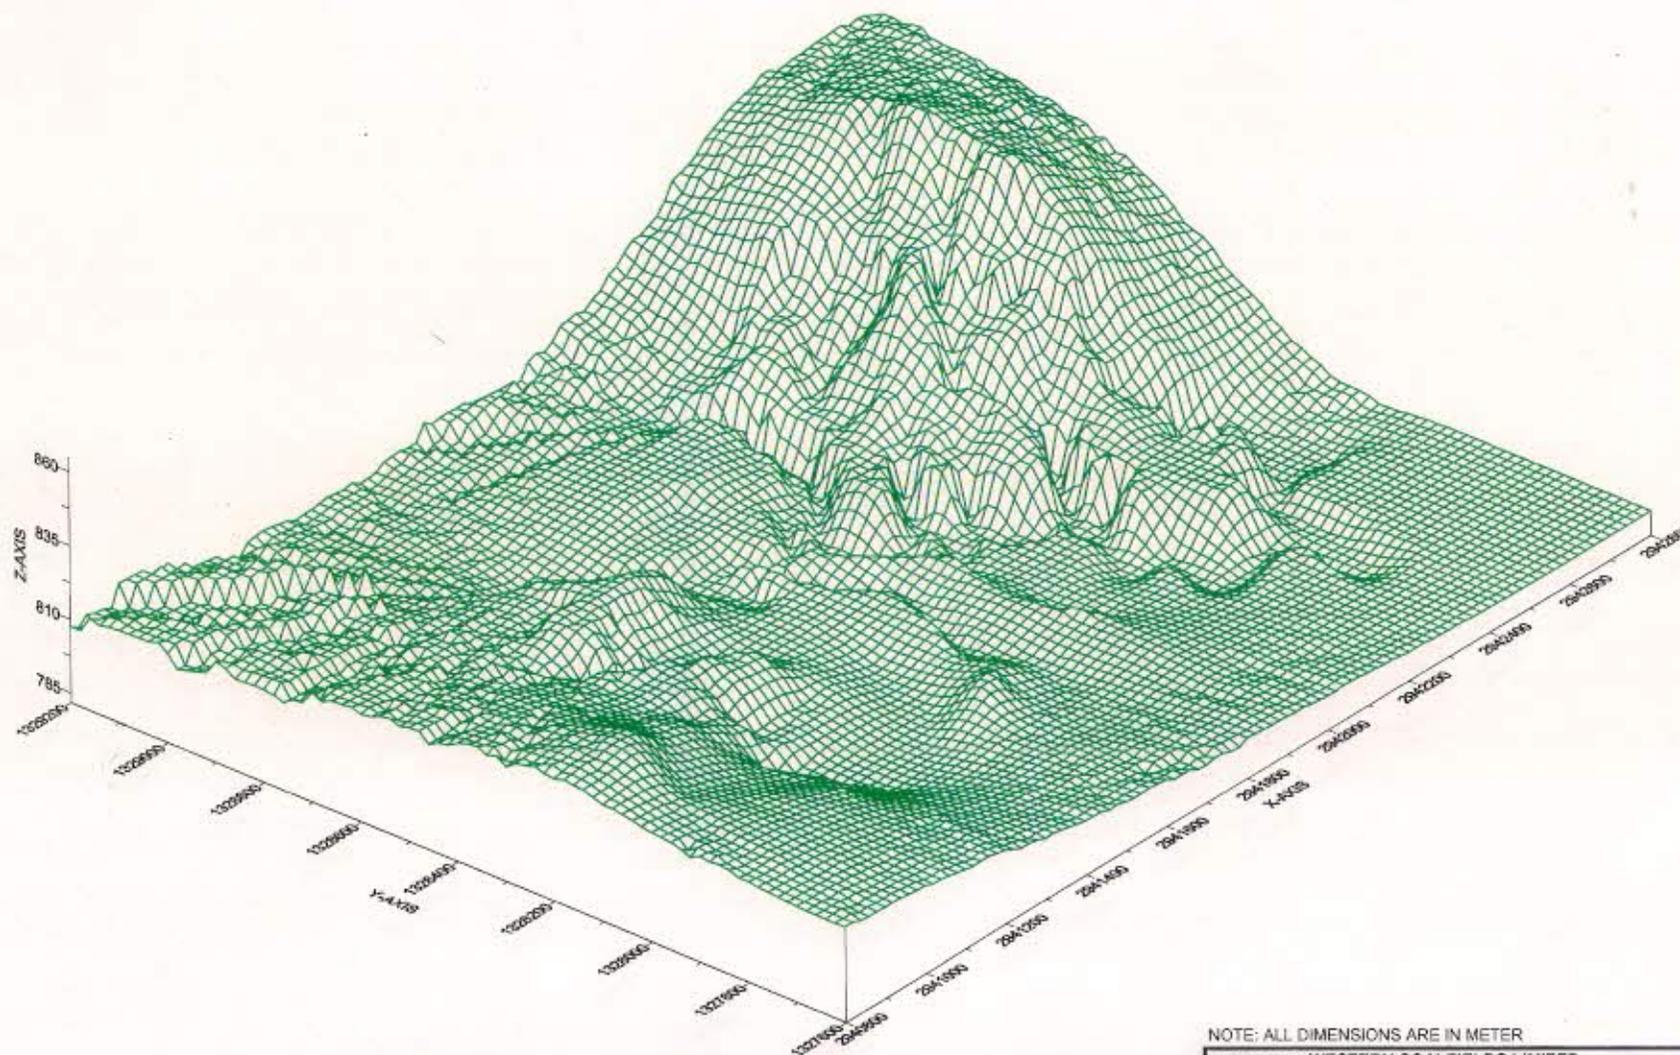
CMPDI ISO 9001 COMPANY	SCALE : 1:12000		SHEET 6 OF 8		
	DRG. NO. PLATE-6			REV. NO. 0

CUSTOMER : WESTERN COALFIELDS LIMITED					
JOB TITLE : SUBSIDENCE PREDICTION FOR DHAIJ NORTH BLOCK				JOB NO. 410-1730	
SUBJECT :3D view of surface before mining.	ACTIVITY	NAME	DESIG.	SIGN	DATE
	PREPARED	B.RIBA	AS.MGR.	<i>[Signature]</i>	
	PROCESSED	V.SINGH	SR.MGR.	<i>[Signature]</i>	
	CHECKED	M.SAHAY	CH.MGR.	<i>[Signature]</i>	
APPROVED	A.K.RAMA	GM	<i>[Signature]</i>

Topography before mining and after extraction of Seam III/III (Top) are shown in Plates 3 and 5 respectively. Change in topography due to subsidence can be seen by comparing the above mentioned plates. For a comparative assessment of ground condition before and after mining, 3D views of surface before and after extraction of Seam III /III (Top) are shown in Plates 6 and 7 respectively. By comparing the above two views, it is observed that there is negligible change in surface topography. Surface profiles before mining and after final subsidence have also been drawn along line AA' and BB" and shown in Plates 8 and 9 respectively.

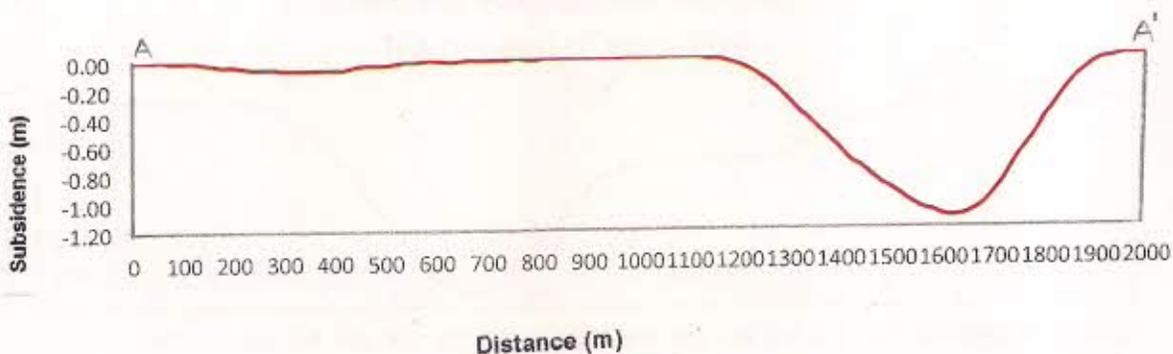
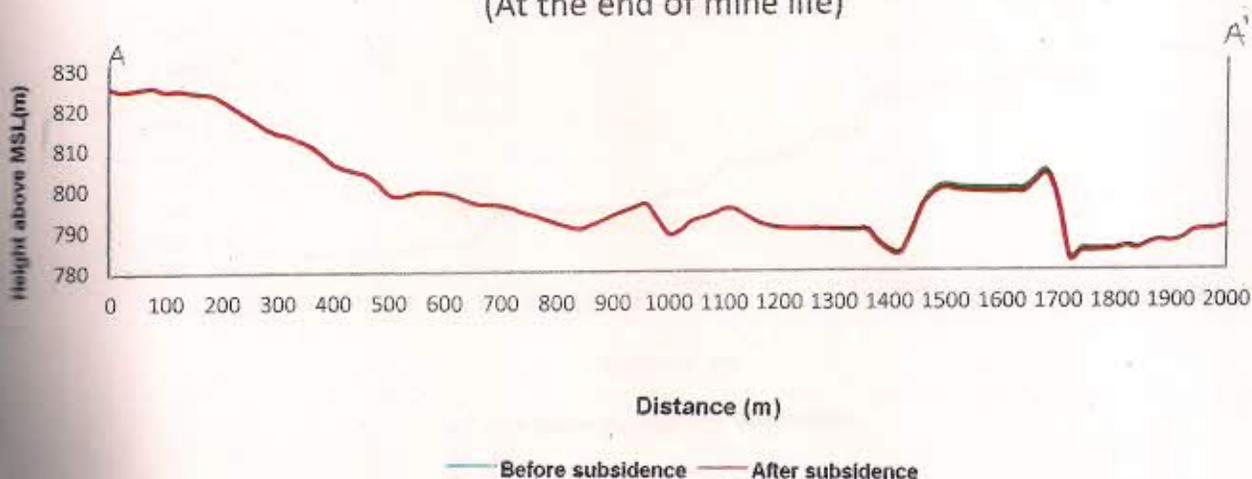
SUBSIDENCE PROFILE ALONG LINE AA'
(At the end of mine life)

SURFACE PROFILE ALONG LINE AA'
(At the end of mine life)

the forest area the estimated maximum possible subsidence likely to take place is 0.823m over the panel PA. From the estimated subsidence at each grid point, subsidence contours are drawn due to extraction of Seam III /III (Top) which is shown in Plate 4. In the plate, subsidence contours are shown alternately in violet and red colours at 0.2m intervals. Final subsidence profiles along line AA' and BB' have been drawn and shown in Plate 8 and 9 respectively. Both lines are intersecting at the maximum subsidence point over the mining area.

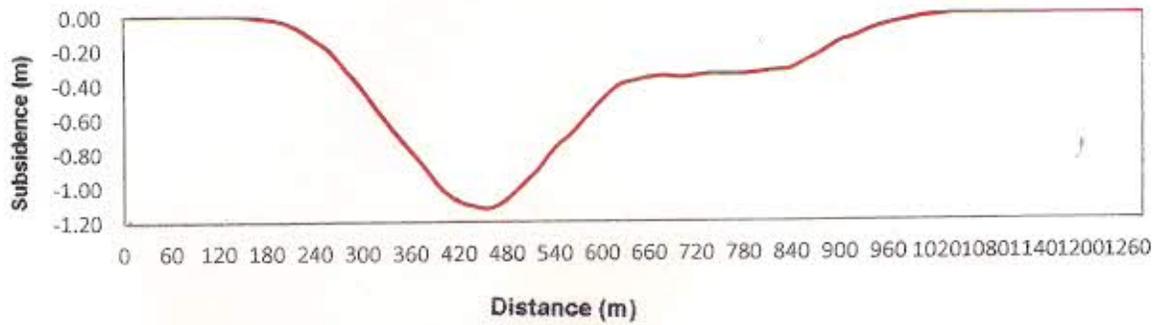
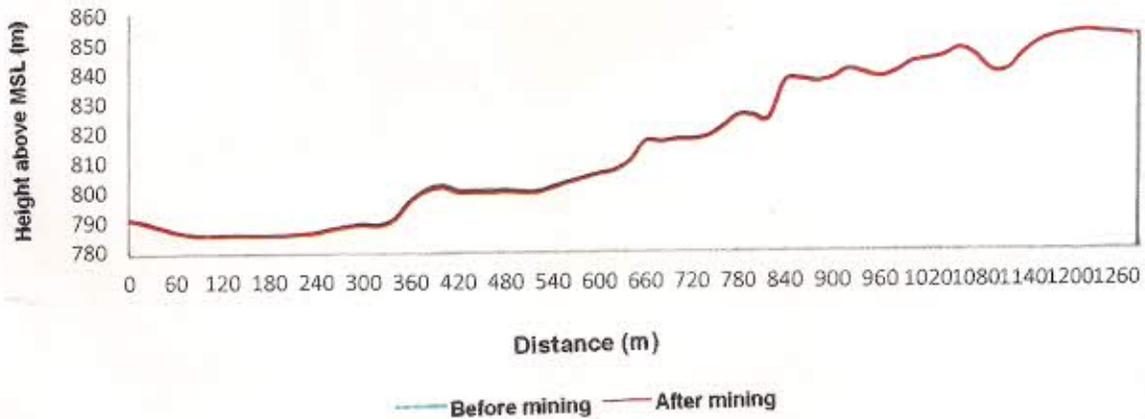
**SUBSIDENCE PROFILE ALONG LINE BB'
(At the end of mine life)**

**SURFACE PROFILE ALONG LINE BB'
(At the end of mine life)**
