# **A STUDY ON THE STATUS OF BIODIVERSITY AND STRUCTURAL STABILITY OF PROPOSED VALANTHODE SMALL HYDRO ELECTRIC PROJECT**

## **FINAL TECHNICAL REPORT**

**SUBMITTED TO  
THE KERALA STATE ELECTRICITY BOARD LIMITED**

**MARCH 2024**

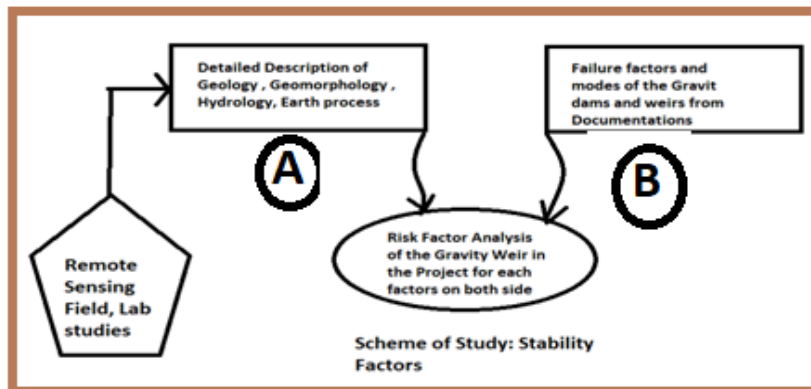
**Fig. 5. Valanthode SHEP: Scheme of Stability and Suitability Factors**

- B. The failure modes recorded are listed (Fig. 5, section B) are considered for the current project and stability of the proposed Valanthode HEP weir is considered.
- C. All possible details and features are considered by available data and still there are remote chance that a few unforeseen situations are unearthed and discussed in with solutions in detail in the chapters of findings and the probable impacts.
- D. Once the project is up and running, preventive maintenance is a must and the same are discussed in chapters dealing with findings and impacts.

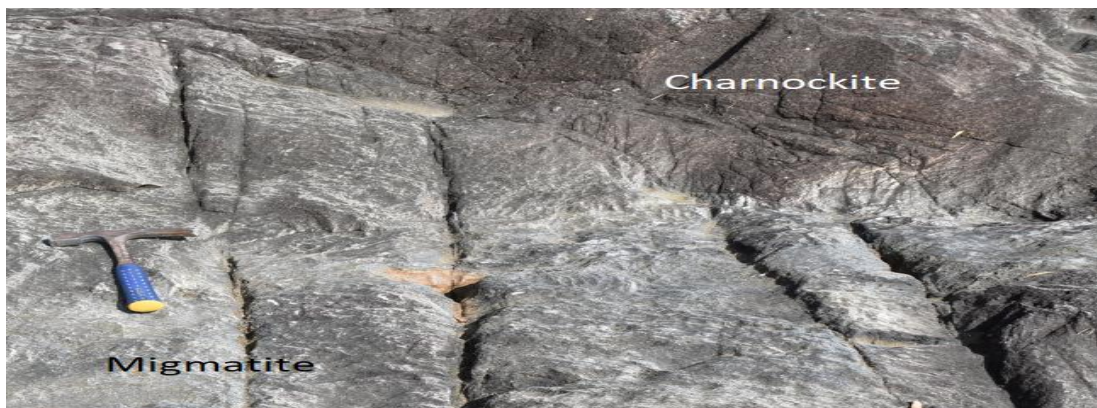
**Fig. 11. Valanthode SHEP: Charnockite getting Migmatised**

The subsurface investigation identified various rock types namely, charnockite, hornblende biotite gneiss, granite gneiss and pyroxene granulite. The rock type exposed at the western end of the weir site is charnockite, within granite gneiss, classified as migmatite with pygmatic fold patterns (Fig. 11 to 15). The general gneissosity / foliation is trending N 40° E - S 40°W with a steep dip towards the northeast.

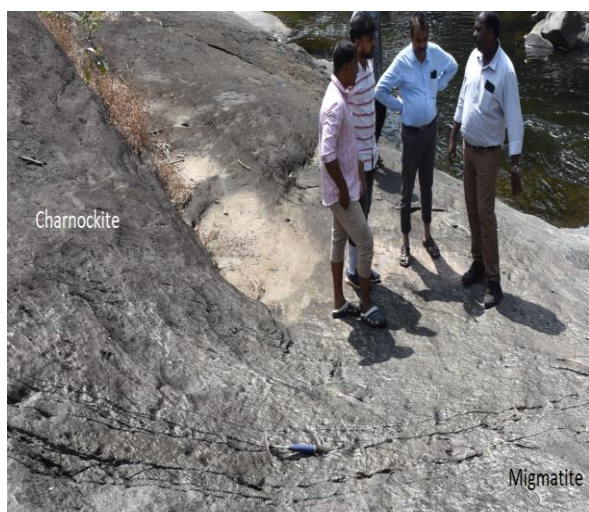
**Fig. 12. Valanthode SHEP: Jointed contact between Charnockite and Migmatite**

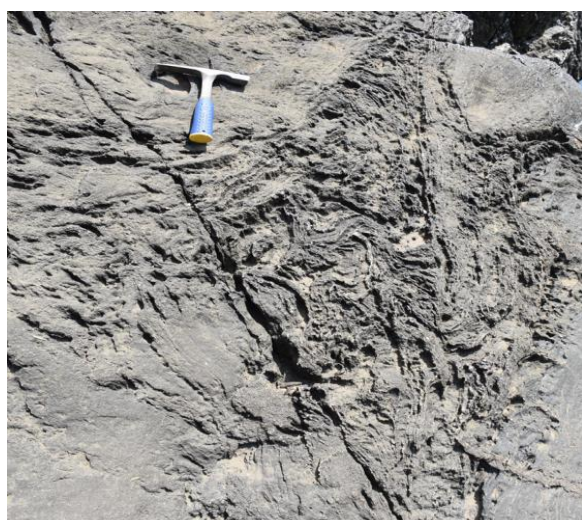
**Fig. 14. Valanthode SHEP: Ptygmatic folds**

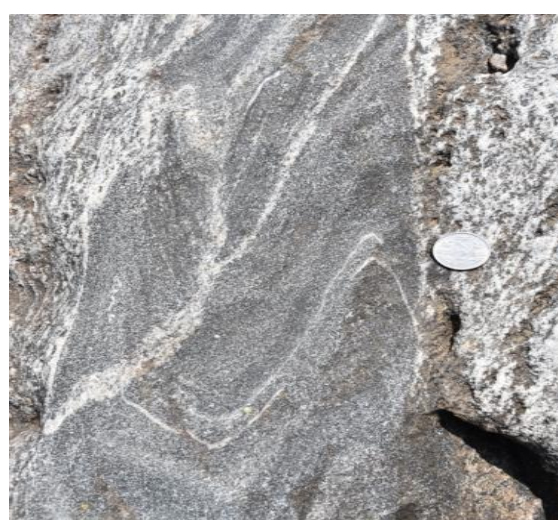
**Fig. 15. Valanthode SHEP: Ptygmatic folds seen in the migmatited gneiss in the eastern section of weir axis.**

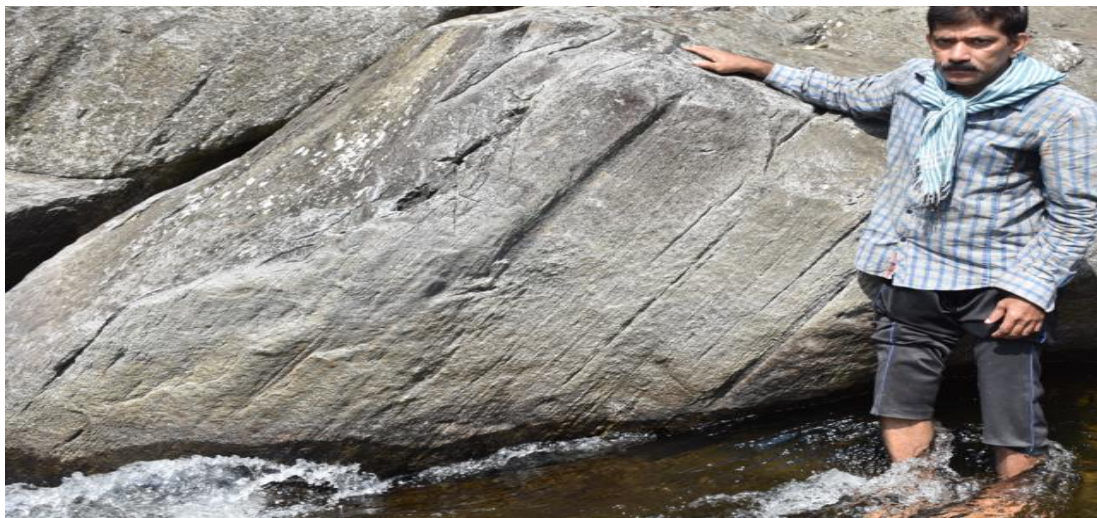
**Fig. 16. Valanthode SHEP: Joint planes exposed in Riverbed at the weir axis.**

- a. **Joint planes:** Joint planes are exposed in crystalline rocks of the area. They are oriented is different directions and are spaced in different locations. One good thing noticed is that there are no gap between the joint planes that allow filtration of water. Since water does not fill them, the stress is not transmitted through. The joint planes do not show any sign of shearing or weathering (Fig. 16).

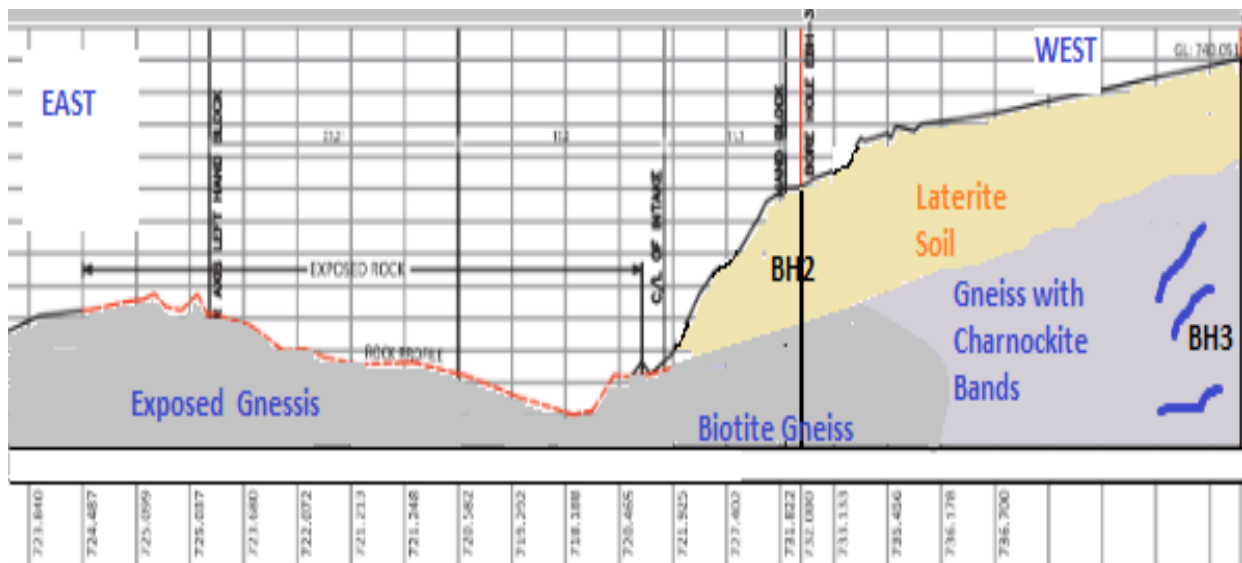
**Fig. 23. Valanthode SHEP: Lithological cross section along the weir axis modified after GSI**

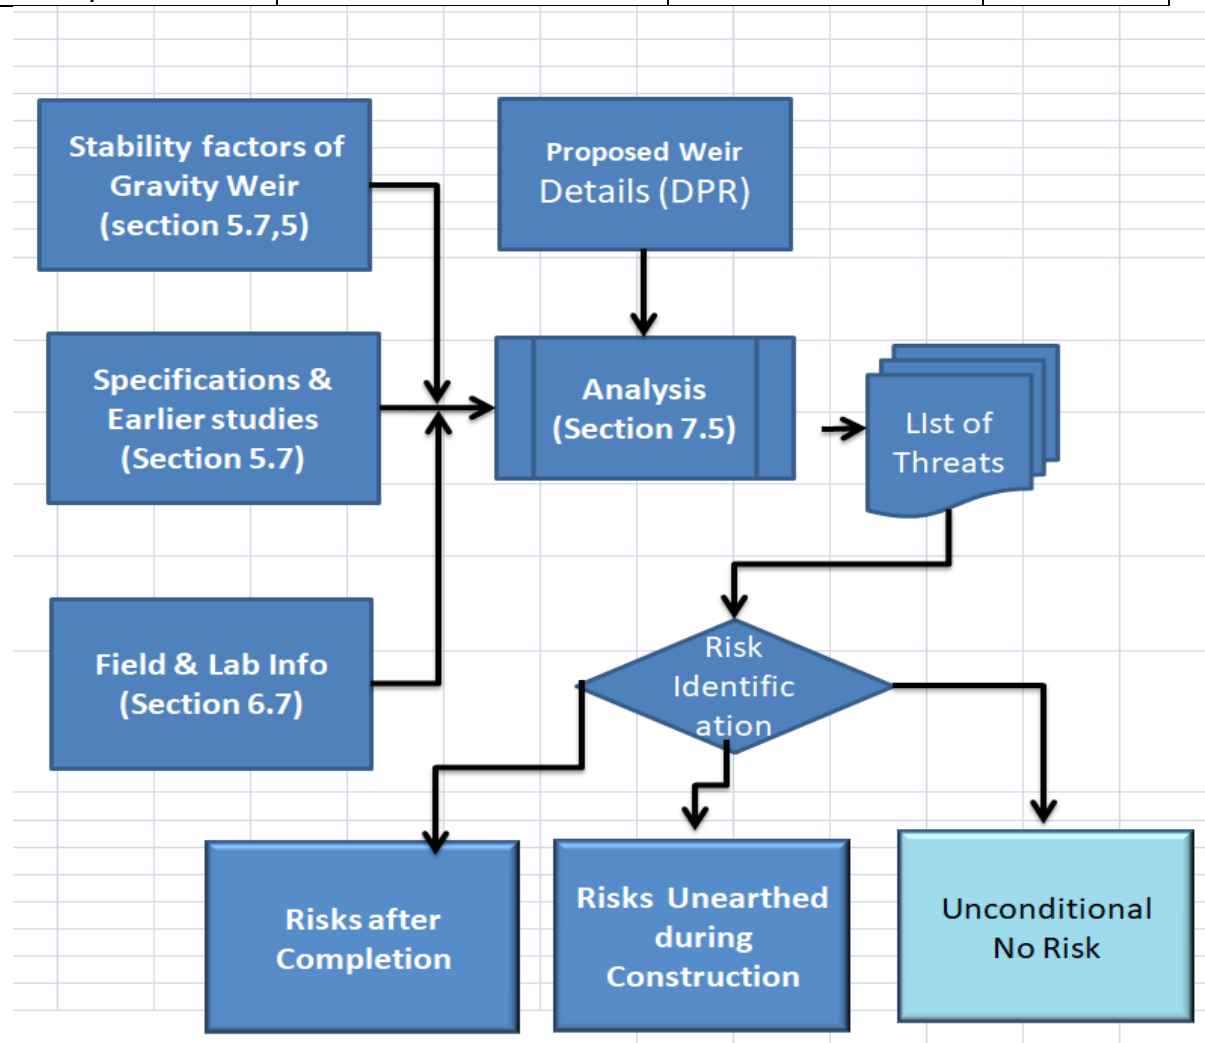
**Fig .31. Valanthode SHEP: Steps of Risk Identification**

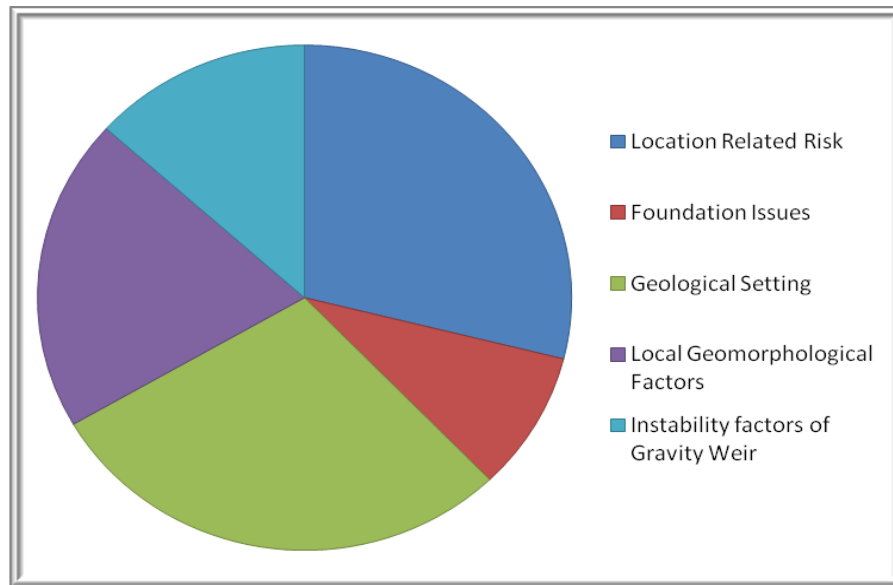
**Fig 32. Valanthode SHEP: Input Data**

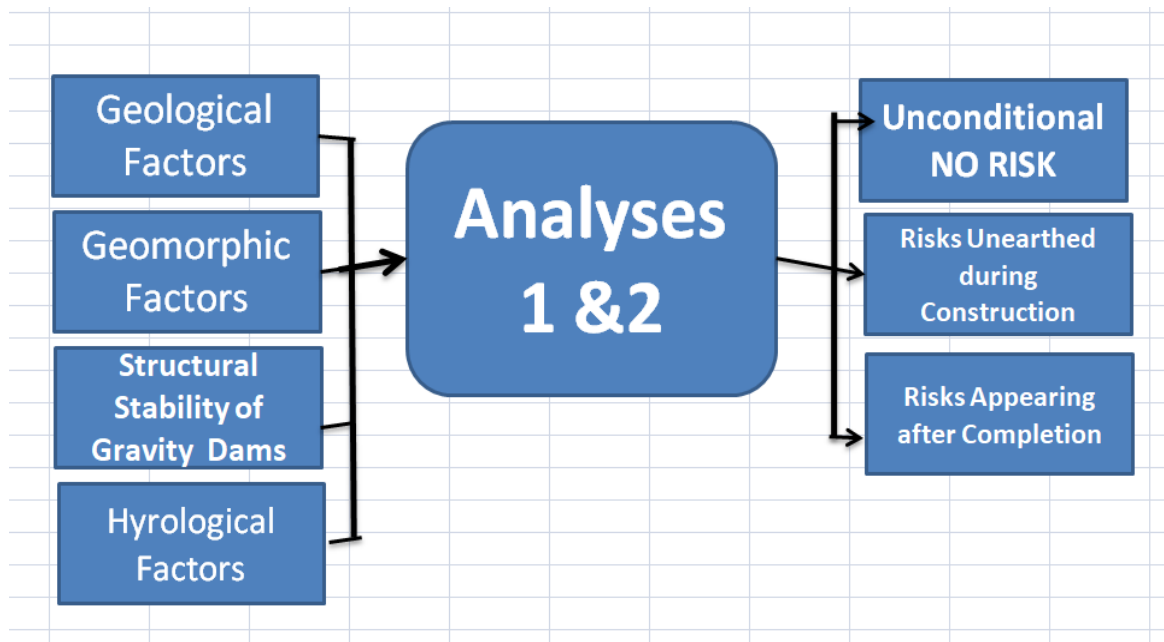
**Fig.33. Valanthode SHEP: Scheme of analysis**
