Geological Assessment of 4.00 Km long Majkhali-Digoti-Majheti motor road District- Almora.

Introduction- Provincial Division, Public Works Department Almora entrusted in construction of 4.00 Km long Majkhali-Digoti-Majheti motor road Almora District. On the request of Shri Harish Pandey, Executive Engineer, Provincial Division, Almora I carried out geological assessment of the above said motor road on dated 27/03/2018. Junior Engineer Shri Ashok Singh accompanied during the site visit.

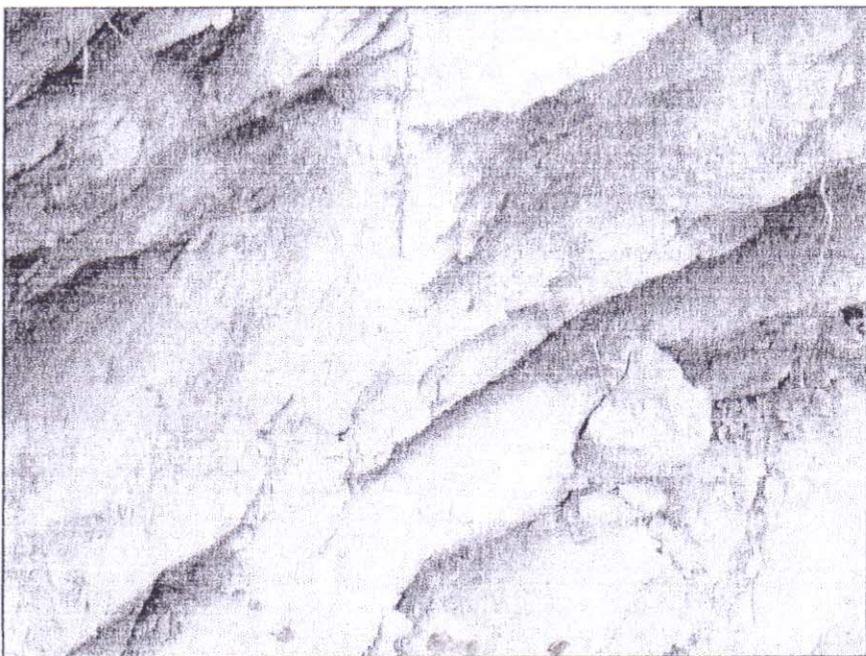
Topography of the area overall is gentle to moderately steep. Area is mostly barren. Rock type observed on the site is Micaceous Quartzite and Schist which belongs to Saryu Formation. The quartzite is moderately hard and compact in strength while the schist is weak in strength. The strength of the rock is estimated by manual test. Some manmade terraces were also observed near to the villages which are mostly cultivated.

Figure 3 Phyllitic Schist outcrop exposed at the site

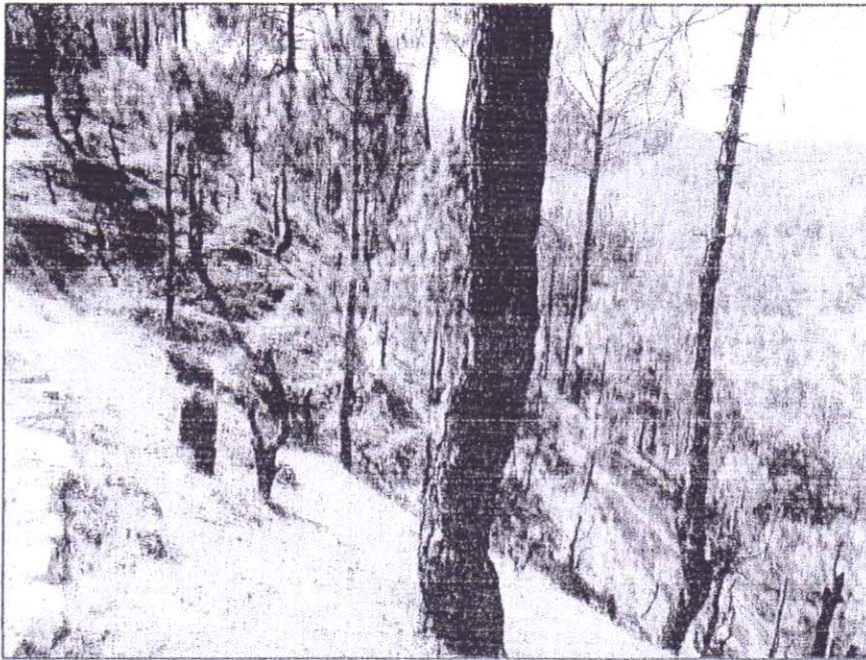
Figure 4 General topography of the area
