कार्यालय अधिशासी अभियन्ता
निर्माण खण्ड, लो०नि०वि०, कपकोट

जनपद बागेश्वर के अन्तर्गत बालीघाट-धरमघर-खन्तोली पुल से गुरगुच्चा प्रा०पा० स्कूल तक मोटर मार्ग के निर्माण हेतु 0.63 है० वनभूमि के प्रत्यावर्तन के सम्बन्ध में। (FP/UK/ROAD /12710/2015)

**Geological Site Assessment of 3.0 Km long Khitoli Bridge to Gurkucha
Motor Road Alignment Corridor between CH 0.0-3.0 Km,
Kapkot Block, District Bageshwar (Kumaon)**

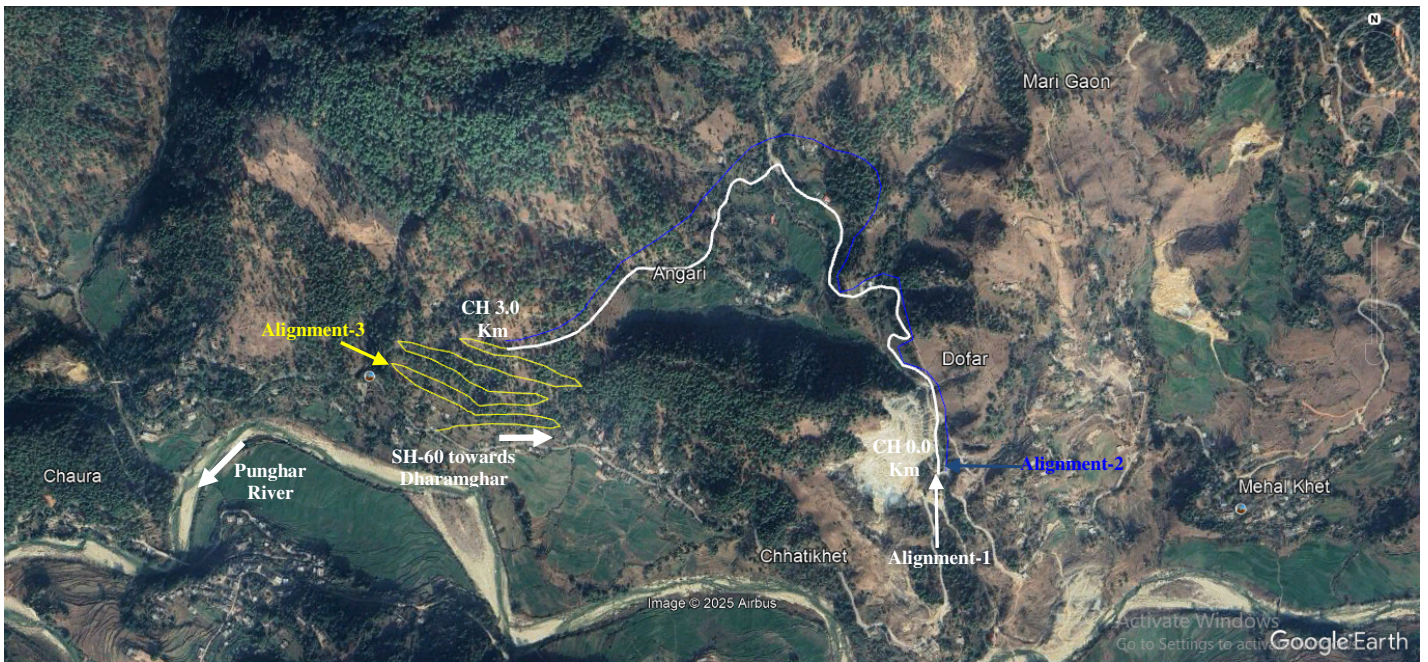
1- Introduction: The Construction Division, PWD Kapkot, has undertaken survey and construction of Khitoli Bridge to Gurkucha motor road. Three different preliminary alignment surveys were carried out for 3 different possible options. Alignment-1 (shown in white) is 3.0 Km, Alignment-2 (shown in blue) is also 3.0 Km and Alignment-3 (shown in yellow) which is 2.0 Km long. Alignment-1 was found geologically suitable by Mr. Vijay Dangwal (Ex. Senior Geologist PWD) and Dr. Tushar Sharma (Geologist, PWD Almora Zone) for which reports was submitted to the division (Letter No.: SG-112/Road Alignment/Kumaon; Dated: 07/02/2013) & (Letter No.: G(AZ)-55/2025; Dated: 20/11/2025) respectively. In order to assess the geological feasibility of all three alignment surveys for selecting the best site, Er. Amit Kumar Patel (Executive Engineer) Construction Division, PWD, Kapkot asked for undersigned to make a site visit for which a visit to the proposed road alignment site was made on 18/05/2026; Er. Deepak Upreti (Junior Engineer) CD PWD, Kapkot was present during the site visit.

Closer Satellite view of the site
