- Sub: (i) Diversion of 4.2 ha of forest land (PH & Barrage Quarry of 0.5 ha and Muck Access Road of 3.7 ha) in respect of Heo Hydro Electric Project (240 MW) being developed by M/s Heo Hydro Power Pvt. Ltd in West Siang District of Arunachal Pradesh.

**REPORT OF THE SITE VISIT OF TATO-I HEP, HEO HEP AND PAUK HEP CARRIED OUT BY
REGIONAL OFFICE SHILLONG .**

The user agency, Velcan Energy, is developing following three Hydro-Electric projects in cascade on River Yarjep in Shi Yomi District (Previously West Siang District), of Arunachal Pradesh. These projects are:

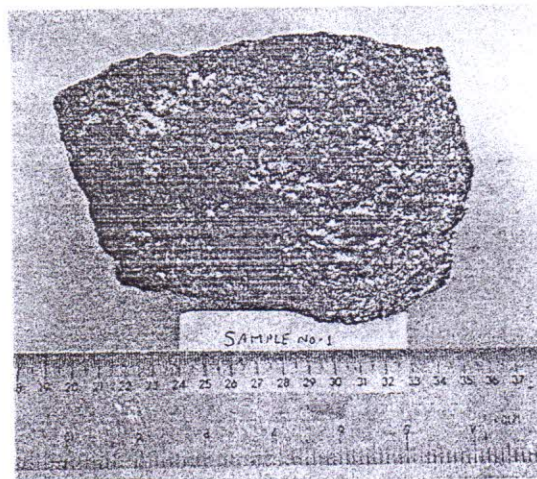
Fig.-1: Rock sample-1

It is a greenish to greyish white rock which is medium to coarse grain having low to medium specific gravity. The rock gives profuse effervesces with dilute hydrochloric acid. The chief mineral which is identified in the hand specimen is calcite. The rock is slightly weathered and has thin encrustation of ferruginous material (Fig-1).

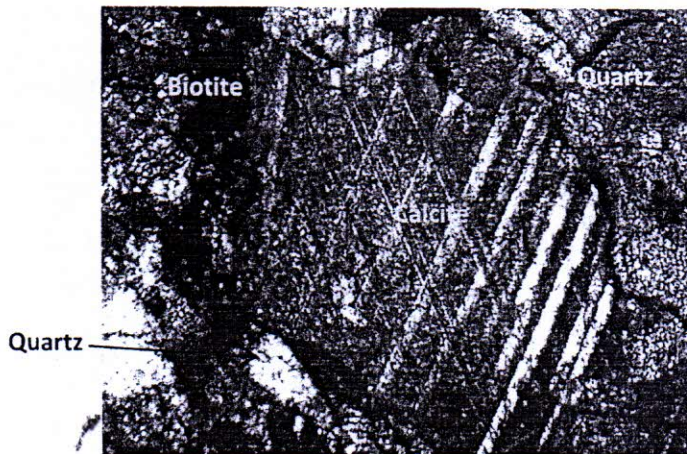
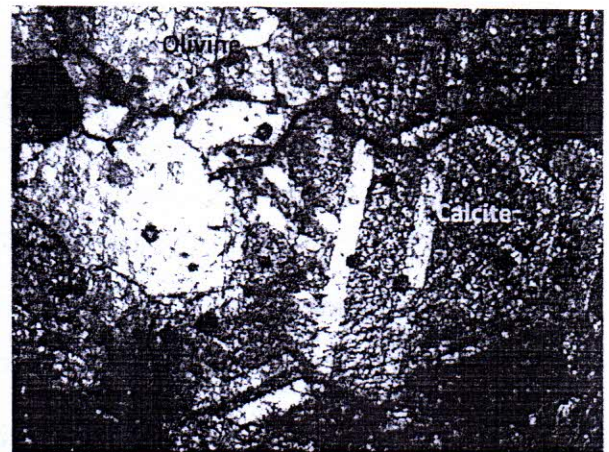
It consists of calcite, quartz, biotite/chlorite, olivine and magnetite. It is a coarse grain rock which is characterized by granoblastic texture. Calcite is identifiable due to polysynthetic twinning. Quartz grains are present as scattered grains throughout the rock and they have sharp boundaries with calcite. Biotite grains are profusely altered. Olivine is identifiable due to its high relief. Magnetite is present as irregular grains that occupy the weathered portion in biotite (Fig-2 & 3).

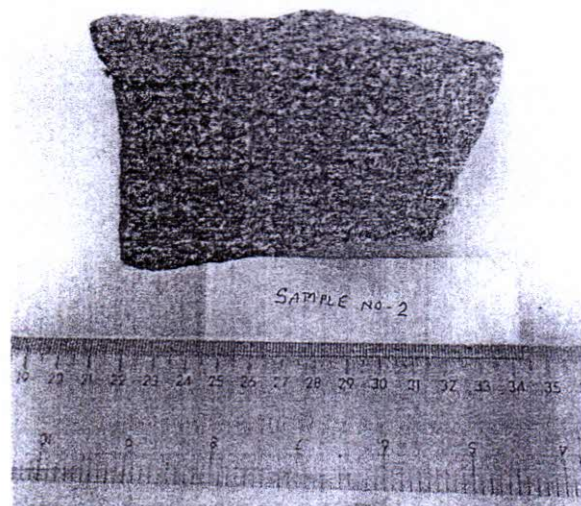
Fig.-4: Rock sample-2

It is a grayish white, medium to coarse grain rock having medium specific gravity. It gives profuse effervesces with dilute hydrochloric acid. Calcite is the main mineral which could be identified in the hand specimen. The rock is slightly weathered in the upper surface and has thin encrustation of ferruginous material (Fig-4).

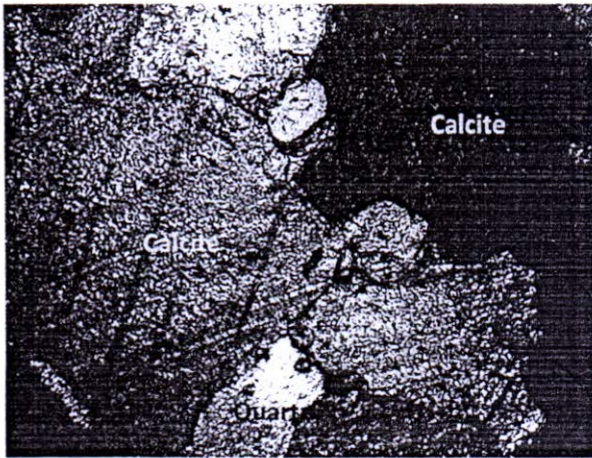
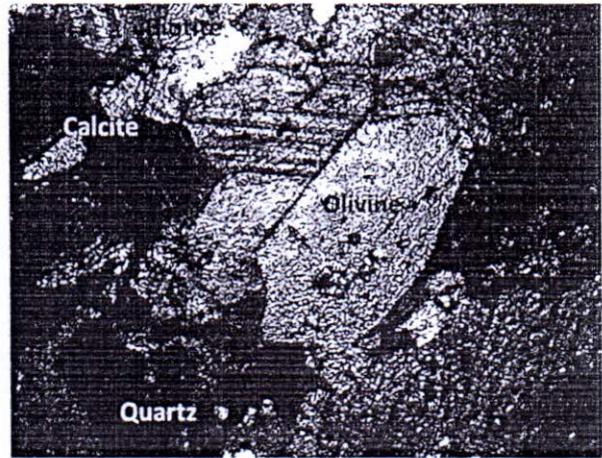
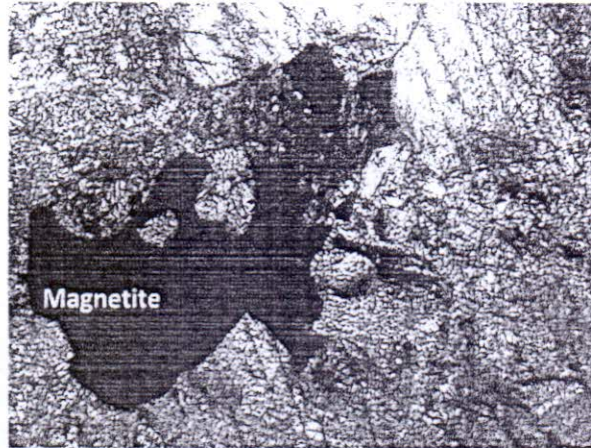
The given rock consists of calcite, quartz, biotite/muscovite, olivine and magnetite. It is a coarse grain rock and exhibit granoblastic texture. Calcite is the predominant mineral and identifiable due to polysynthetic twinning. Quartz grains are present as scattered grains throughout the rock. Mica (both biotite and muscovite) present in the form of flakes. At places biotite grains are altered to chlorite. Olivine is identifiable due to its high relief. Magnetite present as scattered grains throughout the rock (Fig-5 to 7).

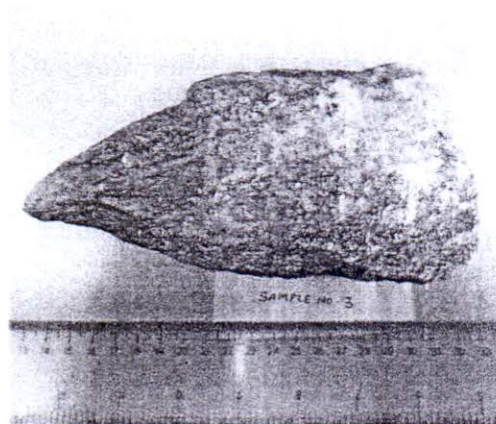
Fig.-8: Rock sample-3

It is a greyish white, medium to coarse grain rock. The rock shows saccaroidal texture. It gives profuse effervesces with dilute hydrochloric acid. Identifiable mineral in the hand specimen is calcite (Fig-8). The rock is slightly weathered in the upper surface. The rock is hard and compact and has medium specific gravity.

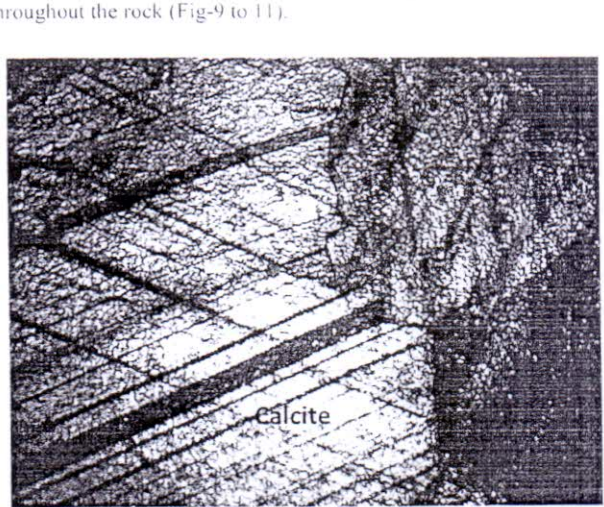
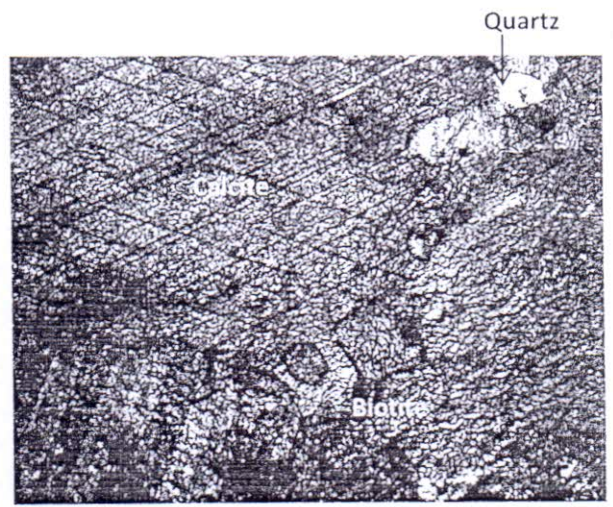
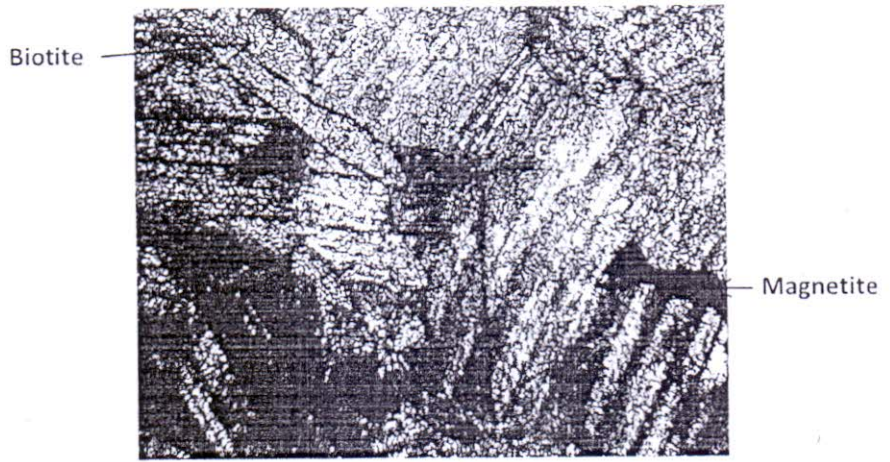
It mainly consists of calcite with minor amounts of quartz, biotite/muscovite and magnetite/iron oxide. It is a coarse grain rock which is characterized by granoblastic texture. Calcite is identifiable due to polysynthetic twinning. Quartz grains are present as scattered grains. Biotite and muscovite present as flakes throughout the rock. At places biotite is altered to chlorite. Magnetite present as irregular grains throughout the rock (Fig-9 to 11).

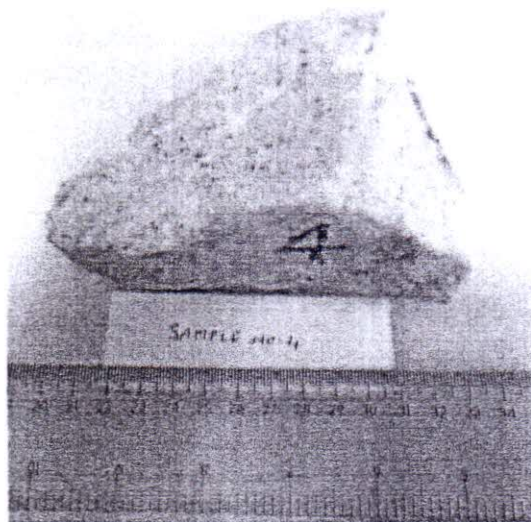
Fig.-: 12 Rock sample-4

It is a yellowish white, medium to coarse grain, iron stained rock. It gives effervesces with dilute hydrochloric acid. The rock shows saccharoidal texture (Fig-12). The chief mineral which is identified in the hand specimen is calcite. The rock also have subordinate amount of ferruginous minerals. It is hard and compact and has medium specific gravity

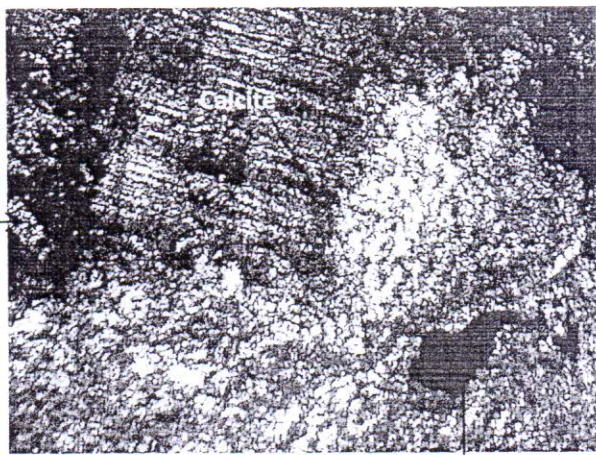
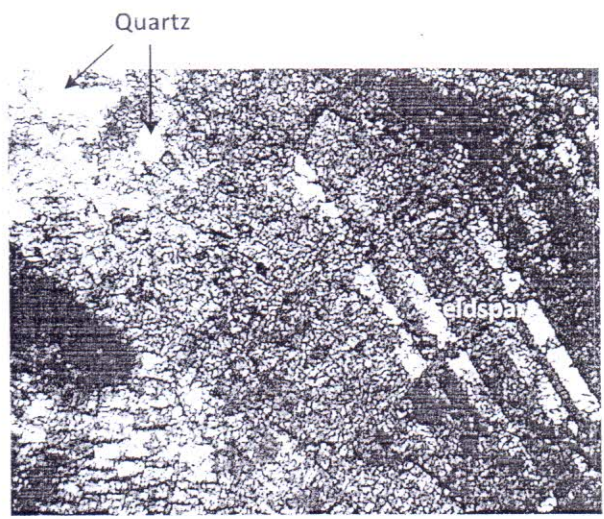
It consists of calcite, quartz, muscovite/biotite, feldspar, chlorite and magnetite/iron oxide. It is fine to medium grained rock where individual grains are identifiable. Most of the quartz grains are present as replacing partially or completely calcite grains. The rock is weathered and flakes of muscovite occupy as clusters at different places of thin section. Some of the grains of calcite are pseudomorphic which have retained the structure of calcite but have been replaced volume by volume by quartz/ feldspar (Fig-13 & 14).

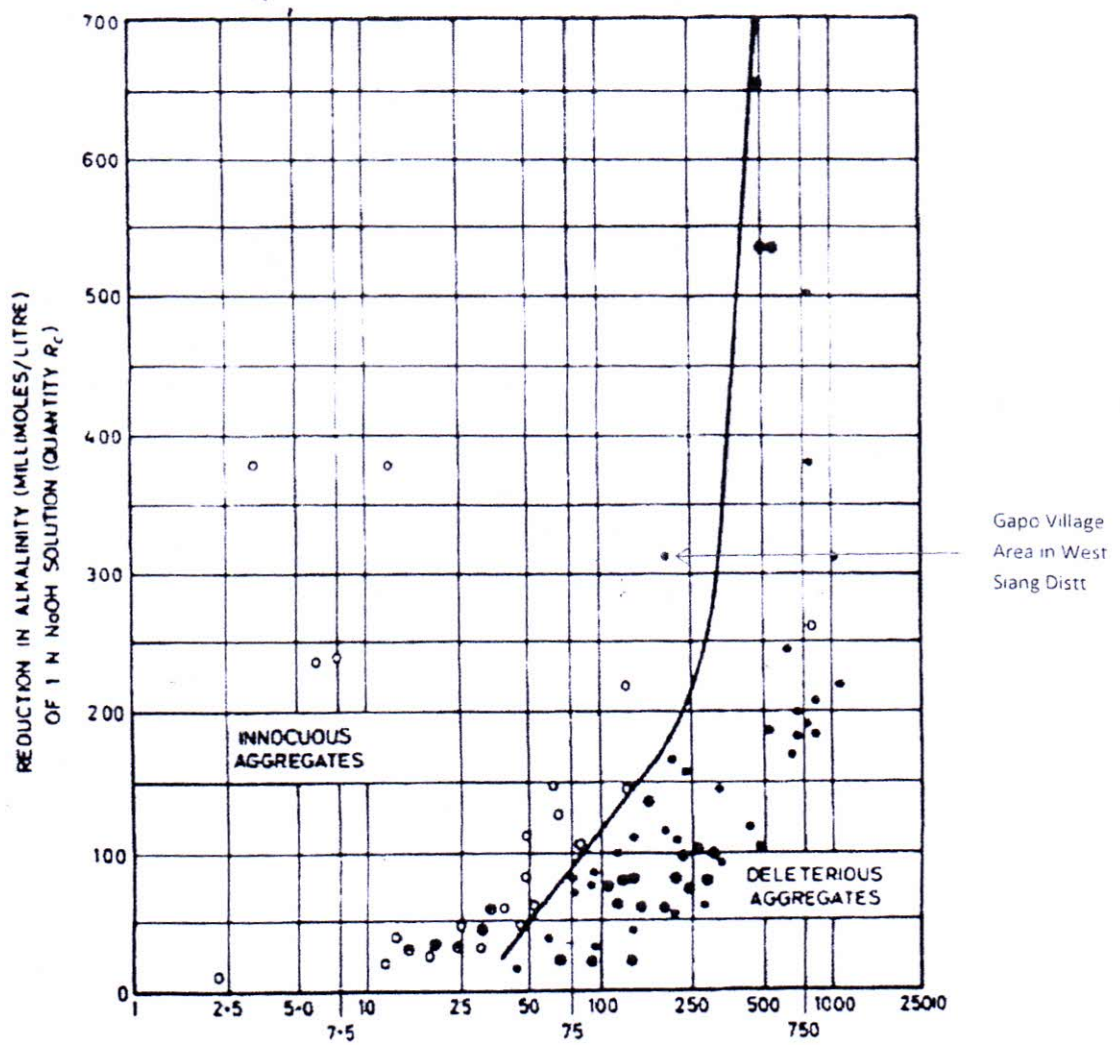
- Aggregates causing mortar expansion more than 0.1 percent in a year when used with a cement containing 1.38 percent alkalis.
- Aggregates causing mortar expansion less than 0.1 percent in a year under same conditions.
- ⊗ Aggregates for which mortar expansions data are not available but which are indicated to be deleterious by petrographic examination.
- ⊙ Aggregates for which mortar expansions data are not available but which are indicated to be innocuous by petrographic examination.
- Boundary line between innocuous and deleterious aggregates.

FIG. 6 ILLUSTRATION OF DIVISION BETWEEN INNOCUOUS AND DELETERIOUS AGGREGATES ON BASIS OF REDUCTION IN ALKALINITY TEST

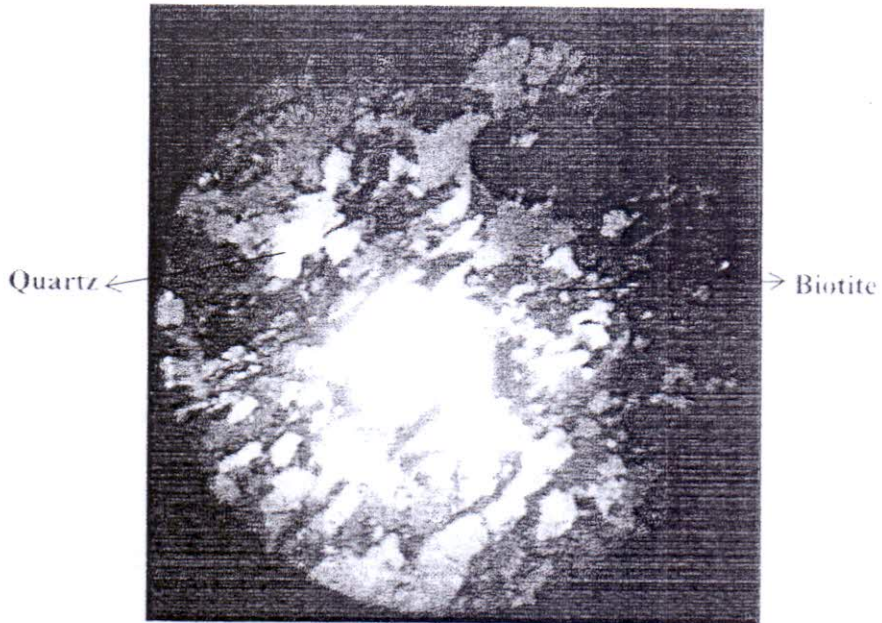
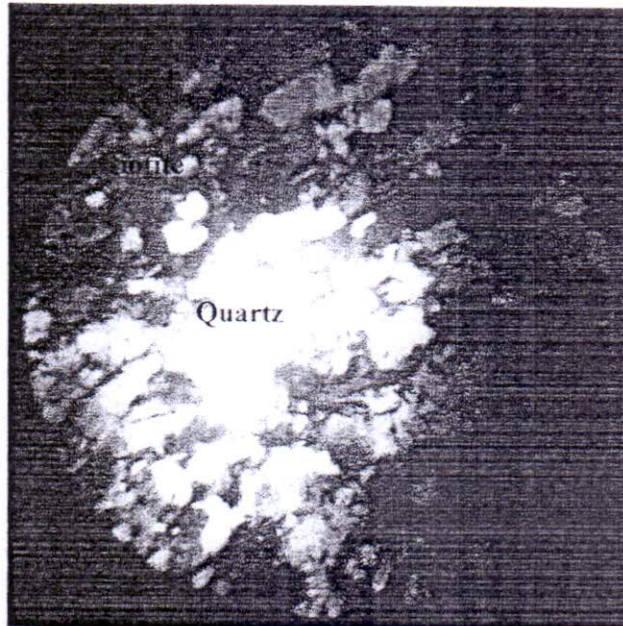
It consists of quartz grains which range in size from medium to coarse, flakes of biotite. Most of the grains of quartz are sutured. Feldspar grains are identifiable due to their cleavage and twinning. At places flakes of biotite are in preferred orientation which defines the foliation of the rock. The rock is deformed and at places strained lamellae in quartz have been observed. At places there are minute grains of quartz around coarse grains of quartz. At places flakes of biotite are present around the boundary of the quartz grain.

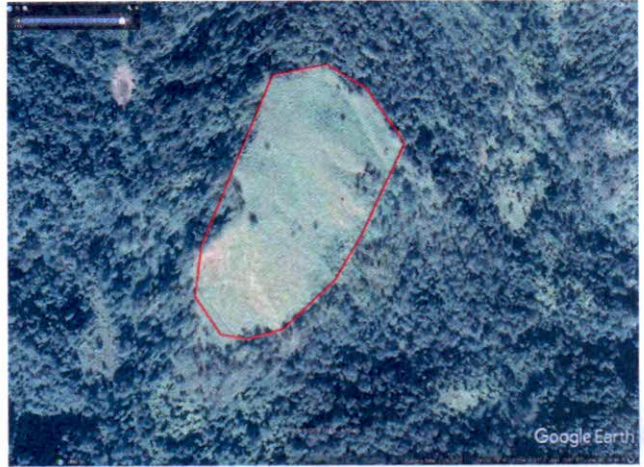
Proposed CA site of 8.40 ha

As per the observation of DSS, the proposed CA site includes 4.16 ha of Moderately Dense Forest and the remaining part is under Open Forest. However, the CA site proposed on the top of hill may be considered as degraded land as seen on Google earth satellite imagery dated 06.12.2017.

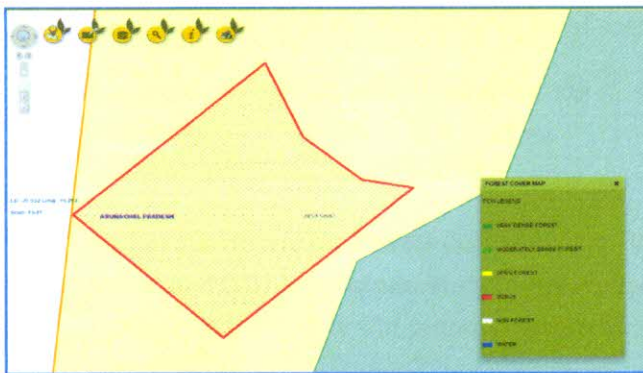
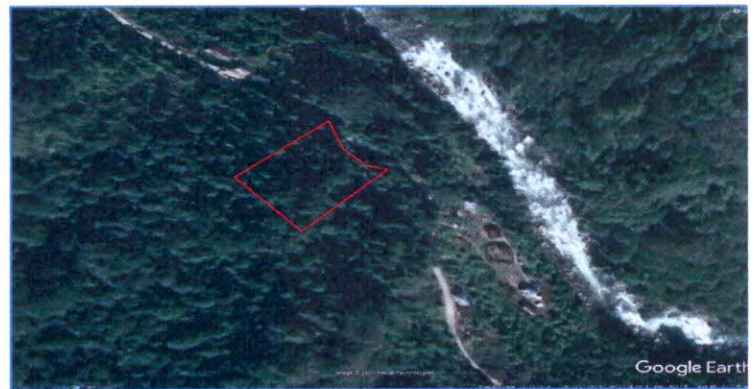
Tato-I PH Quarry (0.5 ha)

The aggregate score of the grid is found to be above 70. Therefore, per DSS rule No.-2, the proposed area has been labelled as Inviolate.

The Forest Cover Map in DSS shows that the entire proposed quarry site falls under Open Forest. Based on visual interpretation of Google Earth satellite imagery dated 23.11.2018, the area proposed on the extreme slope surface (30 degree gradient) is covered with tall trees.

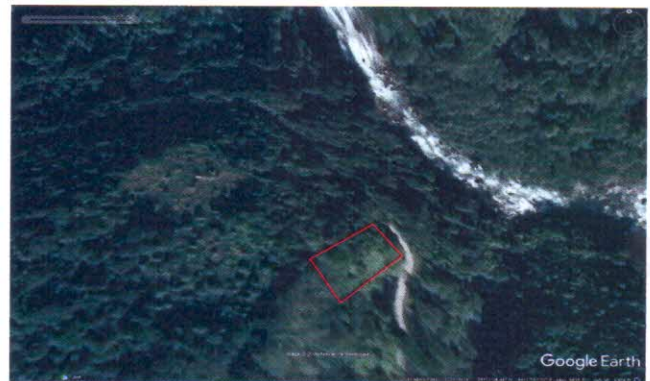
The aggregate score of four parameters of a grid is found to be above 70. Therefore, this proposed quarry site has been considered as Inviolable in accordance with DSS rule No.-2.

As per Forest Cover Map , the entire quarry site falls under Moderately Dense Forest.

Based on visual interpretation of Google Earth satellite imagery dated 23.11.2018, the quarry site proposed on the extreme slope surface (30 degree gradient) is covered with vegetation.

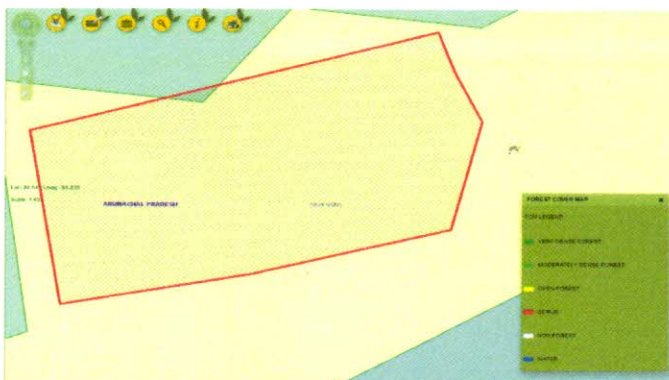
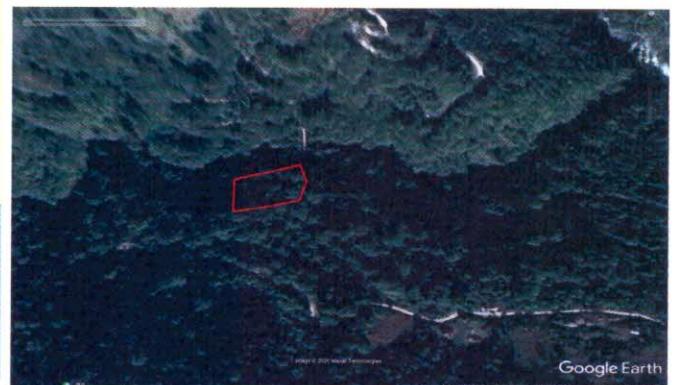
Heo Barrage Quarry from Pauk HEP (0.5 ha)

Based on four parameters (FCM, FTM, BR, LI) of DSS rule No.-2, the proposed quarry site has been considered as Inviolable. The score values are mentioned below.

The Forest Cover Map of DSS shows that the entire quarry site falls under Open Forest. However, as per the observation of Google Earth satellite imagery dated 23.11.2018, the quarry site is proposed on the forested slope.

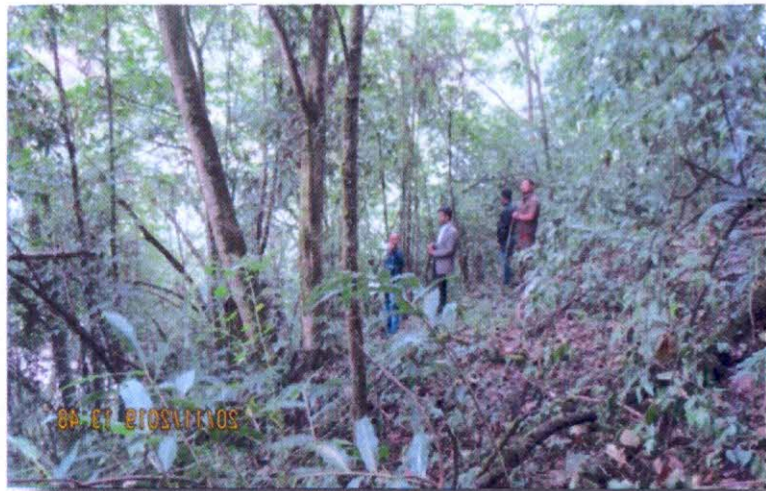
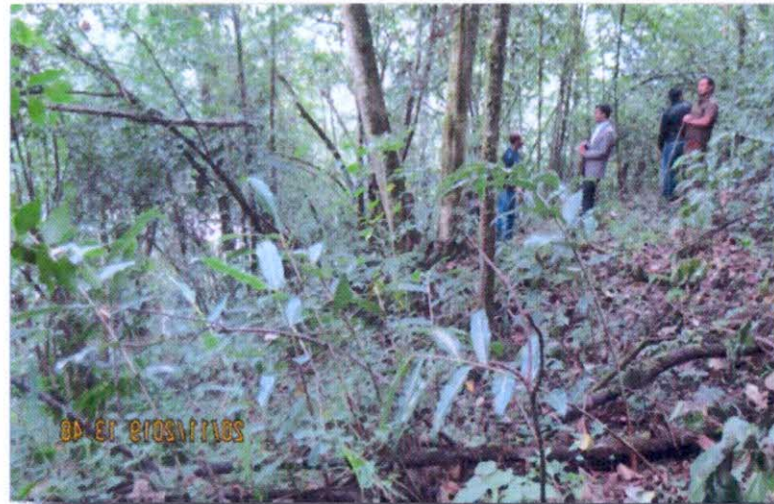
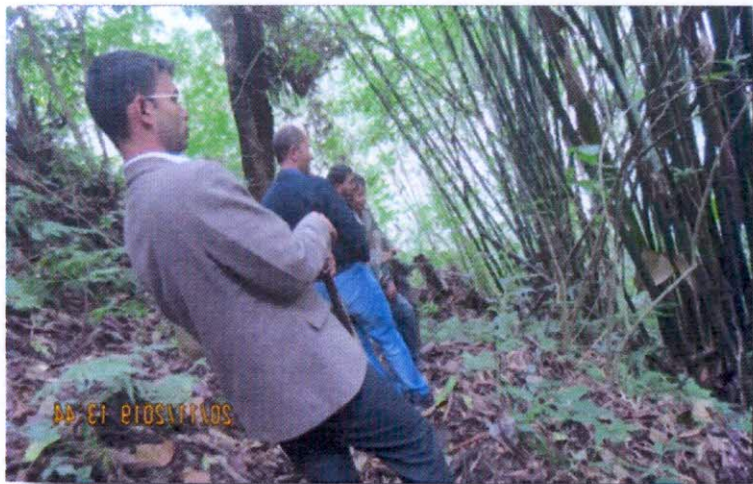
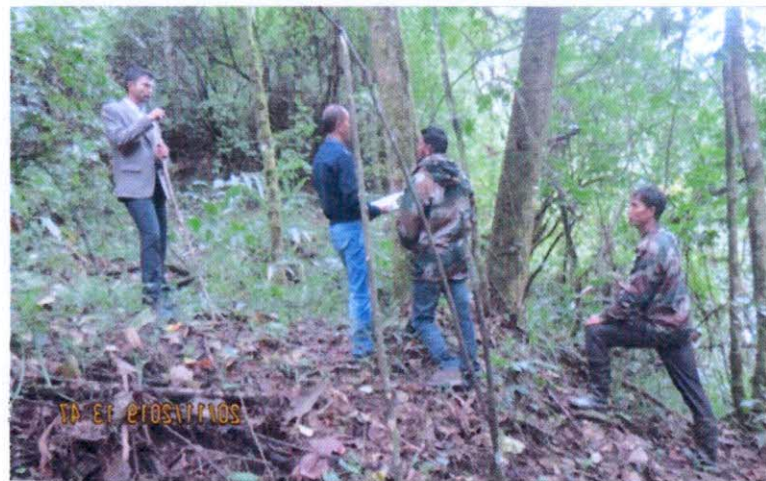
Photographs showing the muck Dumping site (2.0ha) proposed for Heo HEP in Hiri Village.

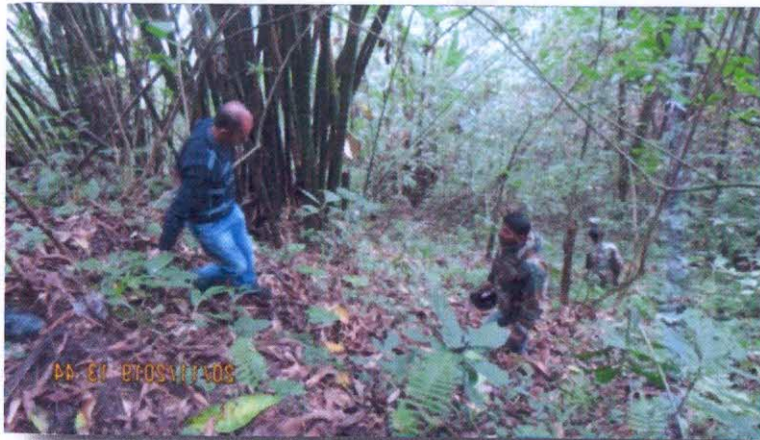
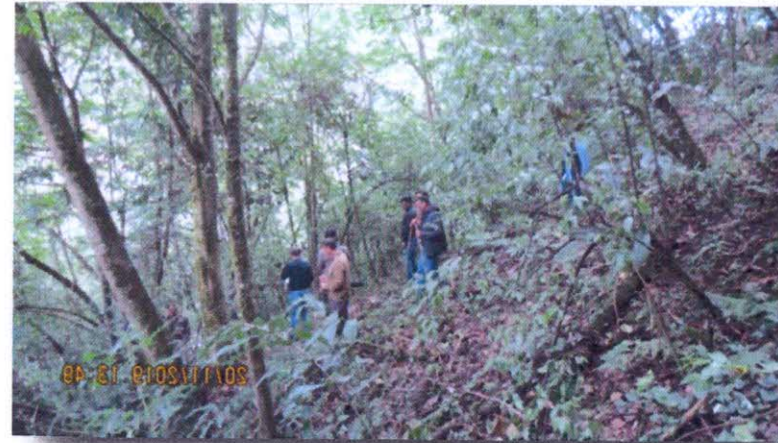
Photographs showing the muck access road (3.7 ha) in Hiri Village for the proposed HeoHEP shifted/deleted from Pauk Hydro Power Project.

The polygon for the change of 3.7 ha from Pauk HEP to Heo HEP being access road to Muck DA has been submitted and the GPS location of the starting and ending point of the road are given as per map at Annexure- E and table given at Annexure-D

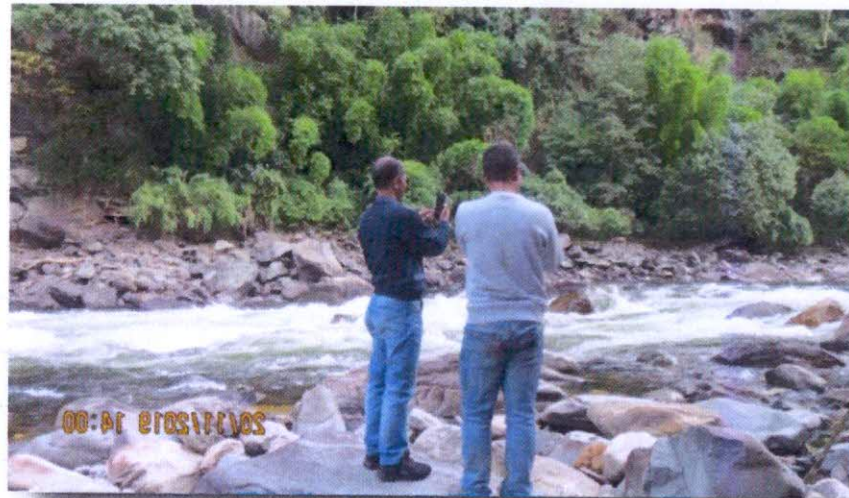
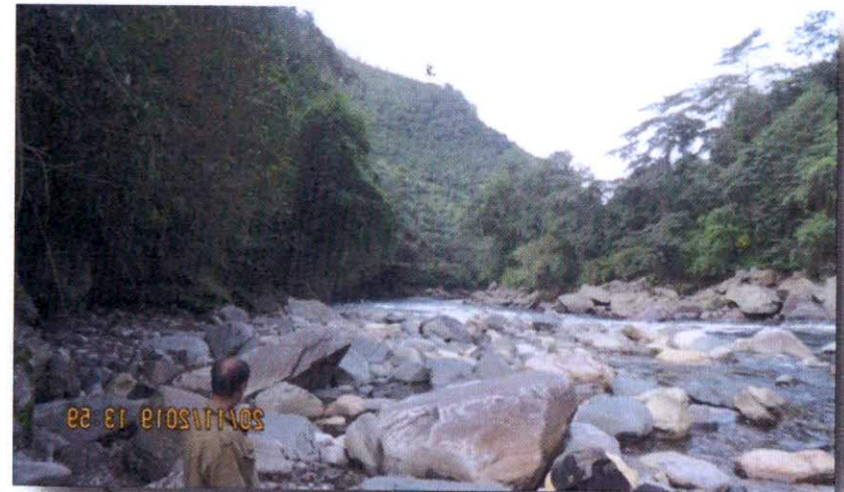
Photographs of river Yargap ('Shi'-local name) below the Muck Dumping site 2.0ha) and Muck Access road (3.7 ha) in Hiri Village for the proposed Heo HEP.

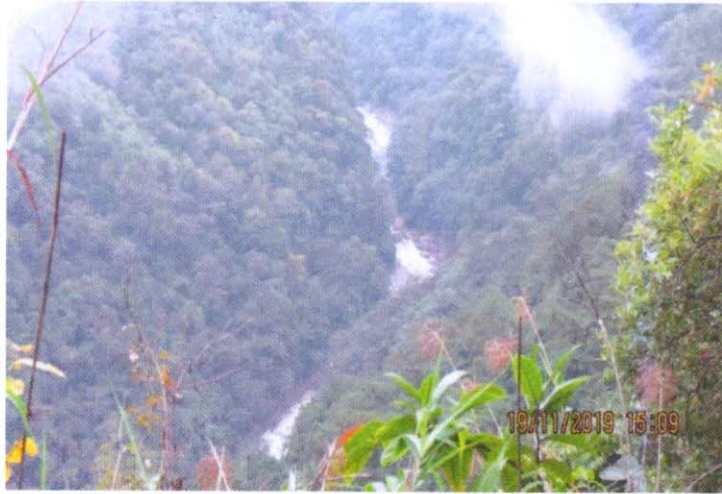
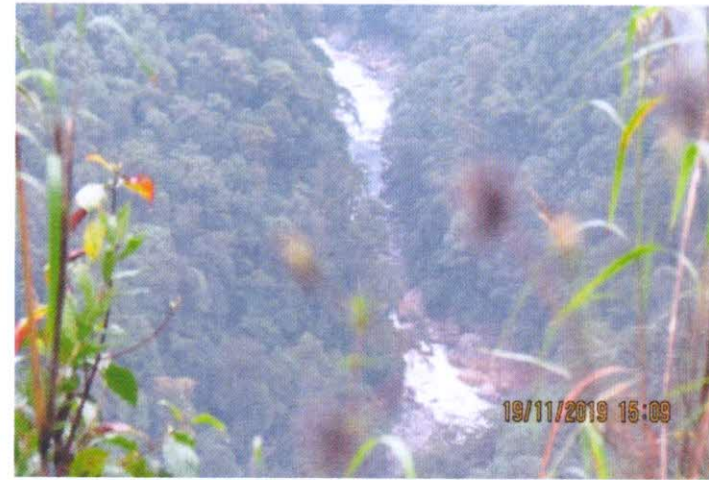
Location of earlier proposed quarry site in Heyo village for Tato-I HEP.

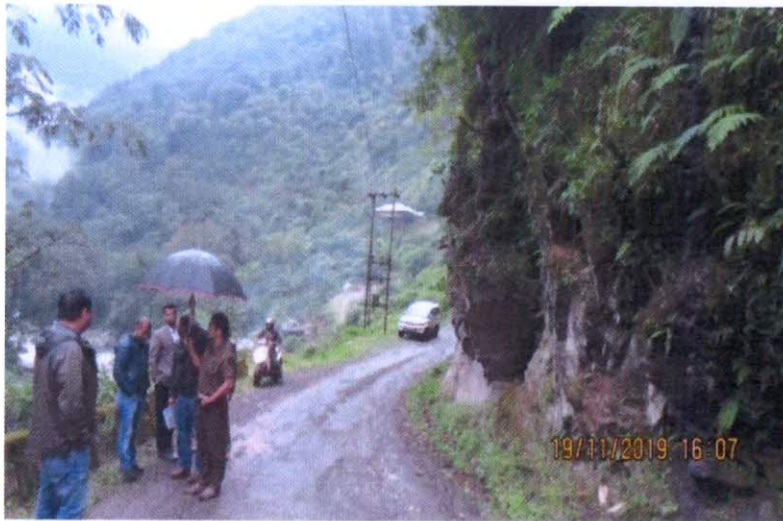
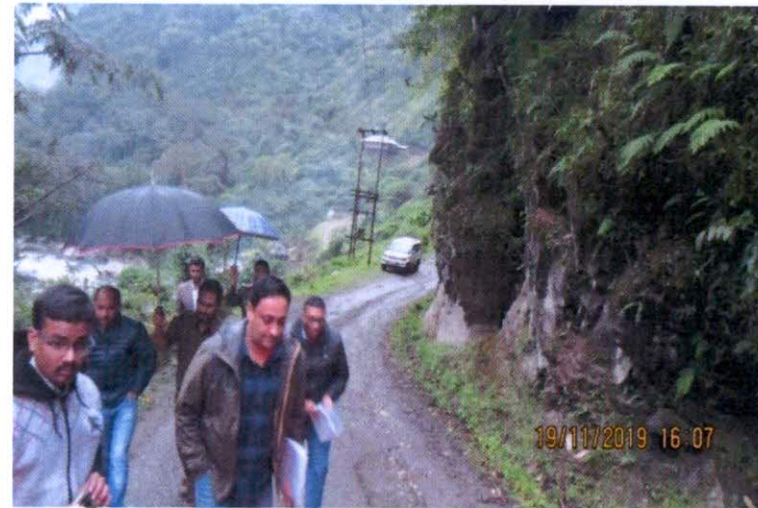
Location of Quarry site(0.5ha) in Padusa village for Tato-I HEP shifted from earlier proposed quarry site in Heyo village.

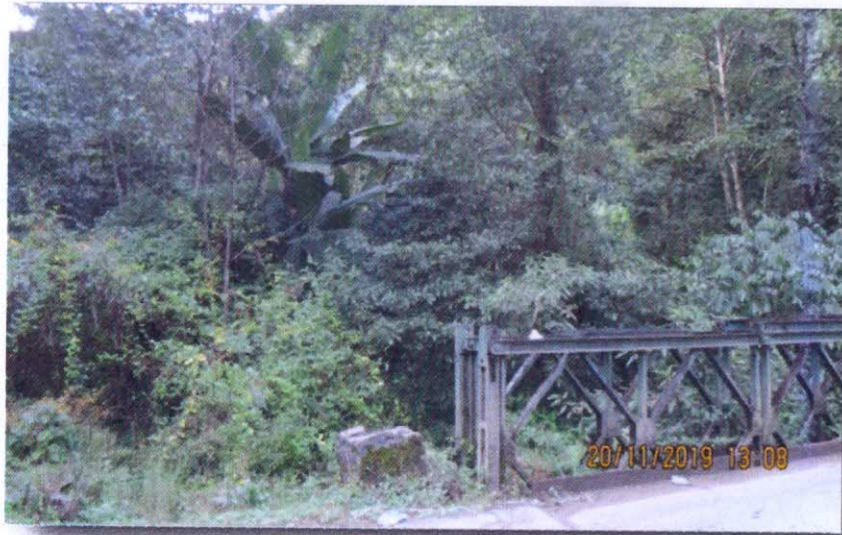
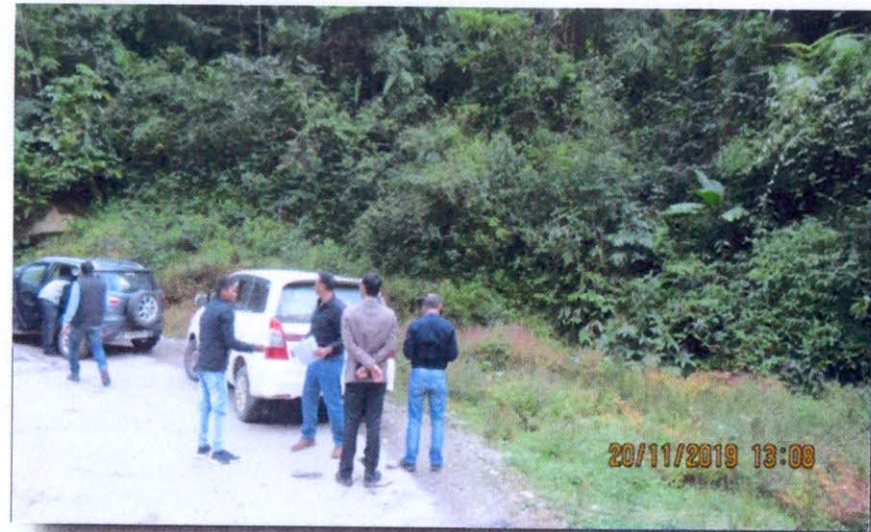
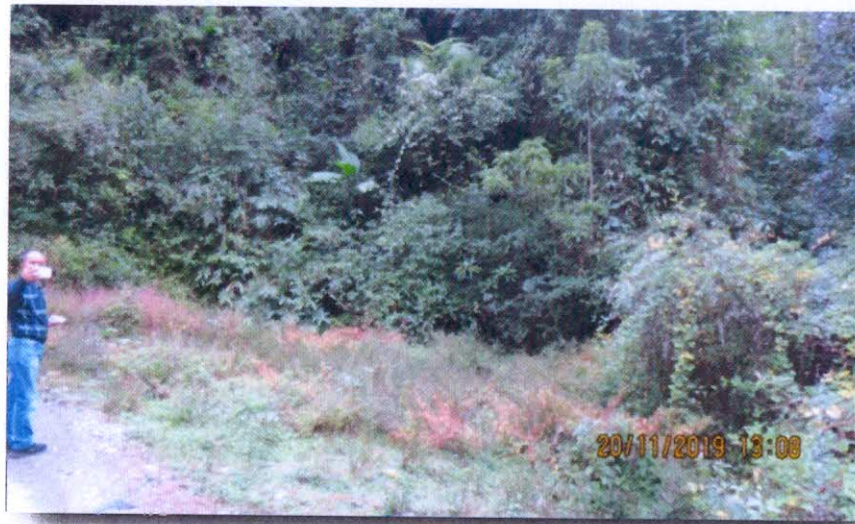
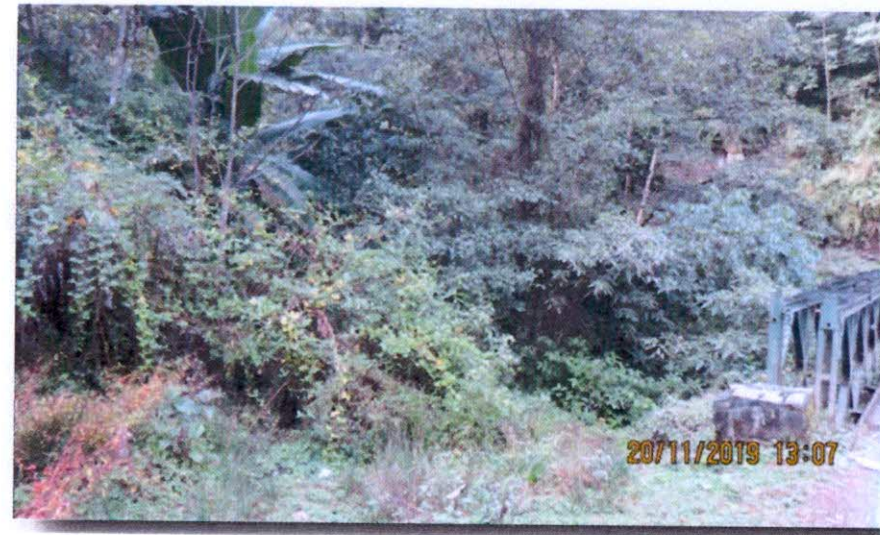
Proposed location of quarry site(0.5ha) near to Saechu Nahla shifted from Pauk HEP and added to Heo HEP.

The Proposed quarry of 1.0 ha under Pauk HEP of which 0.5 ha is to be re-appropriated to Heo HEP is at location Chengrong Village and the GPS location and reading is verified from the shape file submitted and as per map at Annexure- C and table given at Annexure-D.
