Sub :- Valanthode Small Hydro Electric Project – Conducting  
a scientific Evaluation - Reg

Sub: -Valanthode SHE Project (7.50 MW) – Proposal for the diversion of 0.9354 Ha of  
Forest land- Reply to the EDS raised by REC- Report submitting -reg.

Fig.1. Valanthode SHEP: Schematic representation

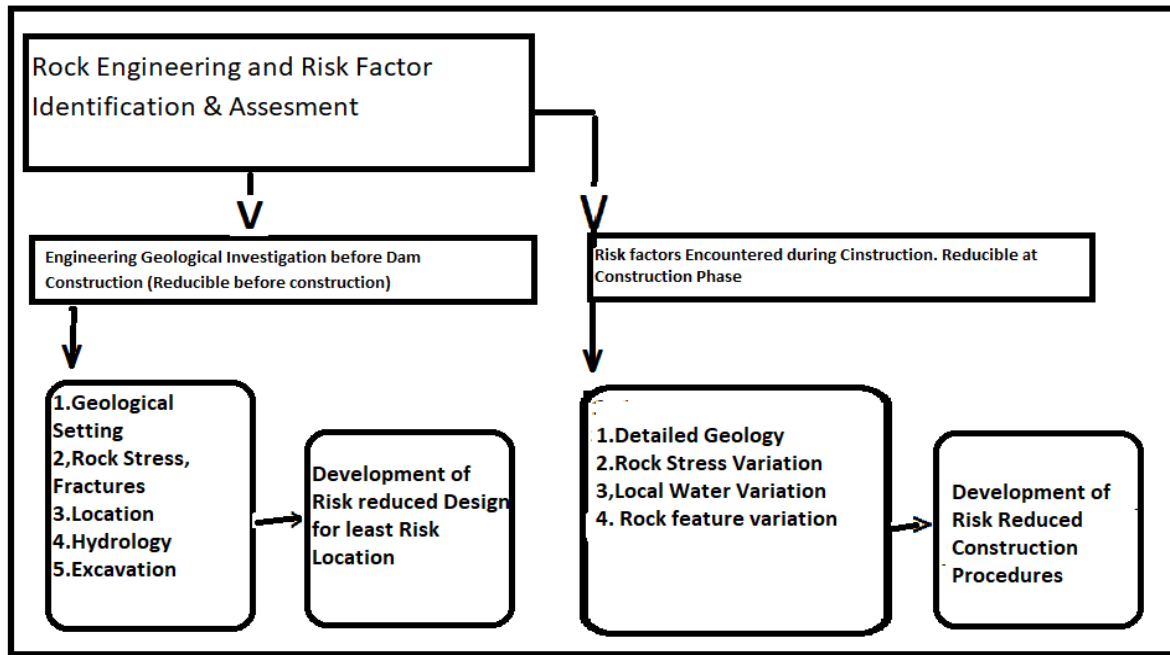
**Fig. 7. Valanthode SHEP: Flow chart of information on Risk factors at different stages of Study and Construction**

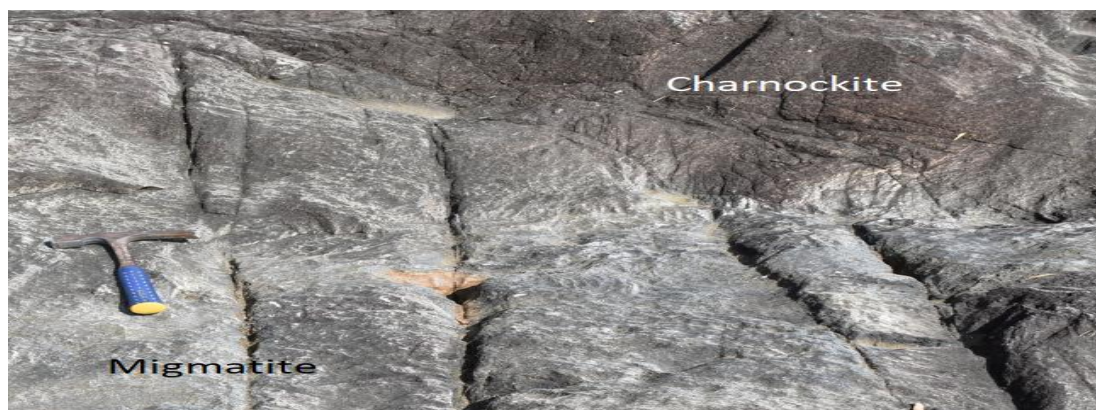
**Fig. 11. Valanthode SHEP: Charnockite getting Migmatised**

The subsurface investigation identified various rock types namely, charnockite, hornblende biotite gneiss, granite gneiss and pyroxene granulite. The rock type exposed at the western end of the weir site is charnockite, within granite gneiss, classified as migmatite with ptymatic fold patterns (Fig. 11 to 15). The general gneissosity / foliation is trending N 40° E - S 40°W with a steep dip towards the northeast.

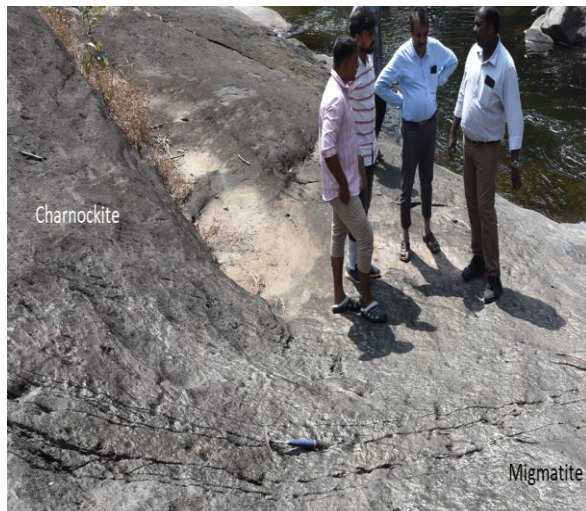
**Fig. 12. Valanthode SHEP: Jointed contact between Charnockite and Migmatite**

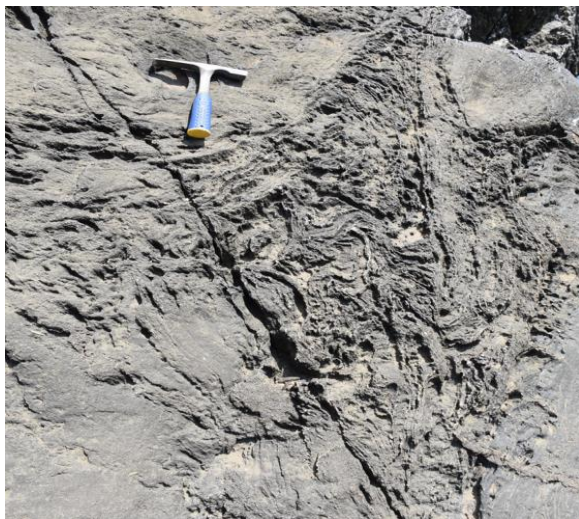
**Fig. 14. Valanthode SHEP: Ptygmatic folds**

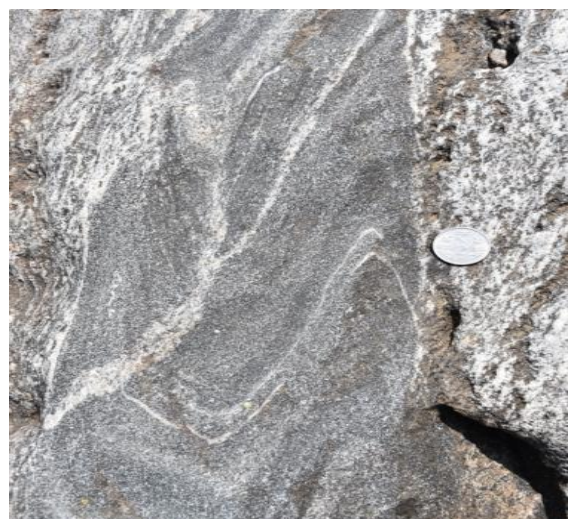
**Fig. 15. Valanthode SHEP: Ptygmatic folds seen in the migmatited gneiss in the eastern section of weir axis.**

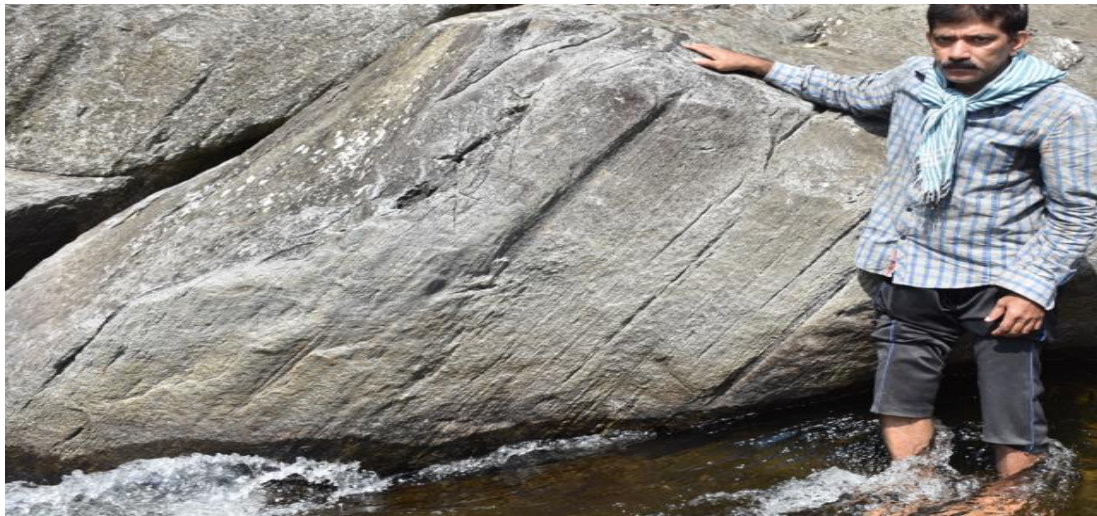
**Fig. 16. Valanthode SHEP: Joint planes exposed in Riverbed at the weir axis.**

- a. **Joint planes:** Joint planes are exposed in crystalline rocks of the area. They are oriented is different directions and are spaced in different locations. One good thing noticed is that there are no gap between the joint planes that allow filtration of water. Since water does not fill them, the stress is not transmitted through. The joint planes do not show any sign of shearing or weathering (Fig. 16).

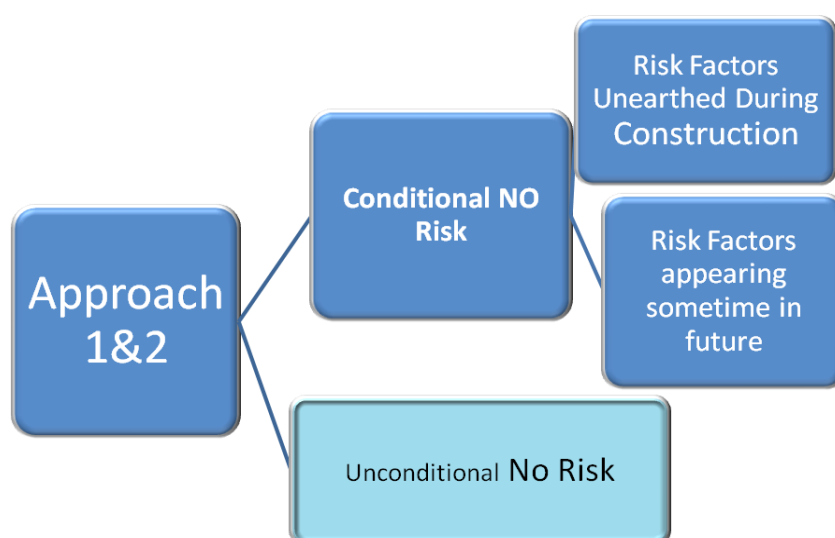
**Fig. 30. Valanthode SHEP: Classification of Risk factors**
