**GOVERNMENT OF MIZOARAM**  
**OFFICE OF THE DIVISIONAL FOREST OFFICER**  
**THENZAWL FOREST DIVISION: THENZAWL**

***Subj: Proposal for diversion of 2.43278Ha of forest land for construction of Bypass at Chhiahtlang and Serchhip (Package -I) on Aizawl-Tuipang section of NH-54 in the State of Mizoram, Engineering , Procurement and Construction (EPC) mode with JICA loan assistance- reg***

PHOTOS SHOWING VIOLATION OF MUCK DISPOSAL PLAN BY NHIDCL IN NH-54 ROAD (PACKAGE-2)

**INSPECTION REPORT OF DISTRICT LEVEL MONITORING COMMITTEE ON IMPLEMENTATION OF JICA of NH 54 WITHIN SERCHHIP DISTRICT (FROM KEITUM VILLAGE TO BUNGLTANG VILLAGE & BYPASS ROAD AT CHHIAHTLANG VILLAGE)**

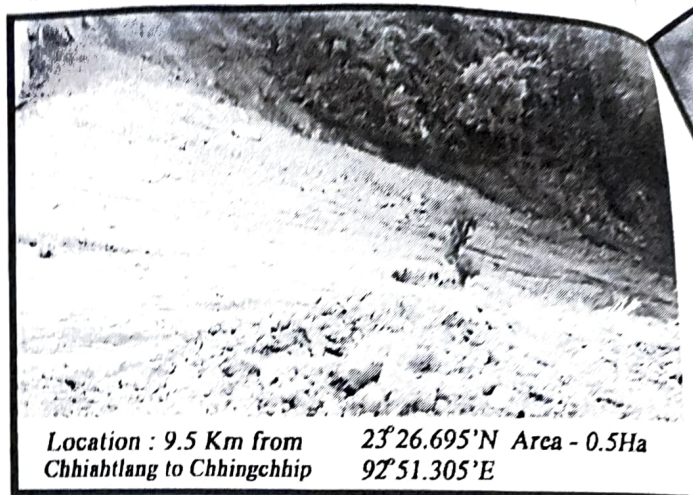
Location-2:

| Sl. No. | Specific locations | GPS Locations | Approx. damaged area (in Ha) |
|---|---|---|---|
| 2 | 9.5 Km from Chhiahtlang towards Chhingchhip | 23° 26' 41.7" N<br>92° 51' 18.3" E | 0.5 |

***Therefore, you are hereby informed to immediately stop all the construction activities of NH-54 Road project (package -2 and Chhiahtlang & Serchhip Bypass) within Thenzawl Forest Division (Serchhip & Hnahthial Districts) unless and until Stage -I approval (IPA) is obtained from MoEFCC, Govt of India to avoid further course legal action.***

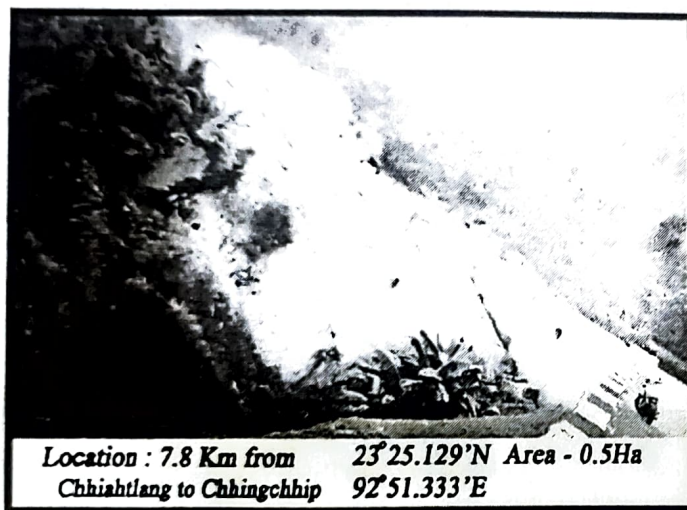
Location-3:

| Sl. No. | Specific locations | GPS Locations | Approx. damaged area (in Ha) |
|---|---|---|---|
| 3 | 7.8 Km from Chhiahtlang towards Chhingchhip | 23° 25' 7.74" N<br>92° 51' 19.98 E | 0.5 |

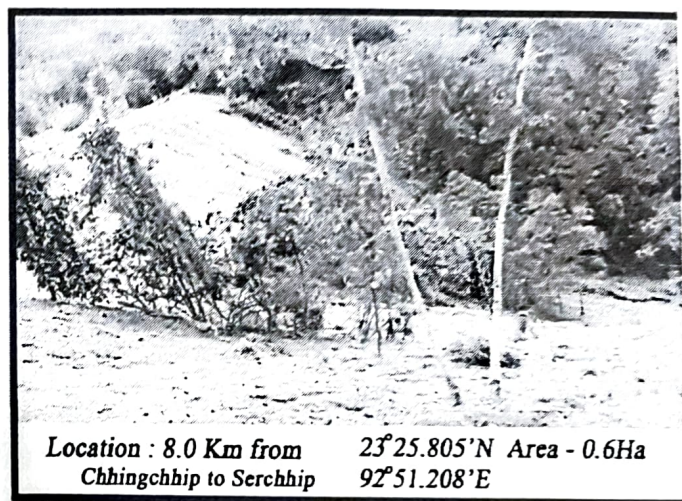
Location-4:

| Sl. No. | Specific locations | GPS Locations | Approx. damaged area (in Ha) |
|---|---|---|---|
| 4 | 8.0 Km from Chhiahtlang towards Serchhip | 23° 25' 48.3" N<br>92° 51' 12.48" E | 0.6 |

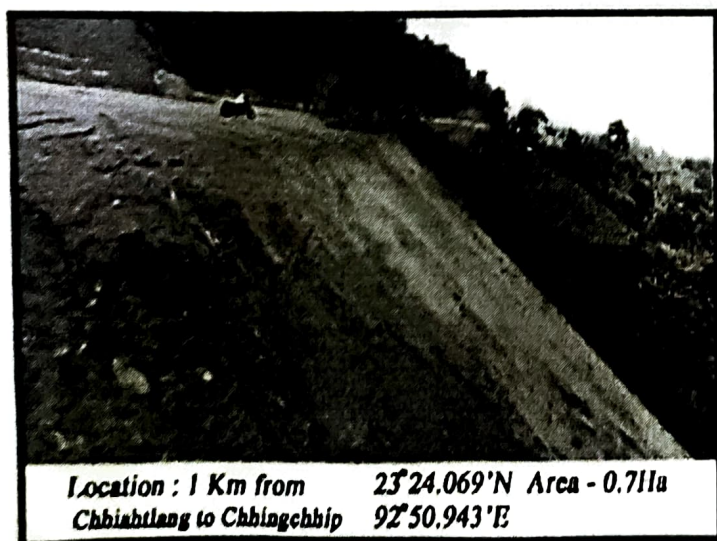
Location-5:

| Sl. No. | Specific locations | GPS Locations | Approx. damaged area (in Ha) |
|---|---|---|---|
| 5 | 1.0 Km from Chhiahtlang towards Chhingchhip | 23° 24' 4.74" N<br>92° 50' 56.4" E | 0.7 |

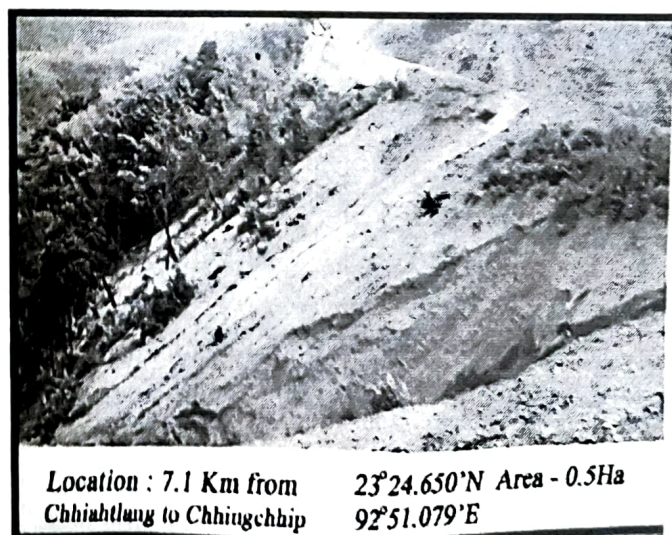
Location-6:

| Sl. No. | Specific locations | GPS Locations | Approx. damaged area (in Ha) |
|---|---|---|---|
| 6 | 7.1 Km from Chhiahtlang towards Chhingchhip | 23° 24' 39" N<br>92° 51' 4.74" E | 0.5 |

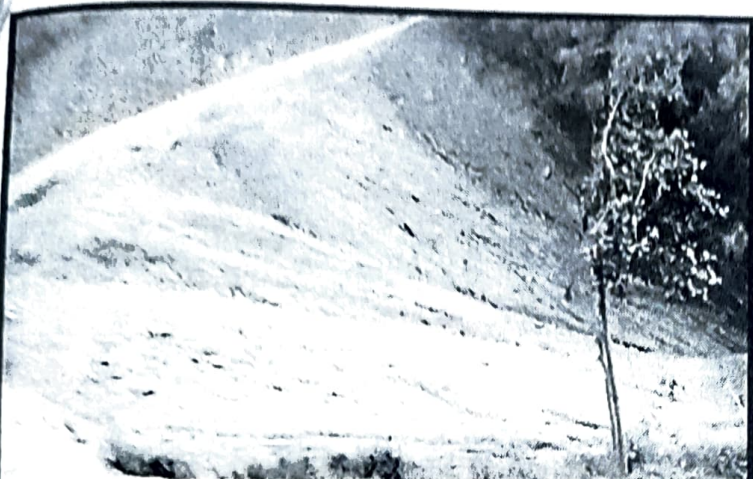
Location-7:

| Sl. No. | Specific locations | GPS Locations | Approx. damaged area (in Ha) |
|---|---|---|---|
| 7 | 7.8 Km from Chhiahtlang towards Chhingchhip | 23° 25' 2.52" N<br>92° 51' 15.24" E | 0.5 |

Location : 7.8 Km from  $23^{\circ}25.042'N$  Area - 0.5Ha  
Chhiahtlang to Chhingchhip  $92^{\circ}51.254'E$

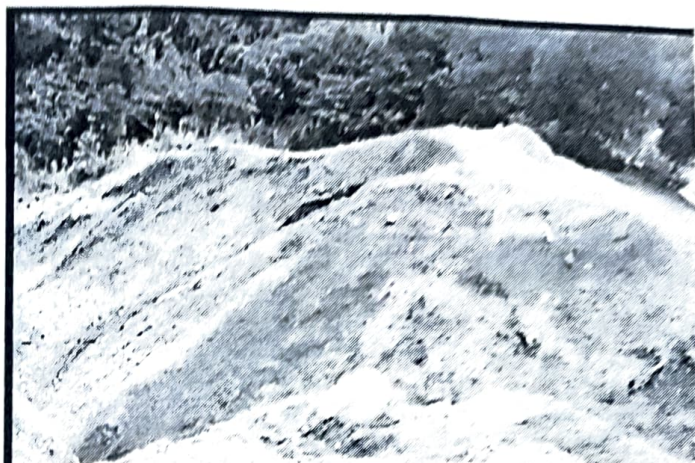
Location-8:

| Sl. No. | Specific locations | GPS Locations | Approx. damaged area (in Ha) |
|---|---|---|---|
| 8 | 0.5 Km from Chhiahtlang towards Chhingchhip | 23° 23' 52.38" N<br>92° 50' 57.3" E | 0.6 |

Location : 0.5 Km from  $23^{\circ}23.873'N$  Area - 0.6Ha  
Chhiahtlang to Chhingchhip  $92^{\circ}50.955'E$

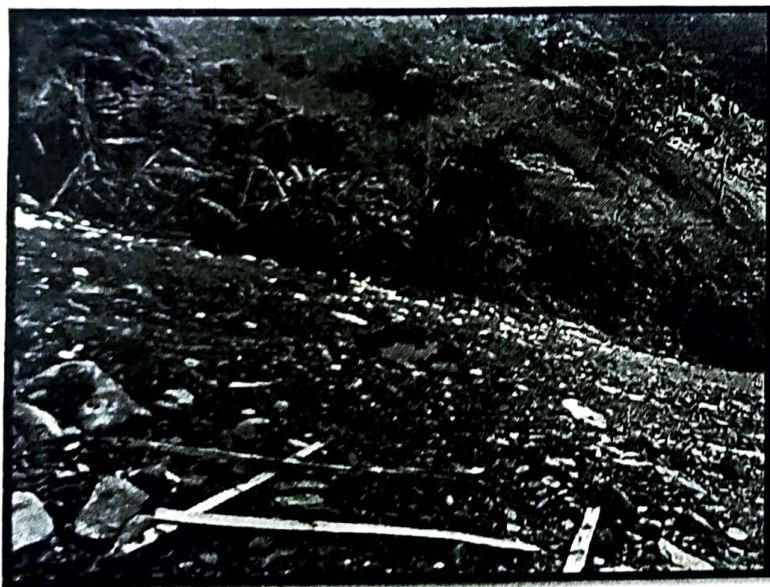
Location-9:

| Sl. No. | Specific locations | GPS Locations | Approx. damaged area (in Ha) |
|---|---|---|---|
| 9 | Serchhip to Keitum road near Dumping ground | 23° 15' 47.66" N<br>92° 52' 47.46" E | 0.2 |
